Deteriorating Buildings: Ticking Time Bombs

TH205

Thursday, June 21, 2018 | 7:30 AM – 9:00 AM

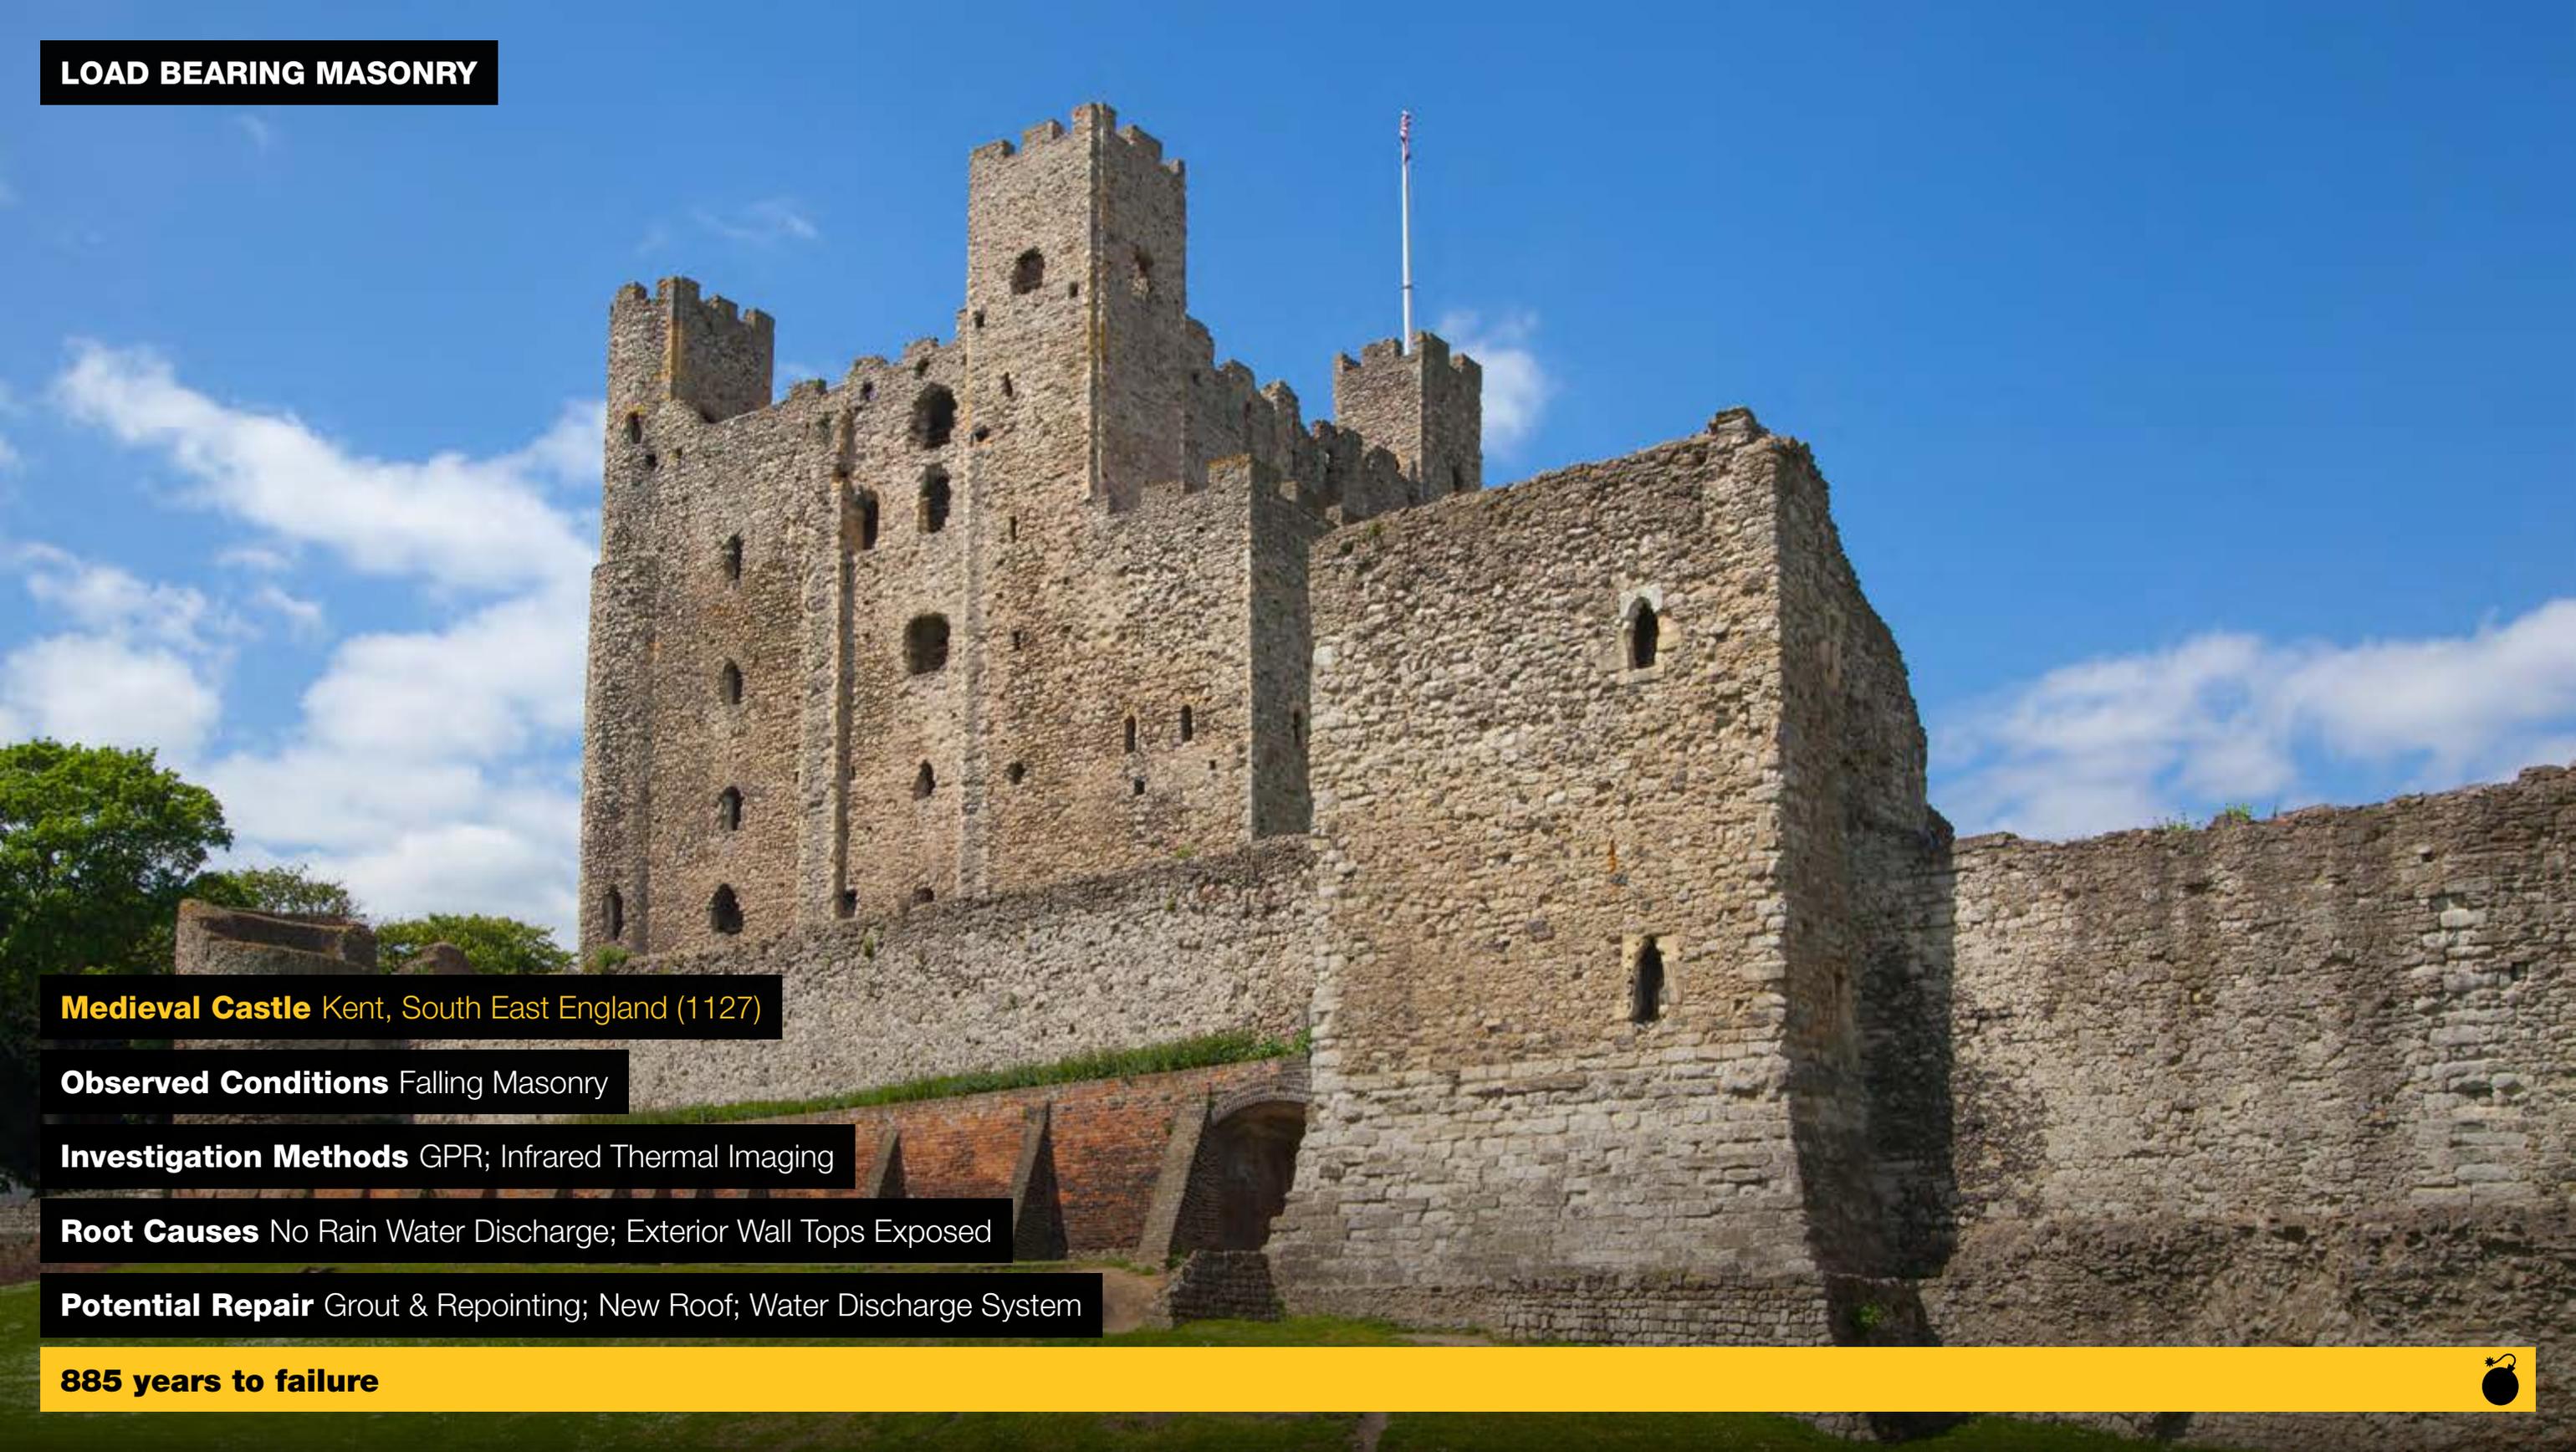
Medieval Castle Kent, South East England (1127)

Observed Conditions Falling Masonry

Root Causes No Rain Water Discharge; Exterior Wall Tops Exposed

885 years to failure

Potential Repair Grout & Repointing; New Roof; Water Discharge System

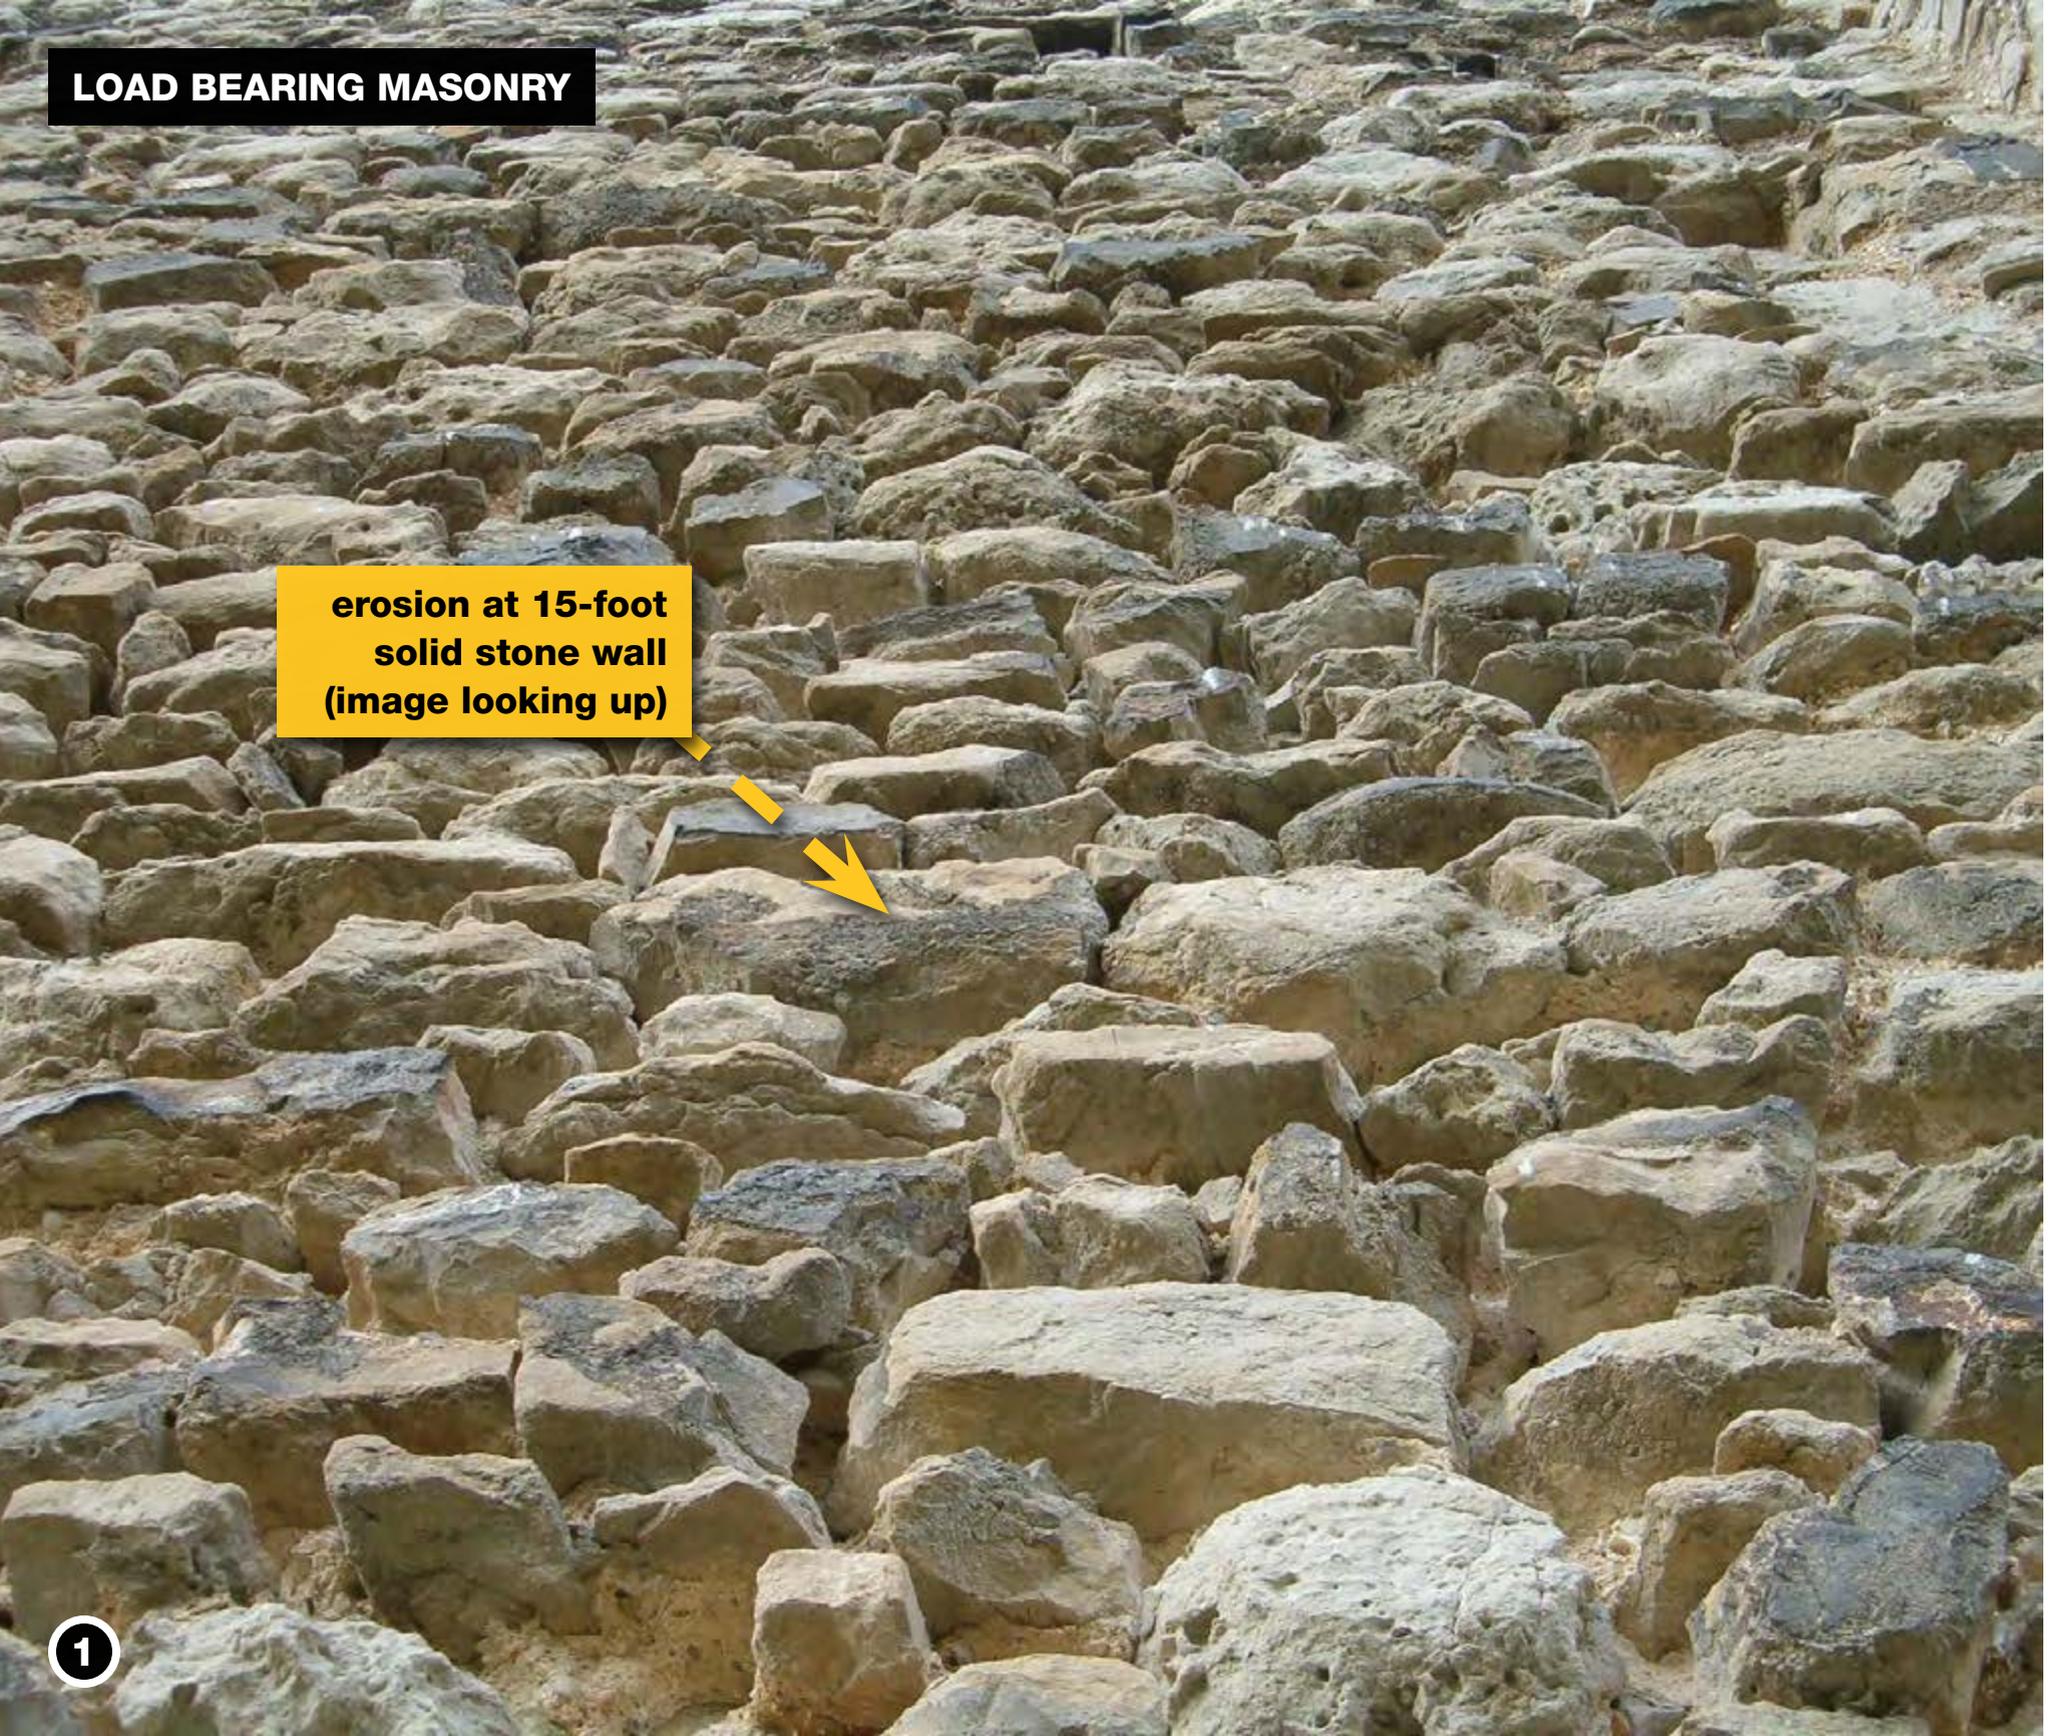
**erosion at 15-foot
solid stone wall
(image looking up)**

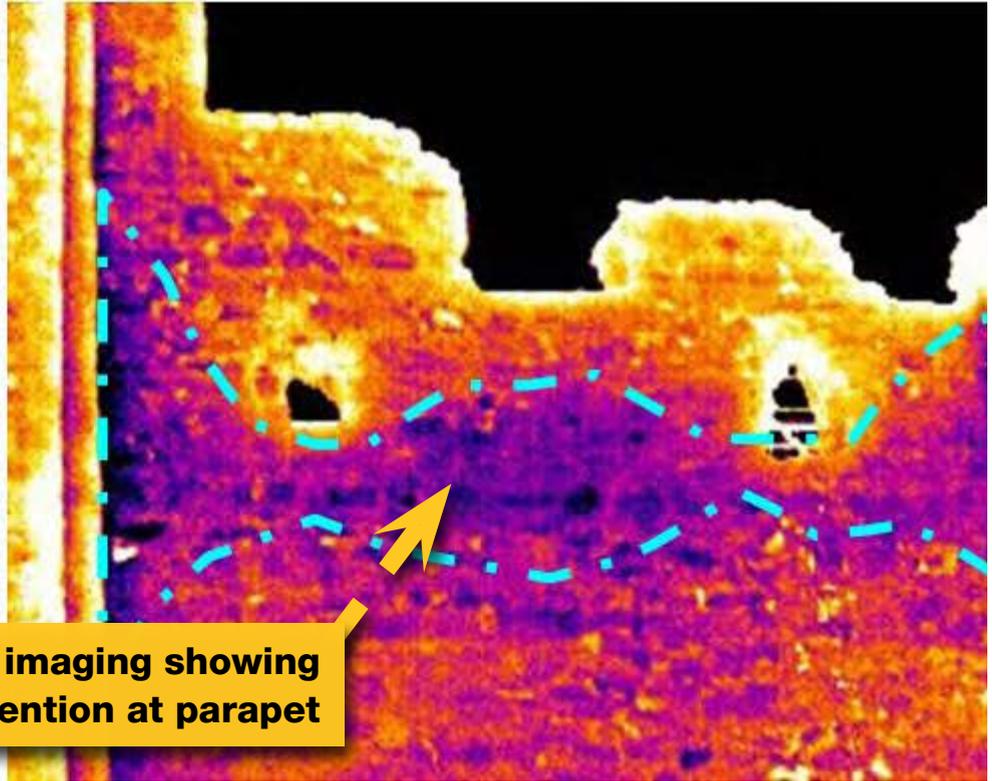
thermal imaging showing moisture retention at parapet

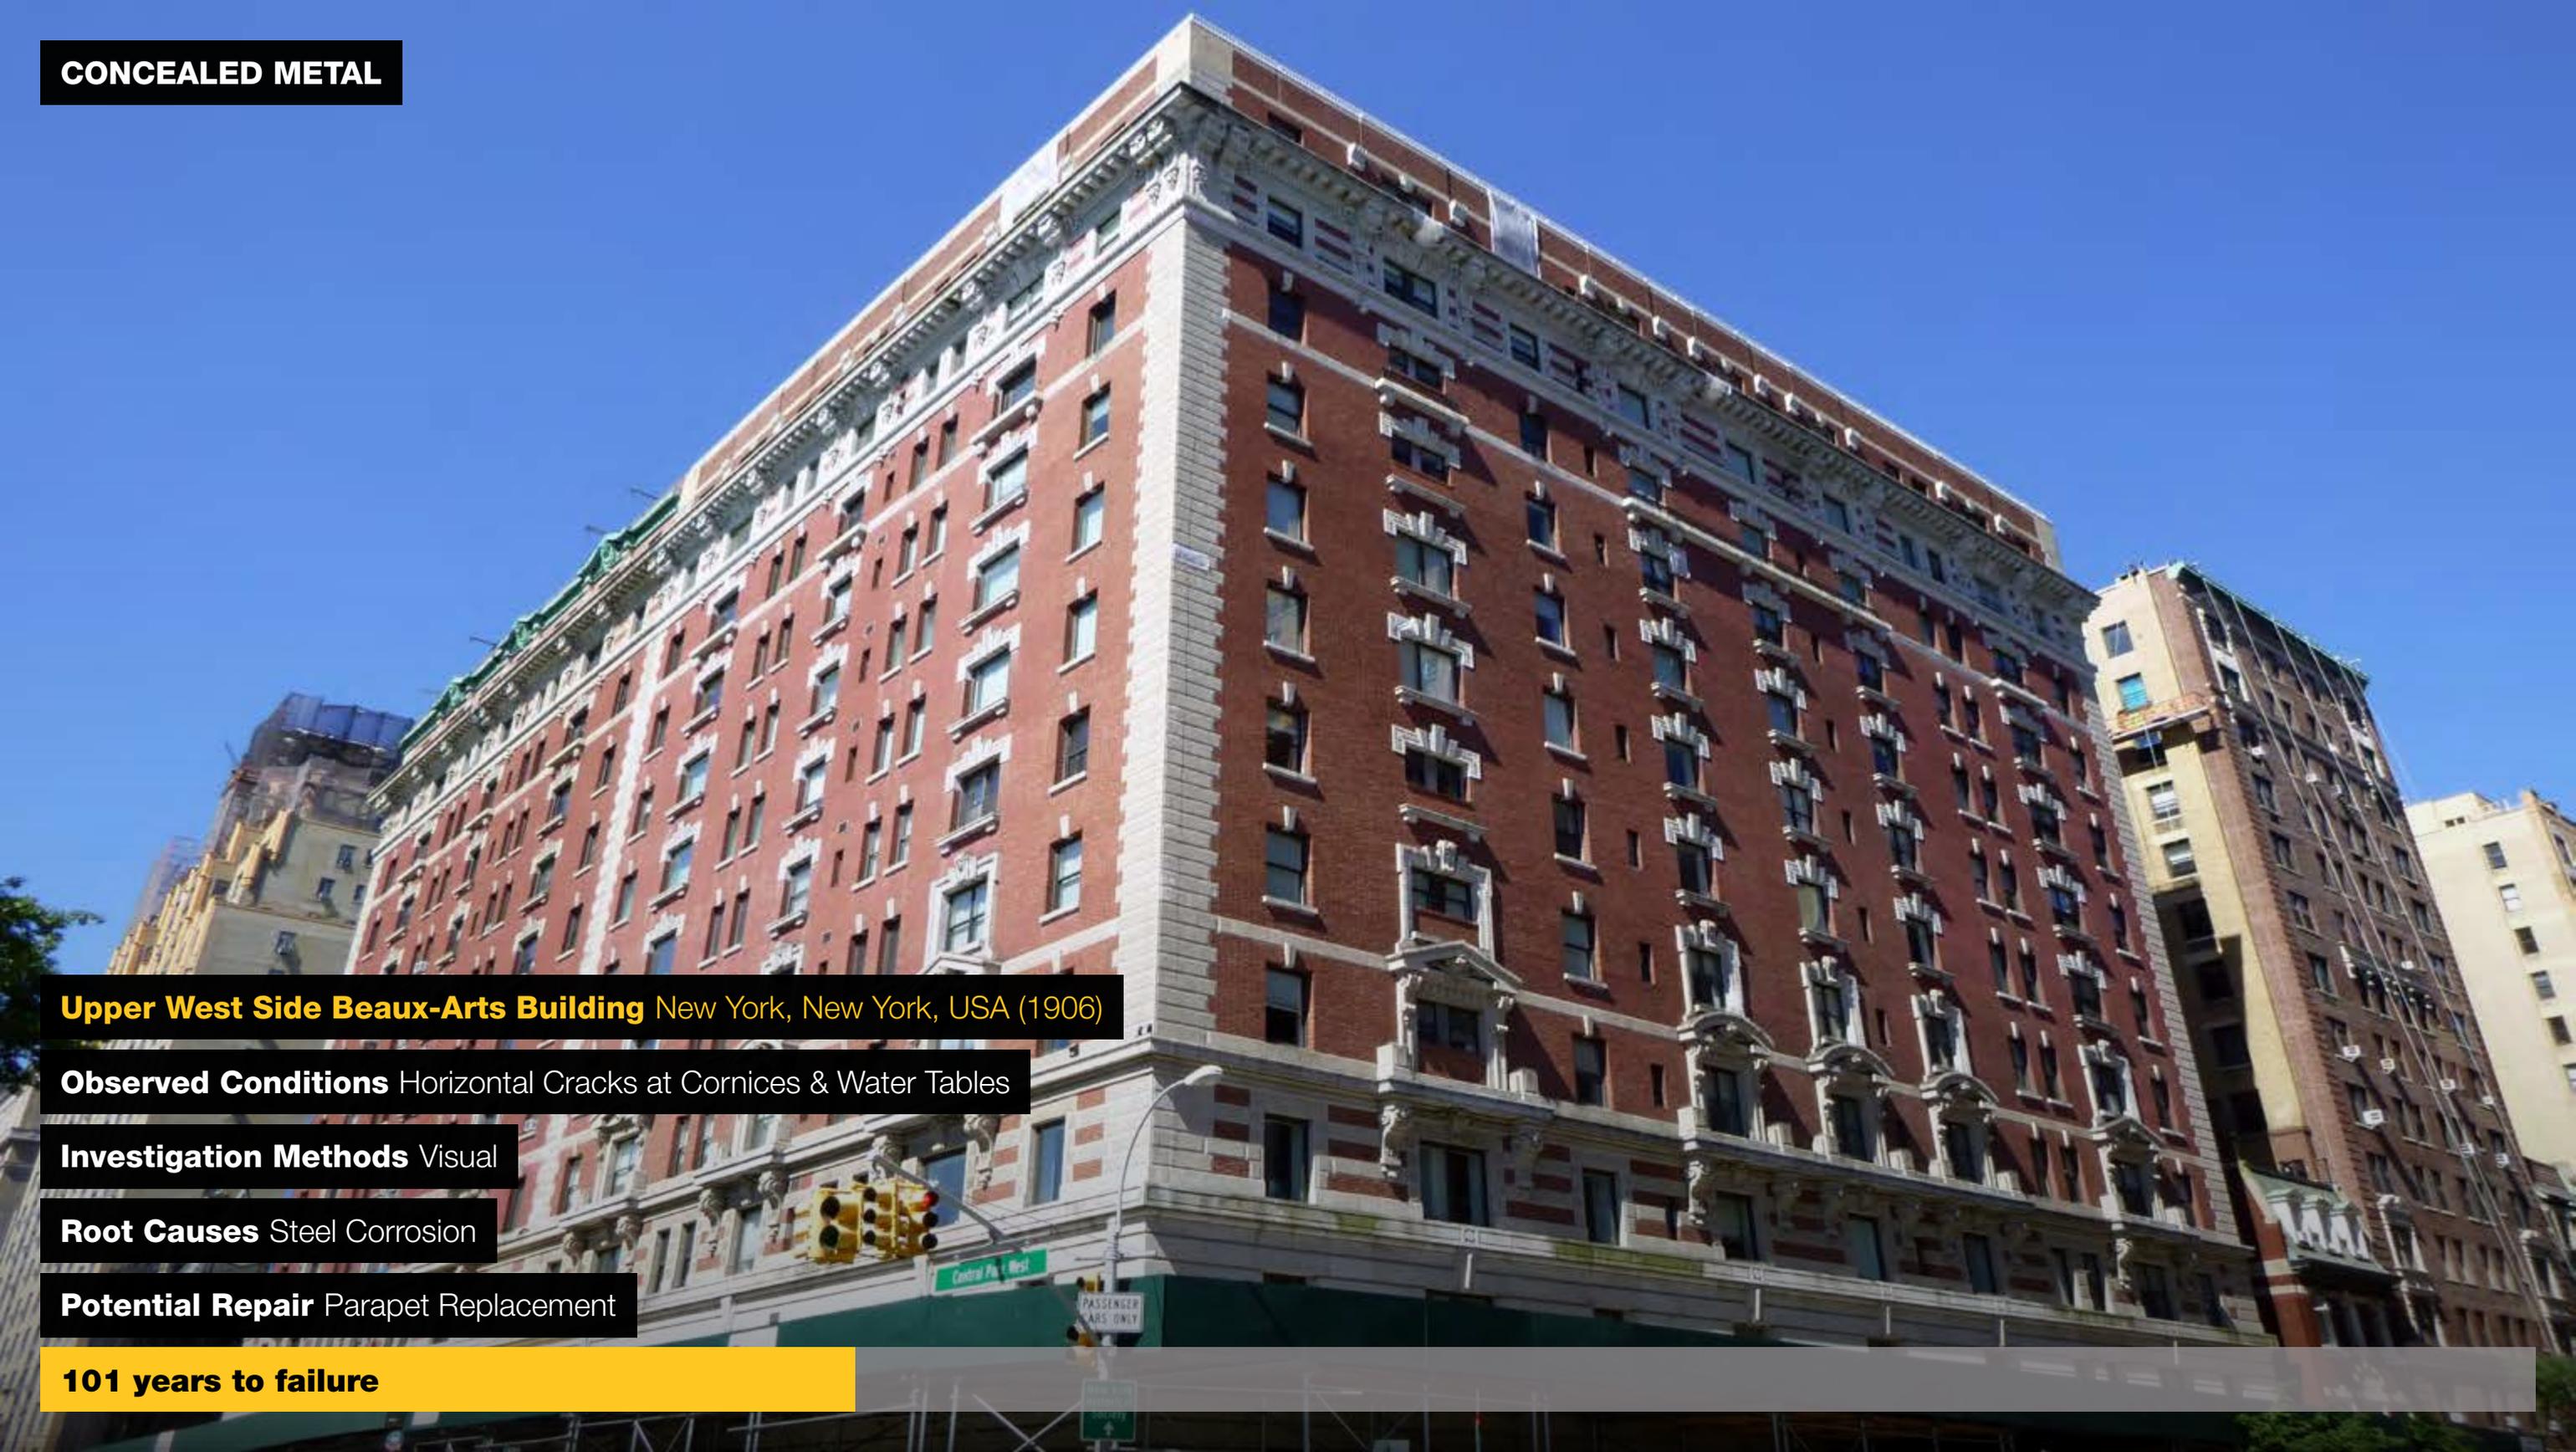
Upper West Side Beaux-Arts Building New York, New York, USA (1906)

Observed Conditions Horizontal Cracks at Cornices & Water Tables

Root Causes Steel Corrosion

101 years to failure

Potential Repair Parapet Replacement

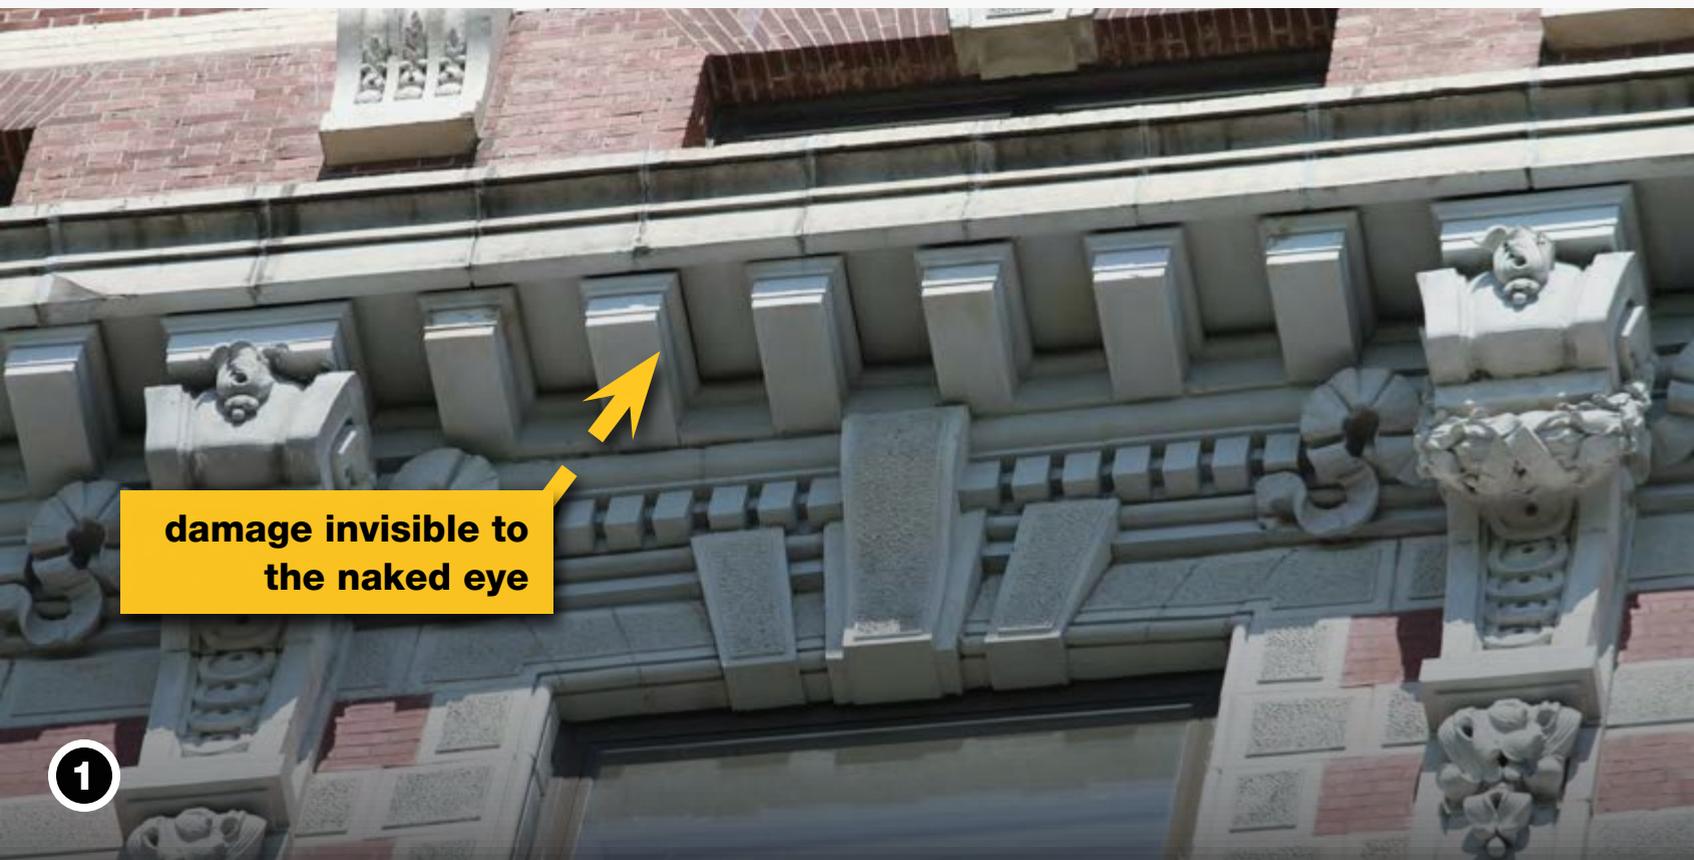
damage invisible to the naked eye

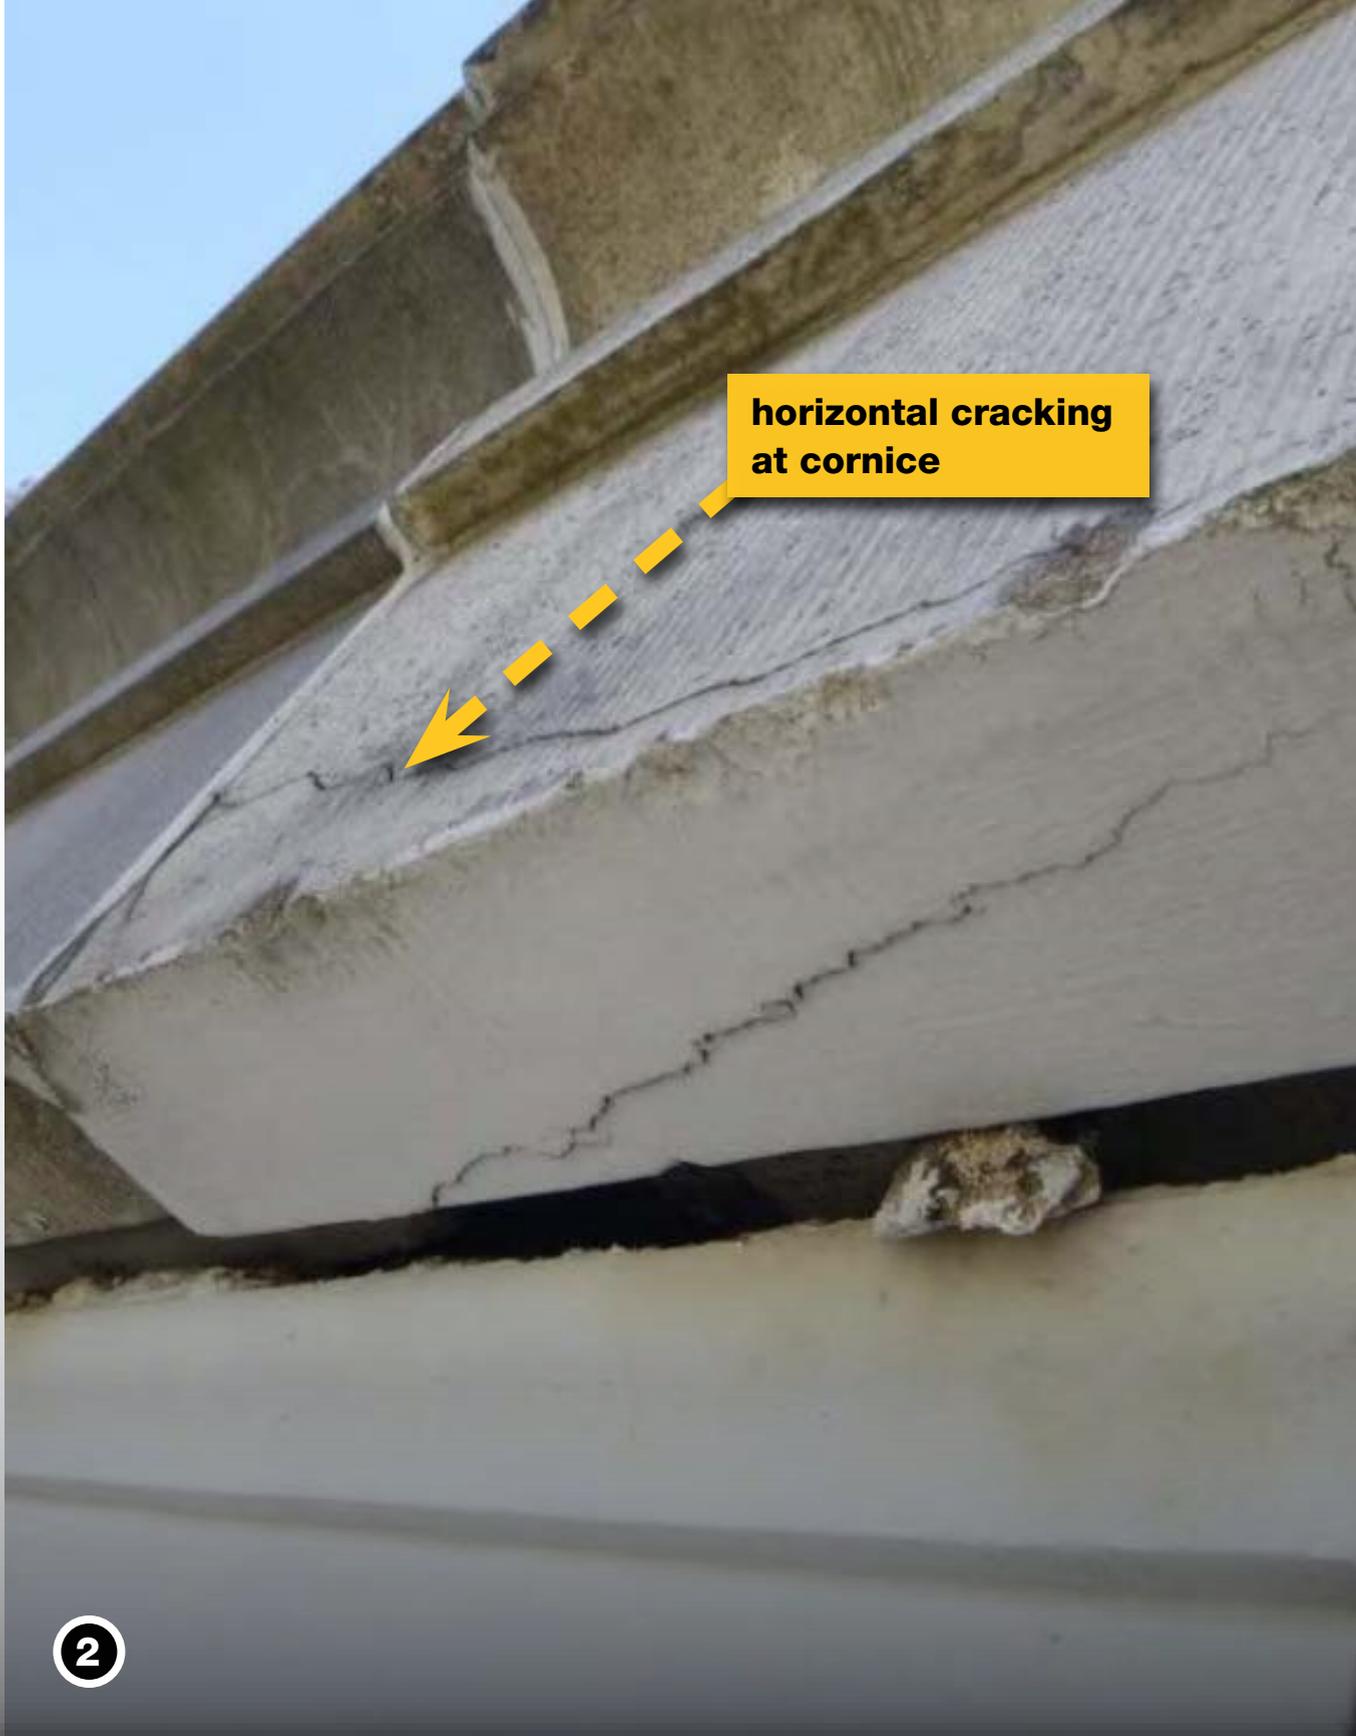
shifting terra
cotta units

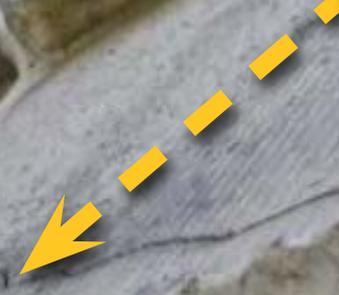
horizontal cracking
at cornice

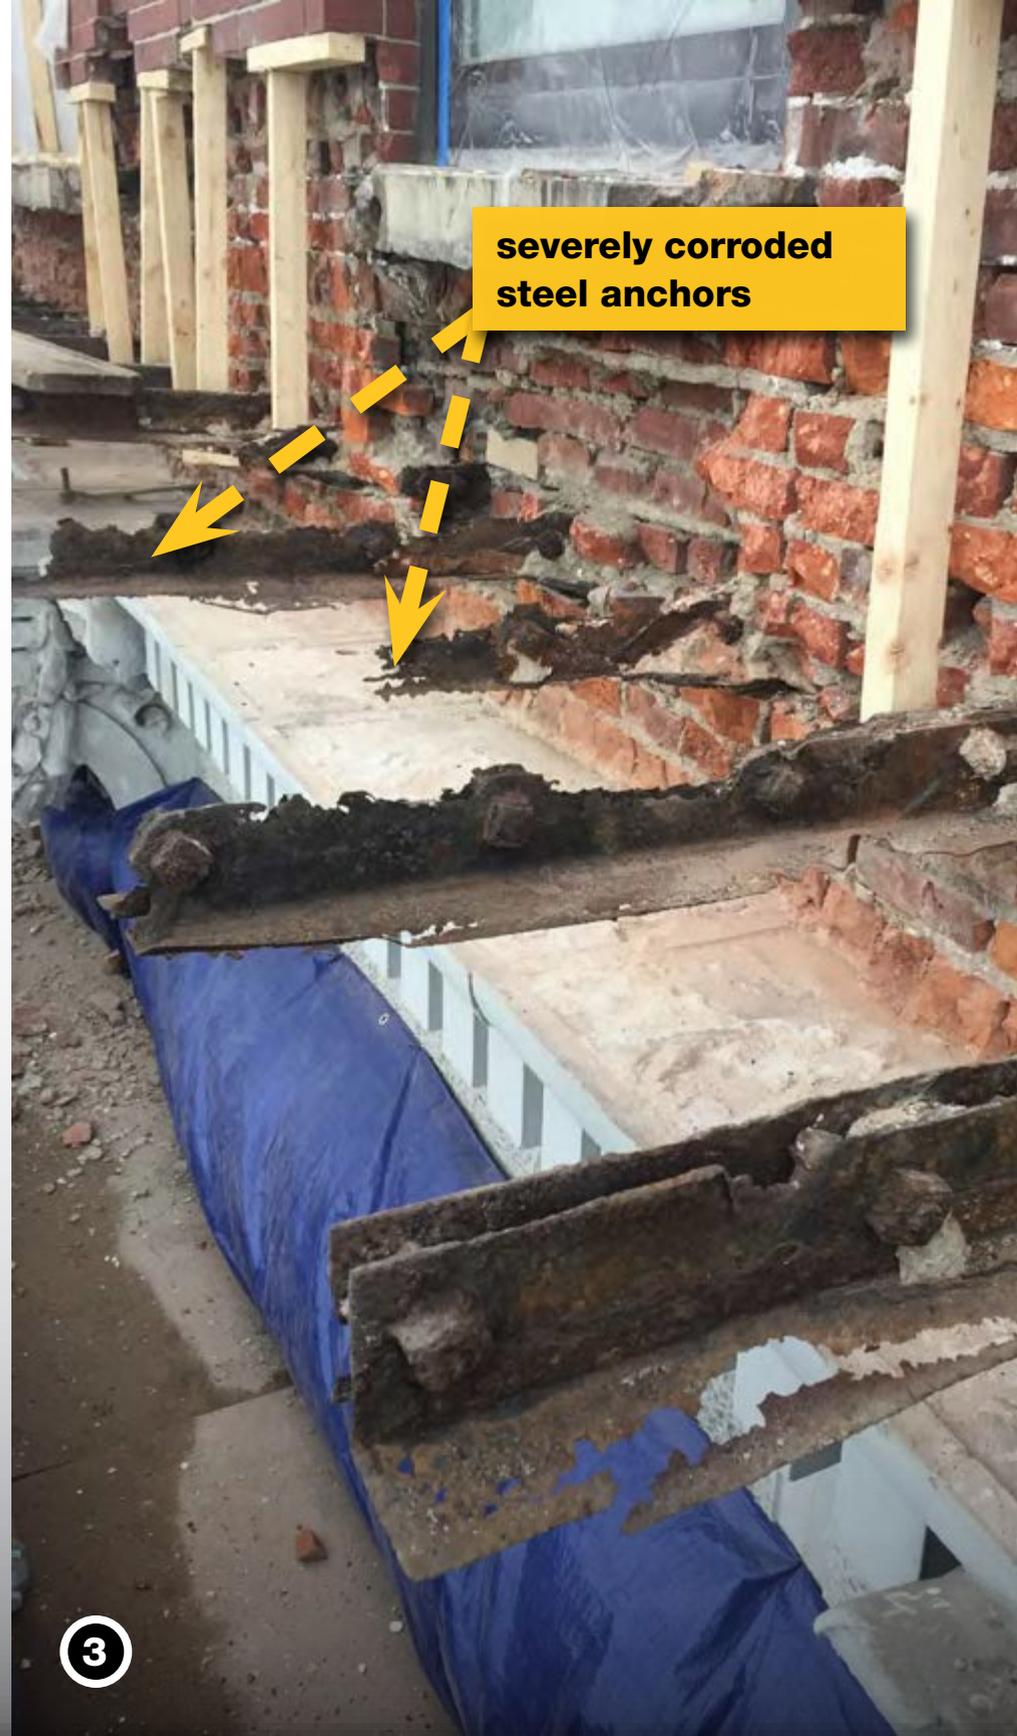
severely corroded steel anchors

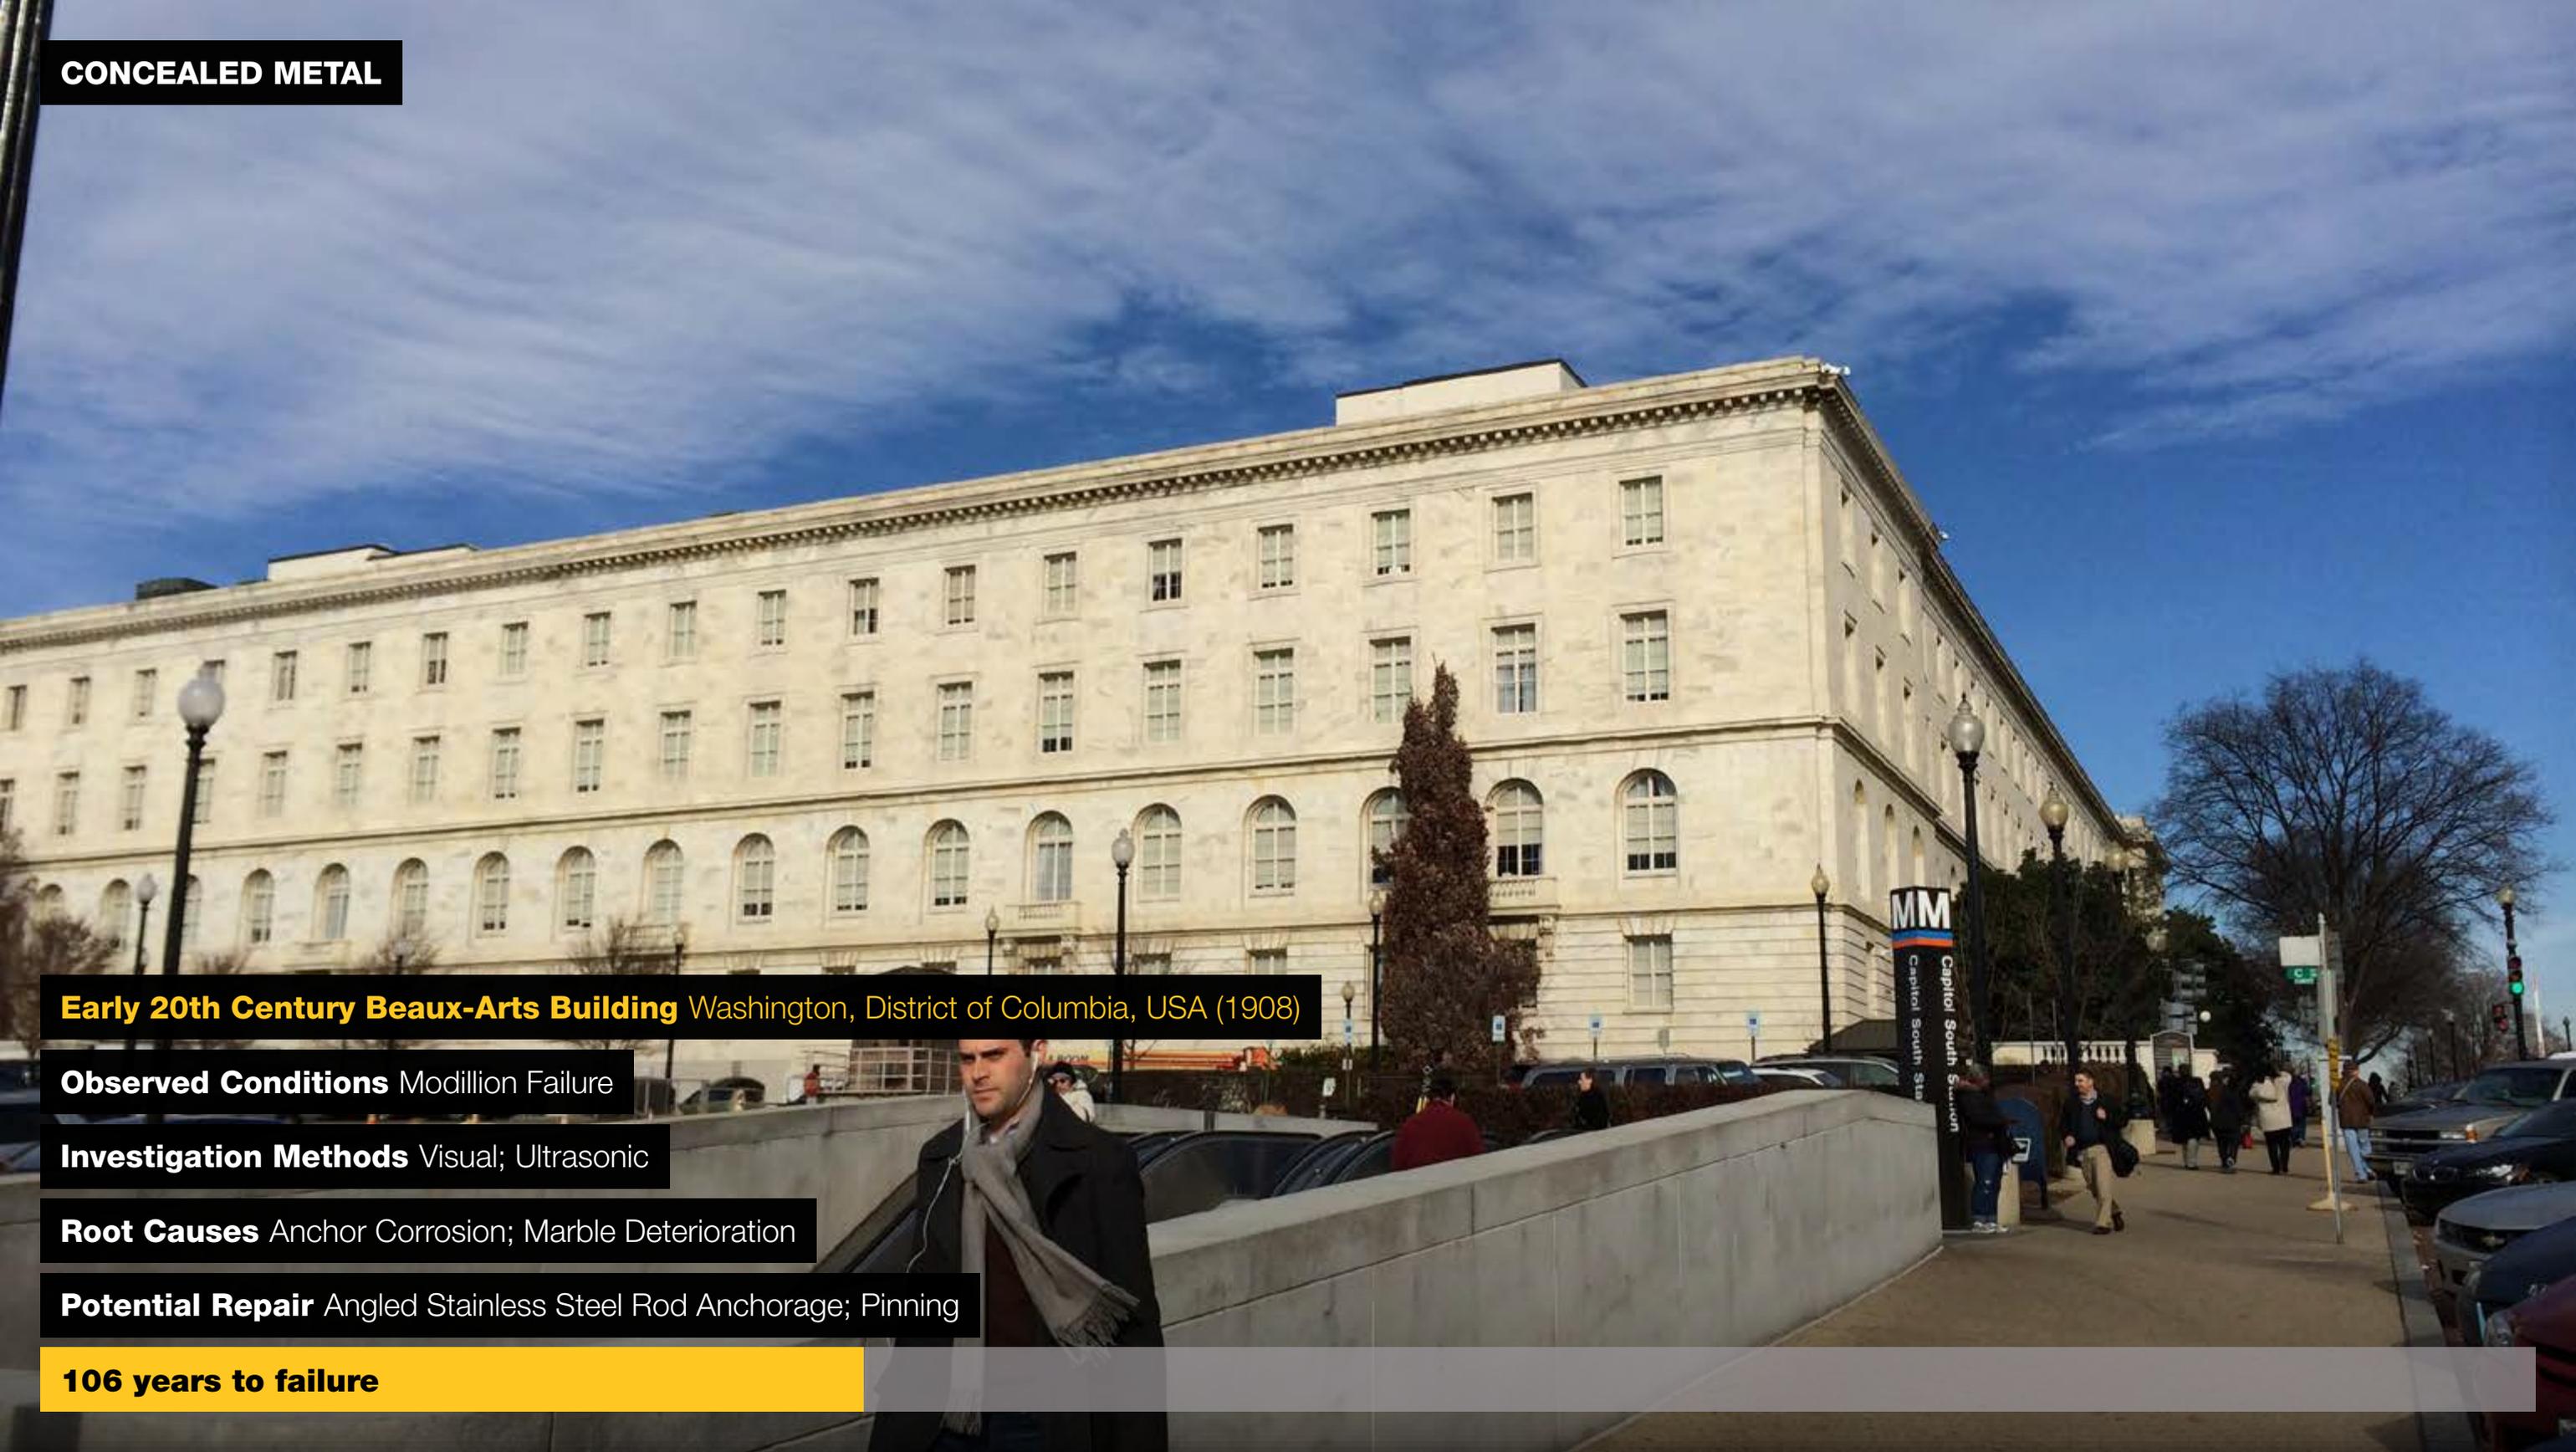
Early 20th Century Beaux-Arts Building Washington, District of Columbia, USA (1908)

Observed Conditions Modillion Failure

Root Causes Anchor Corrosion; Marble Deterioration

106 years to failure

Potential Repair Angled Stainless Steel Rod Anchorage; Pinning
