Deteriorating Buildings: Ticking Time Bombs

TH205

Thursday, June 21, 2018 | 7:30 AM – 9:00 AM

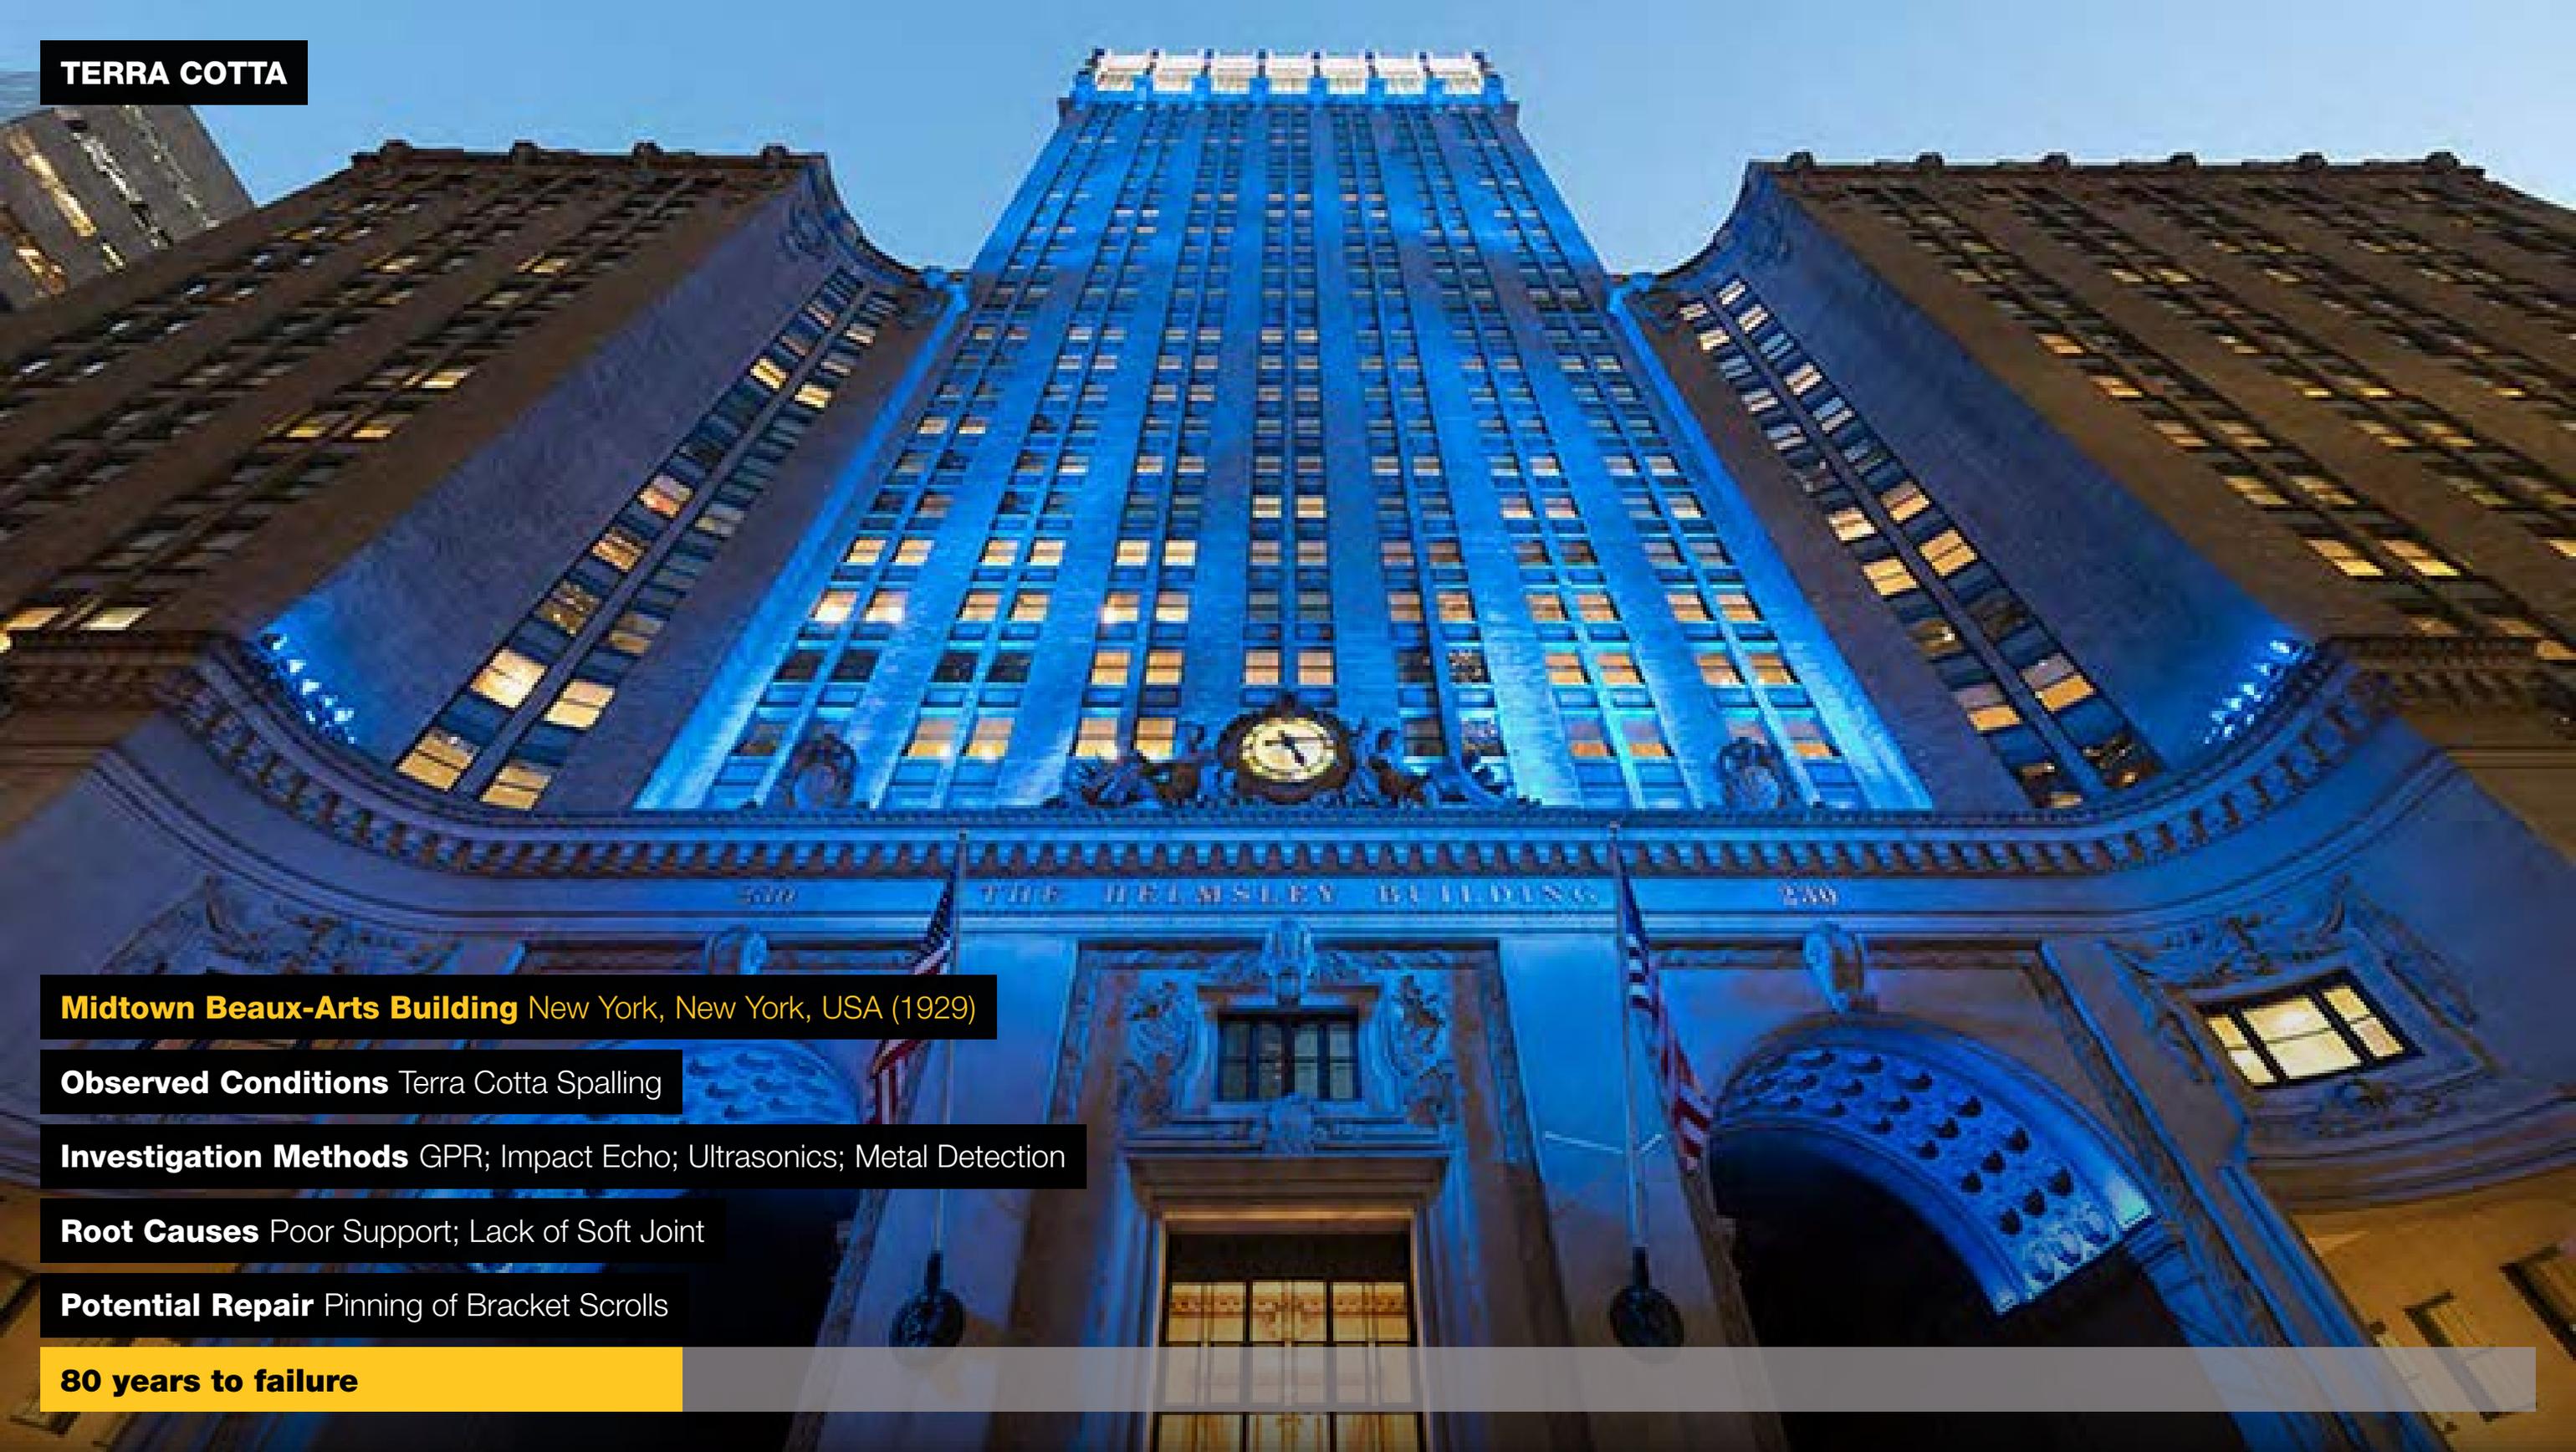
Midtown Beaux-Arts Building New York, New York, USA (1929)

Observed Conditions Terra Cotta Spalling

Root Causes Poor Support; Lack of Soft Joint

80 years to failure

Potential Repair Pinning of Bracket Scrolls

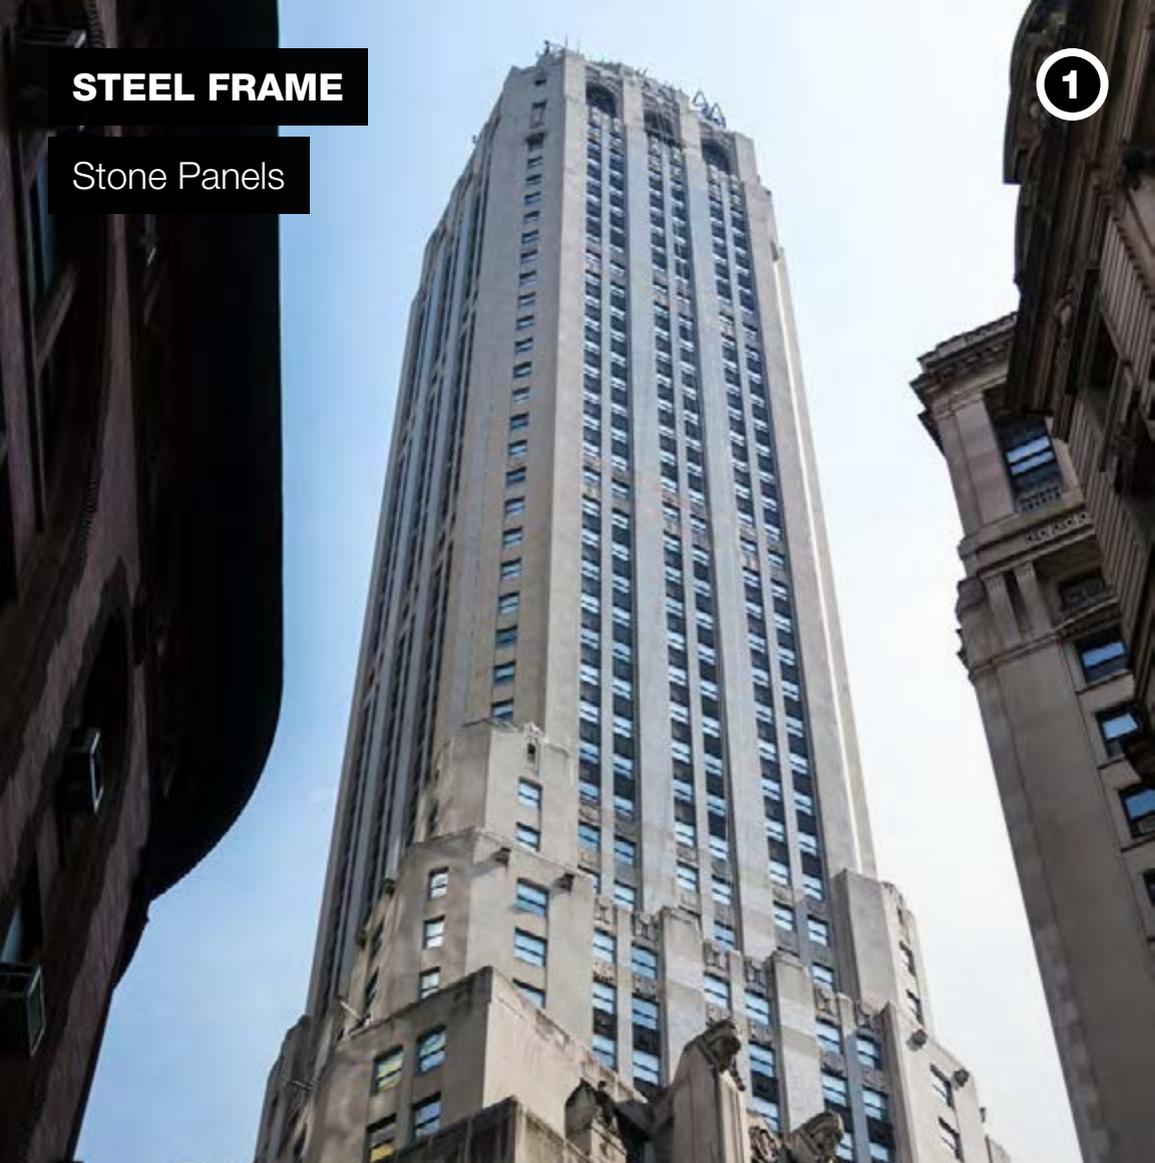
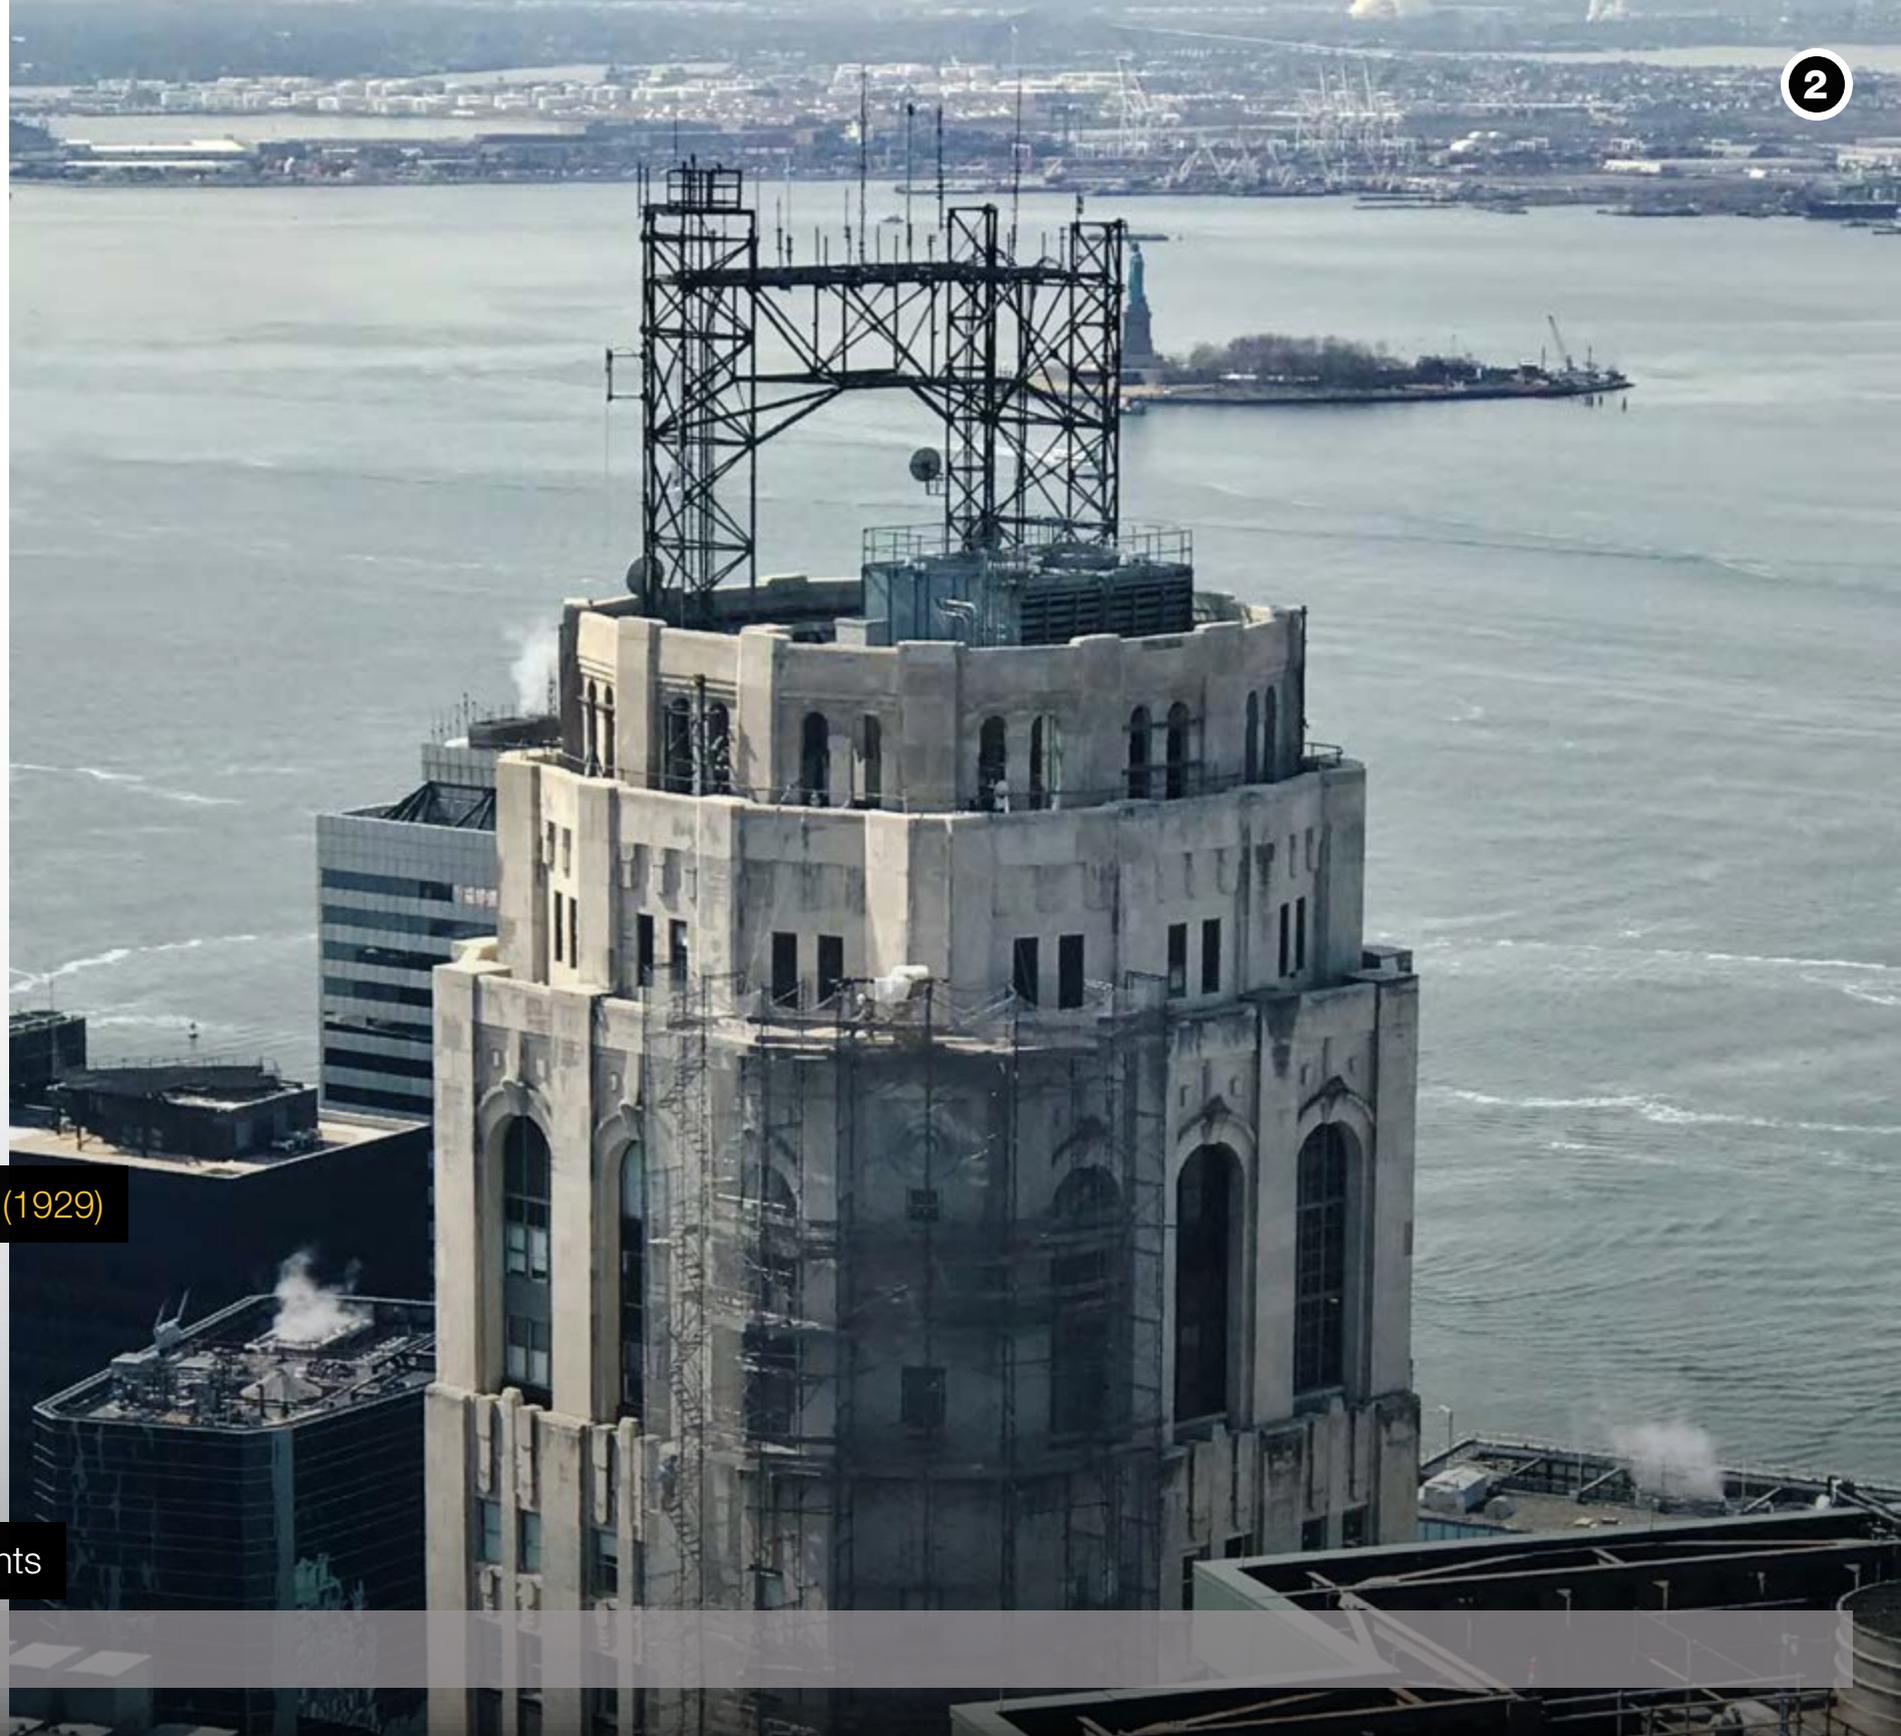
Financial District Art Deco Building New York, New York, USA (1929)

Observed Conditions Vertical Cracking of Limestone

Root Causes Steel Sizing Design; Steel Corrosion

87 years to failure

Potential Repair Replace Stone; Modify Steel; New Expansion Joints

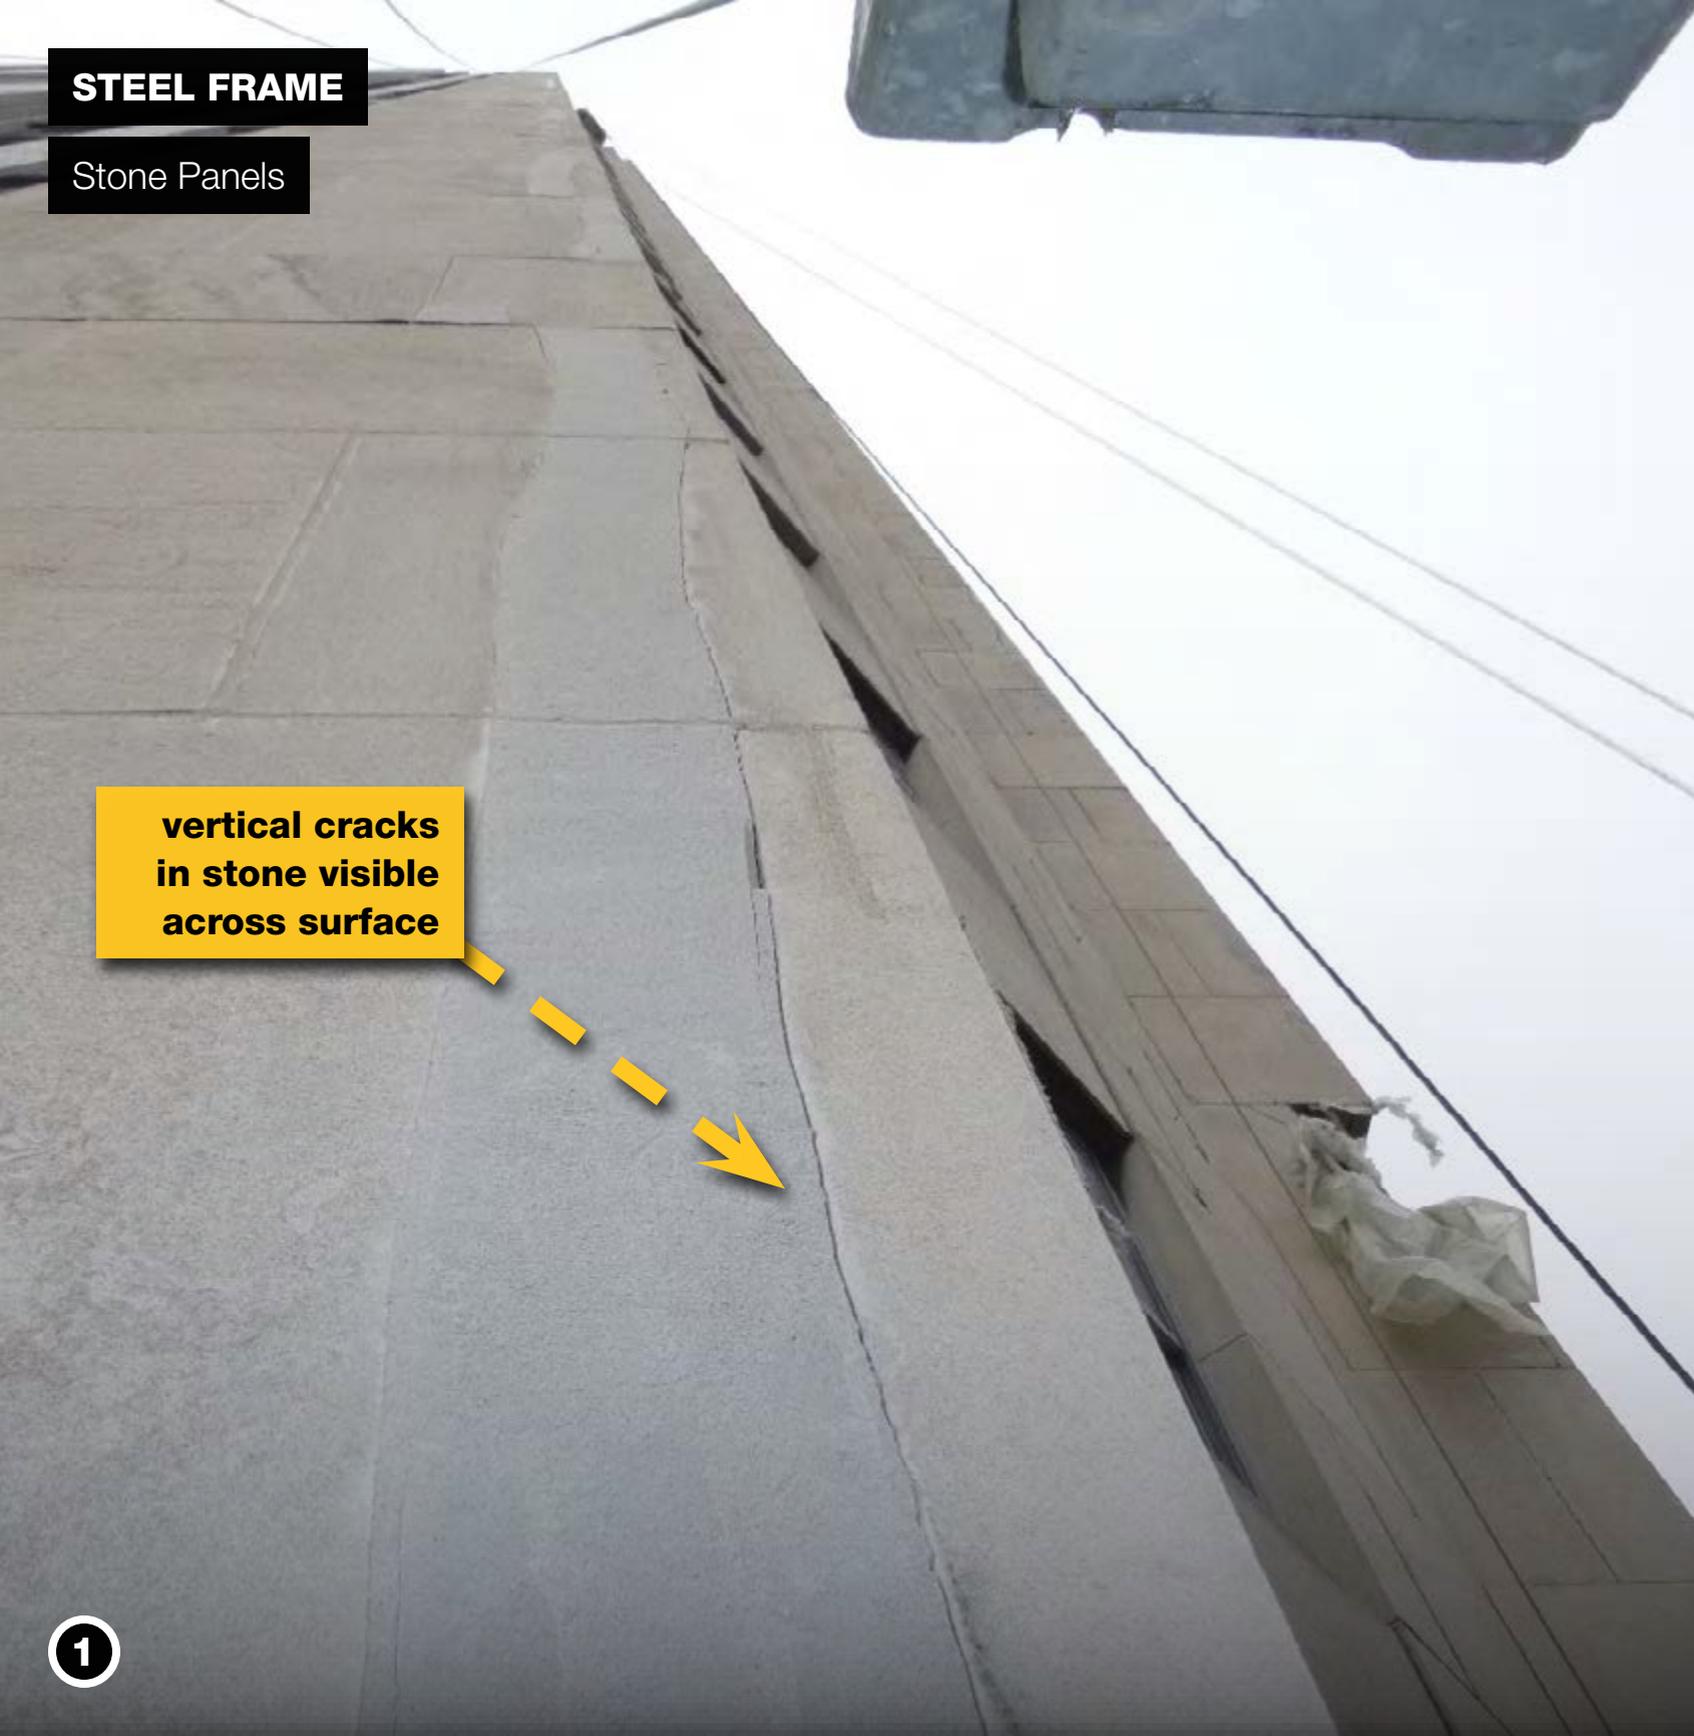
**vertical cracks
in stone visible
across surface**

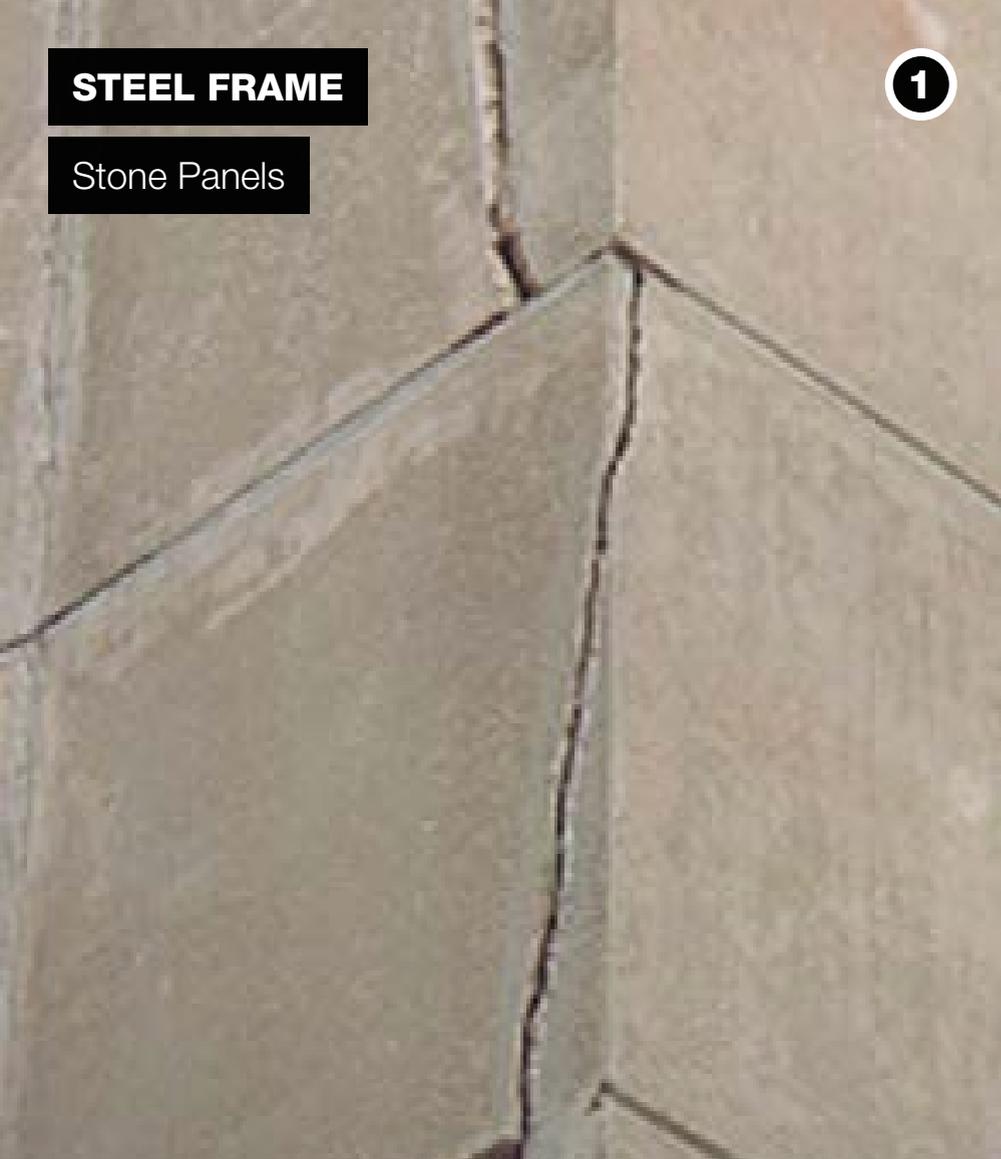
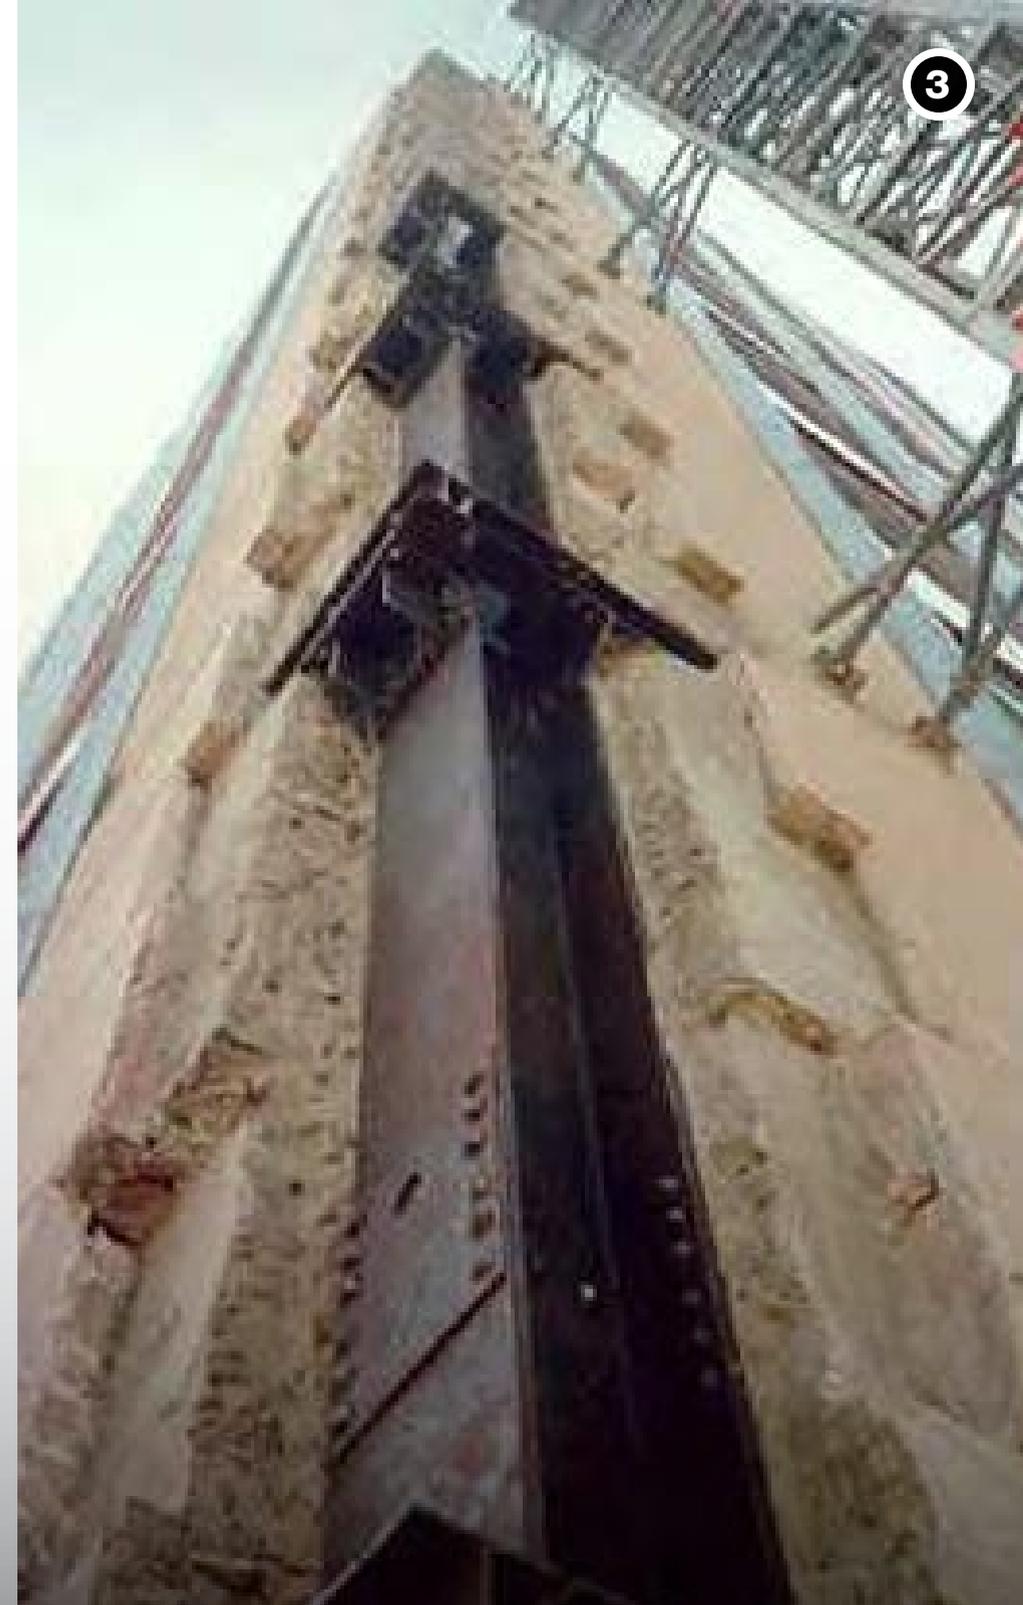
Midtown Art Deco Building New York, New York, USA (1931)

Observed Conditions Vertical Cracking of Limestone

Root Causes Steel Corrosion

68 years to failure

Potential Repair Steel & Limestone Replacement

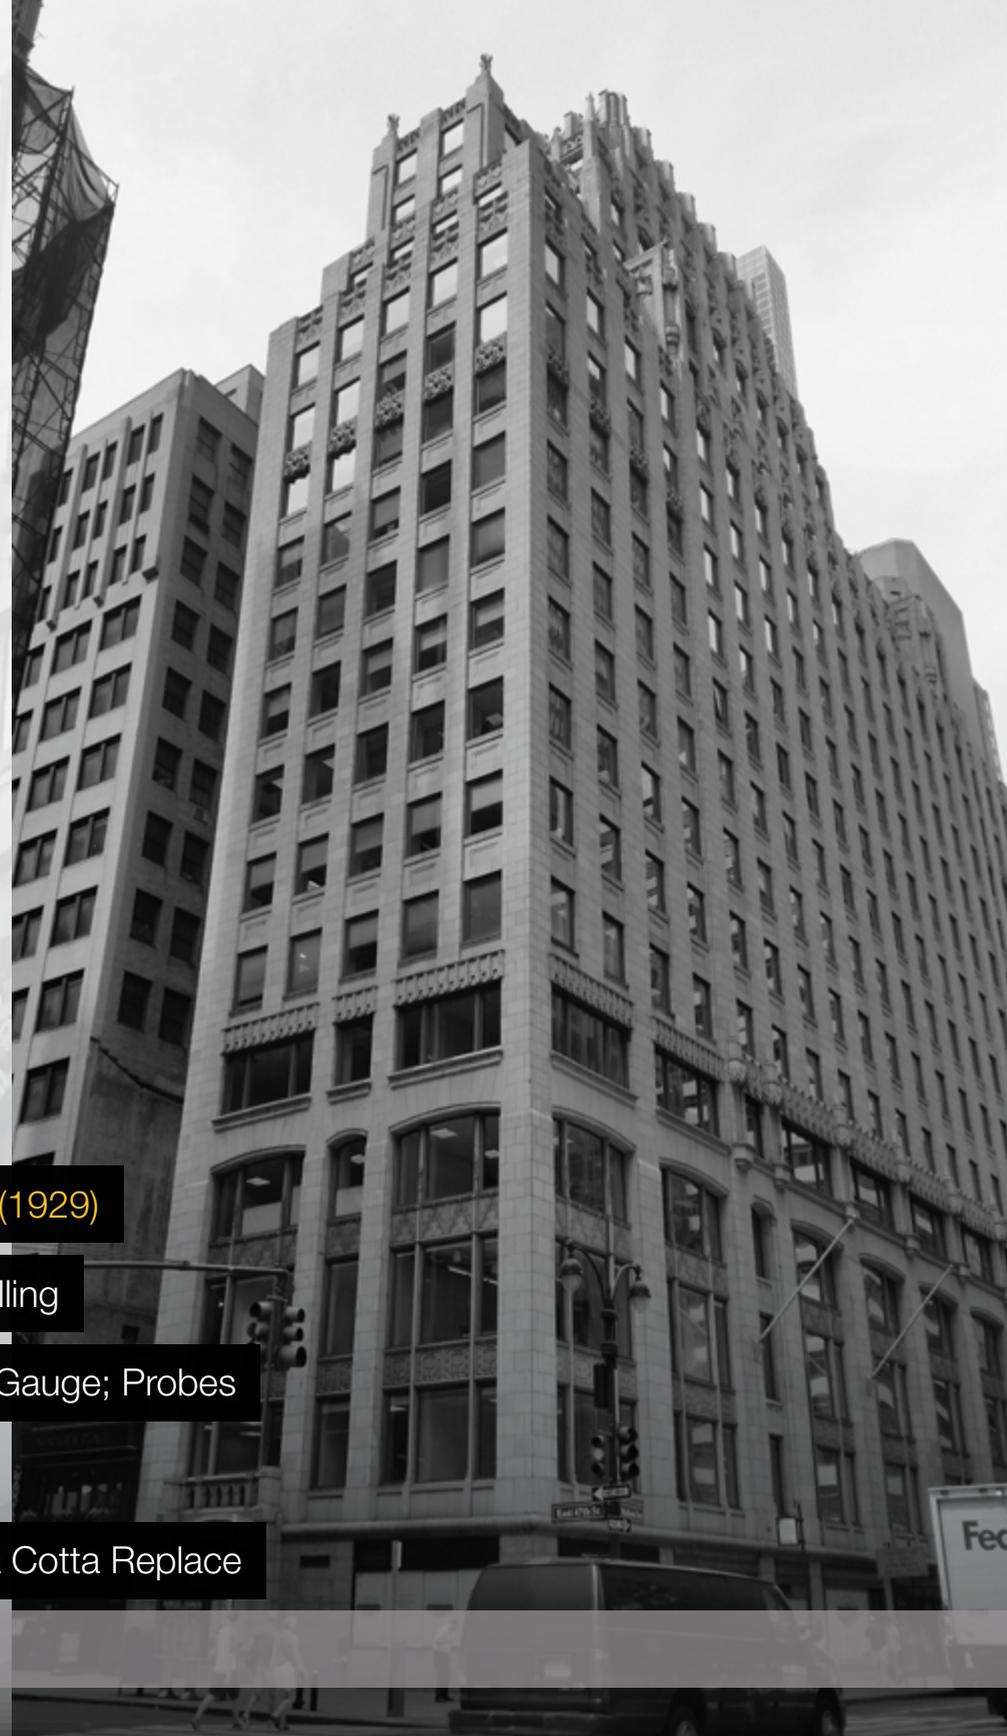
Midtown Art Deco Building New York, New York, USA (1929)

Observed Conditions Steel Deterioration; Cracking; Spalling

Root Causes Corroding Steel Behind Terra Cotta

88 years to failure

Potential Repair Steel Cleaning and Waterproofing; Terra Cotta Replace

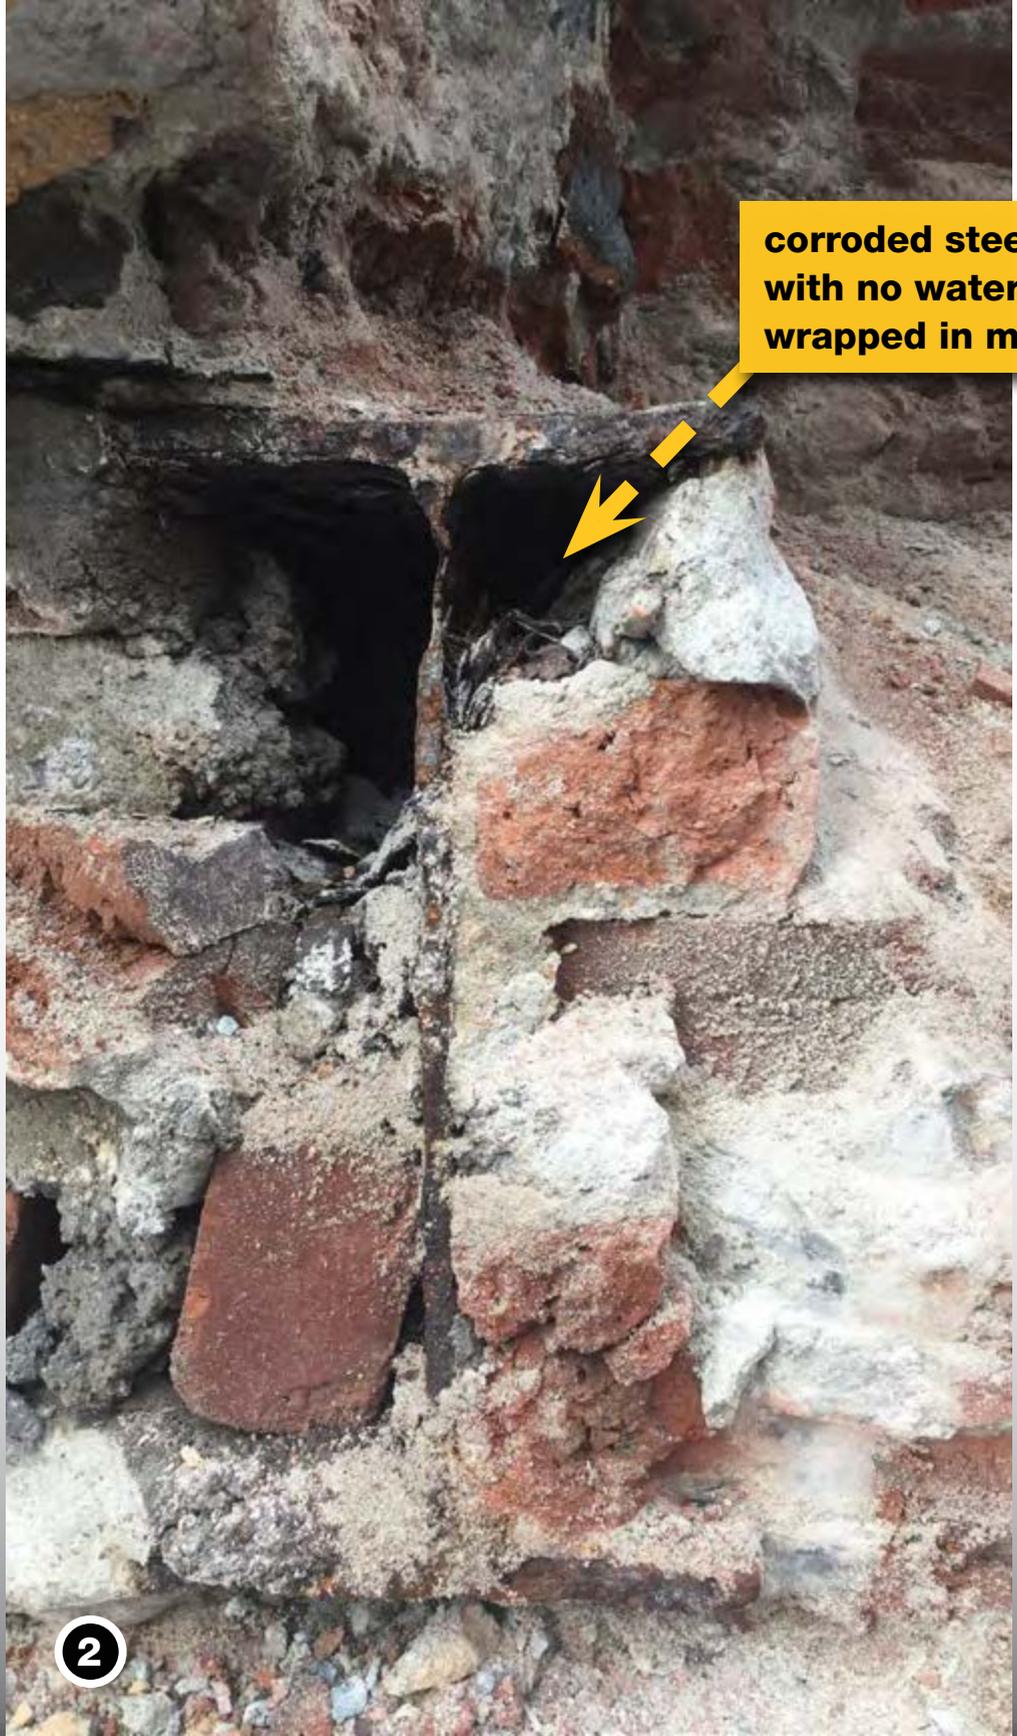
**corroded steel section
with no waterproofing
wrapped in masonry**

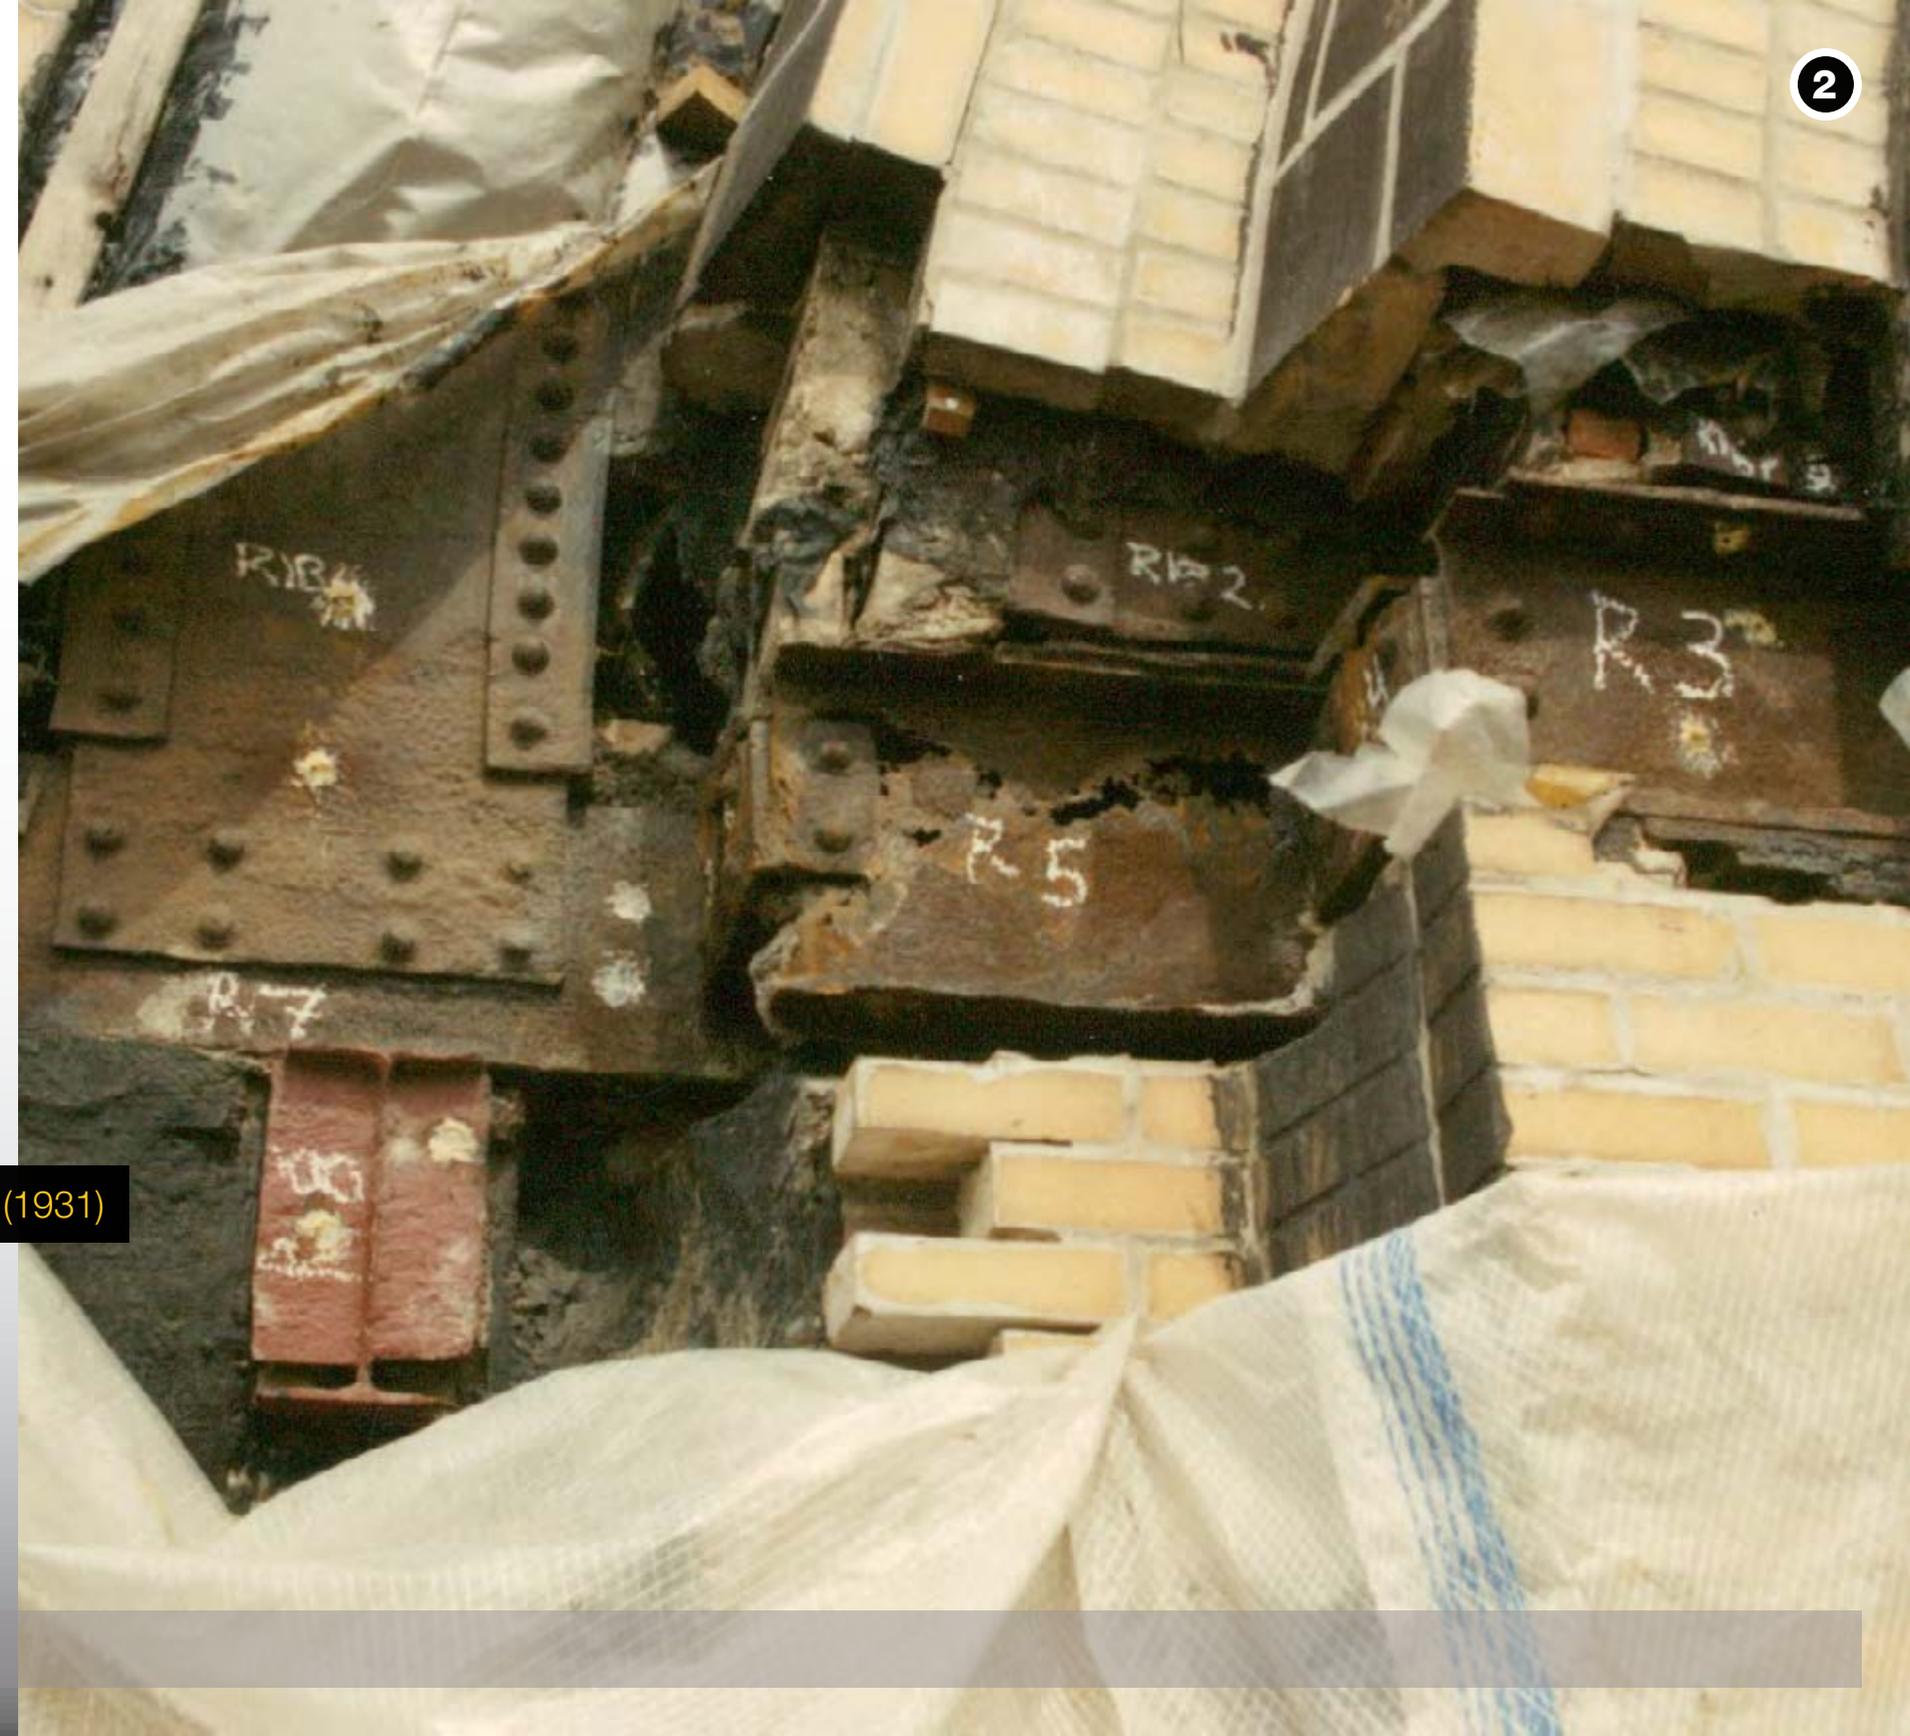
Upper West Side Art Deco Building New York, New York, USA (1931)

Observed Conditions Cracked Masonry

Root Causes Material Corrosion

68 years to failure

Potential Repair Steel Replacement

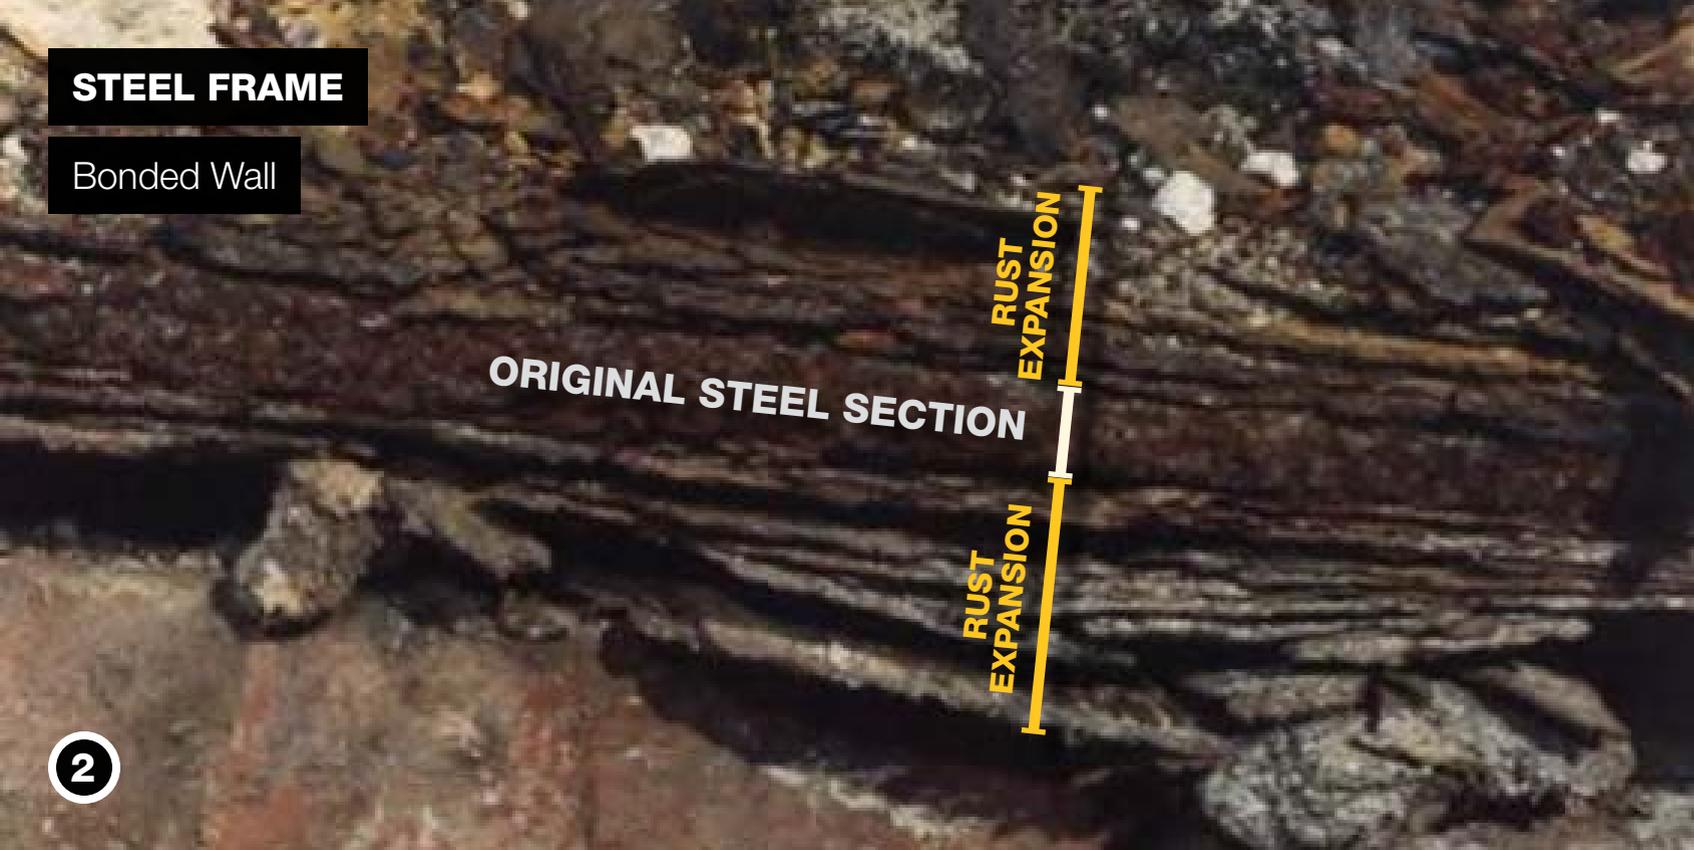
ORIGINAL STEEL SECTION

RUST EXPANSION
