Deteriorating Buildings: Ticking Time Bombs

TH205

Thursday, June 21, 2018 | 7:30 AM – 9:00 AM

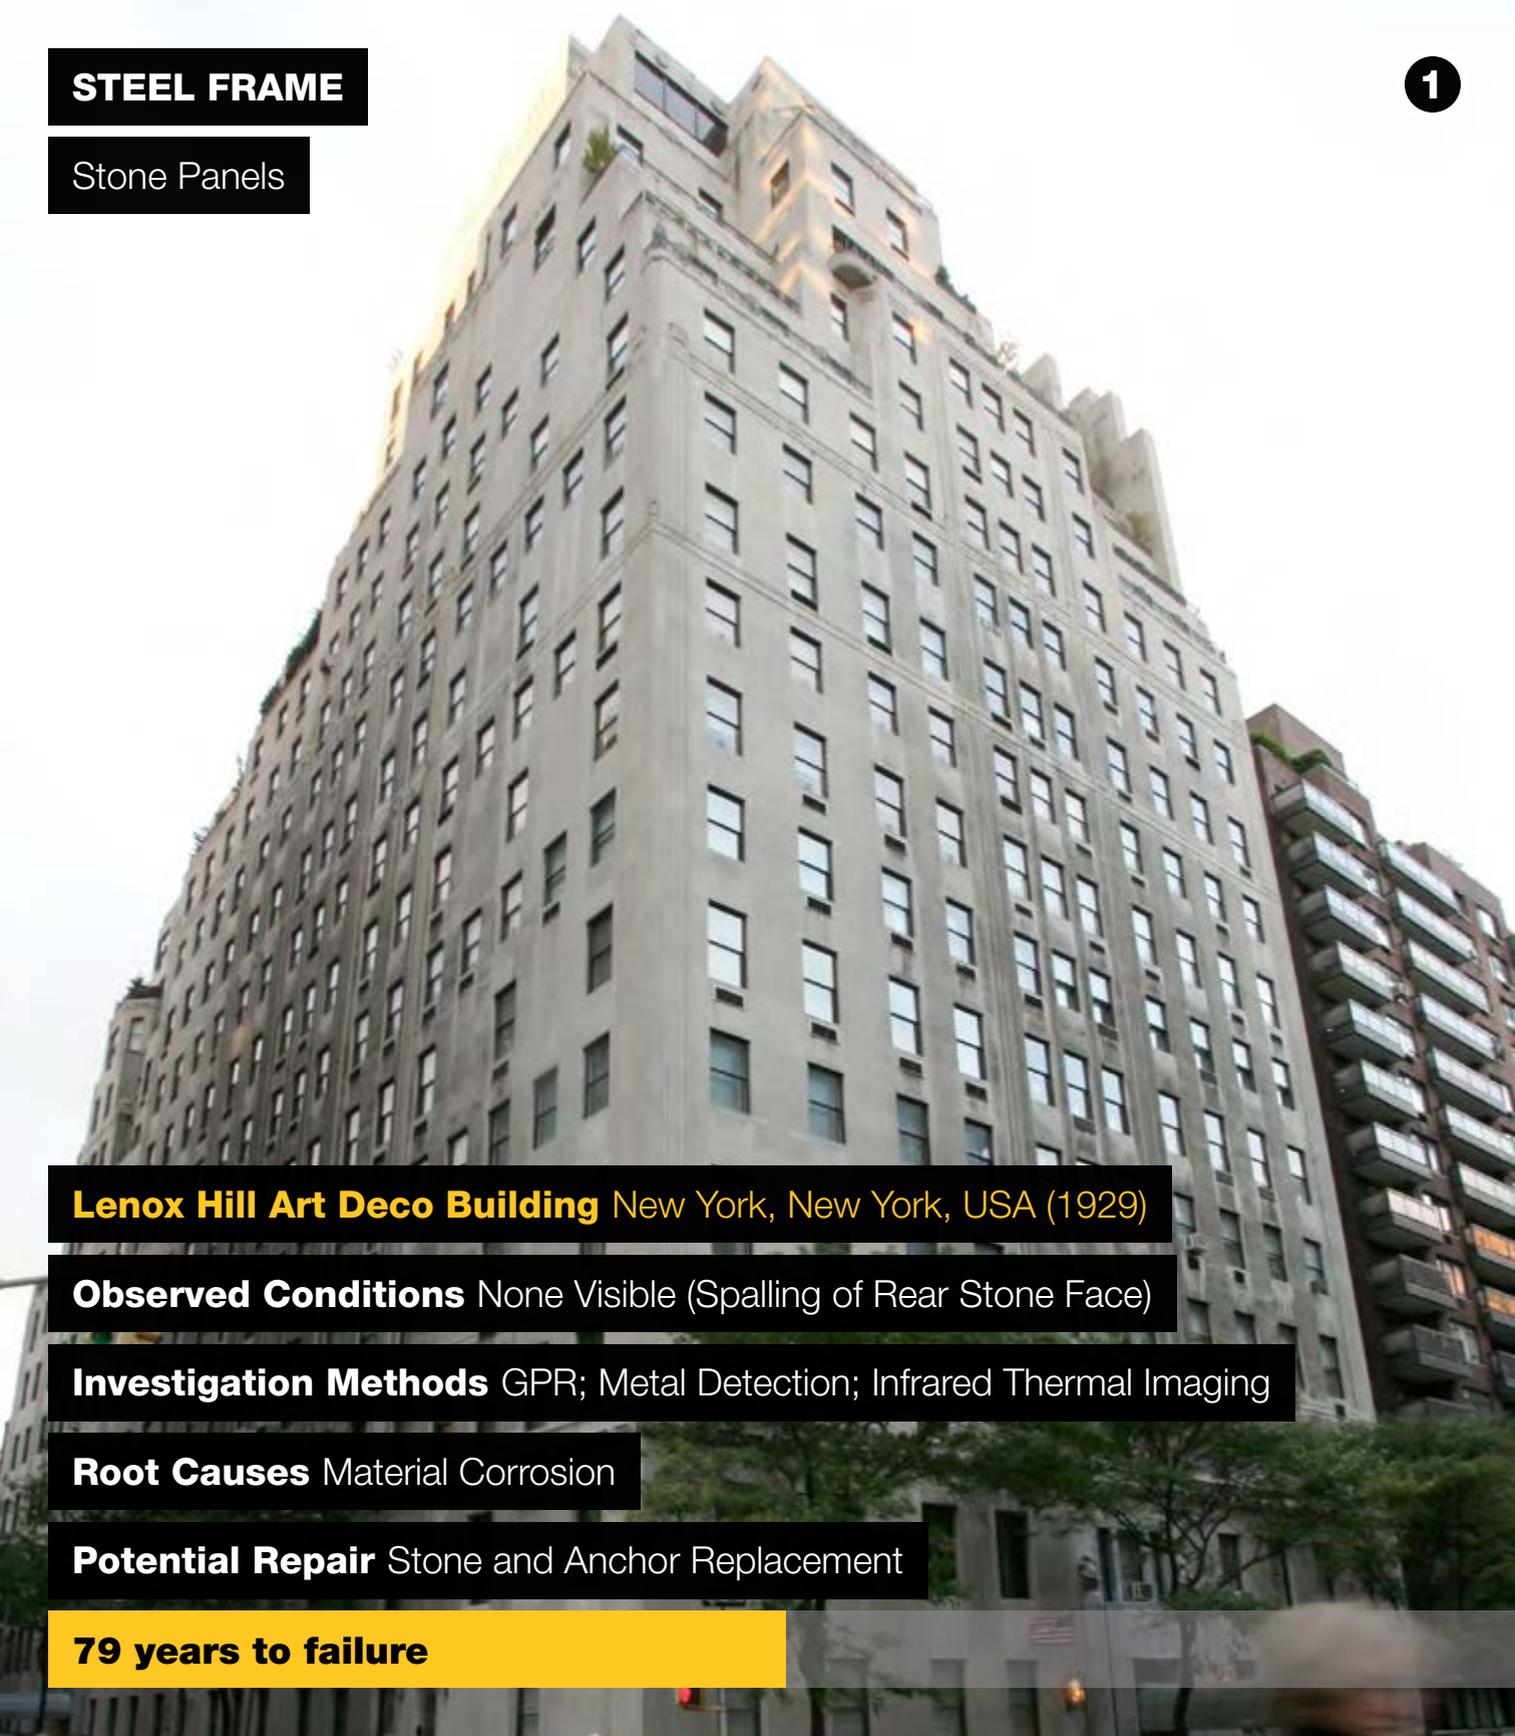
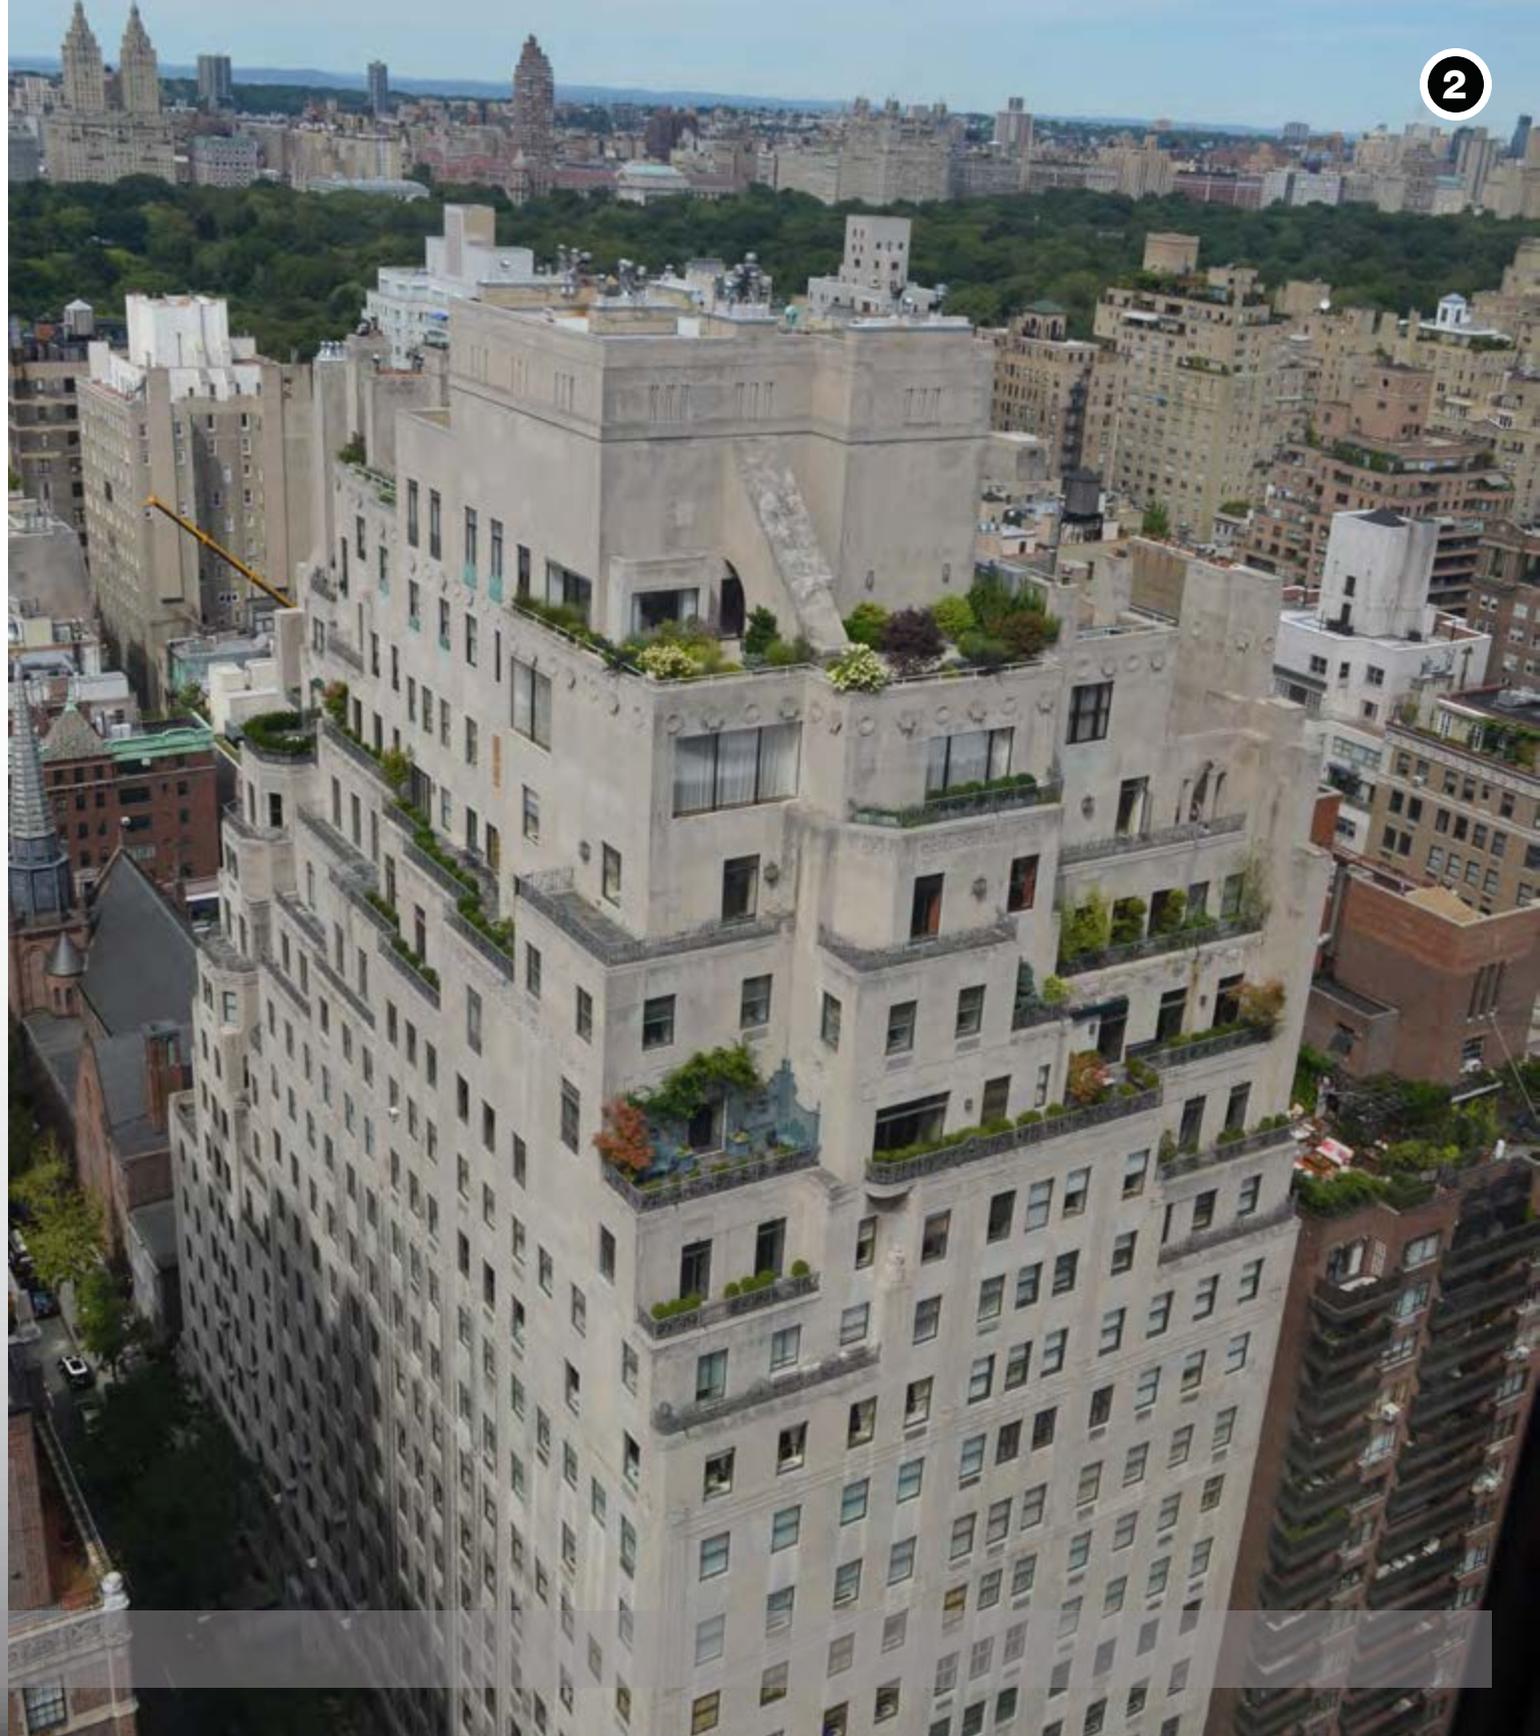
Lenox Hill Art Deco Building New York, New York, USA (1929)

Observed Conditions None Visible (Spalling of Rear Stone Face)

Root Causes Material Corrosion

79 years to failure

Potential Repair Stone and Anchor Replacement

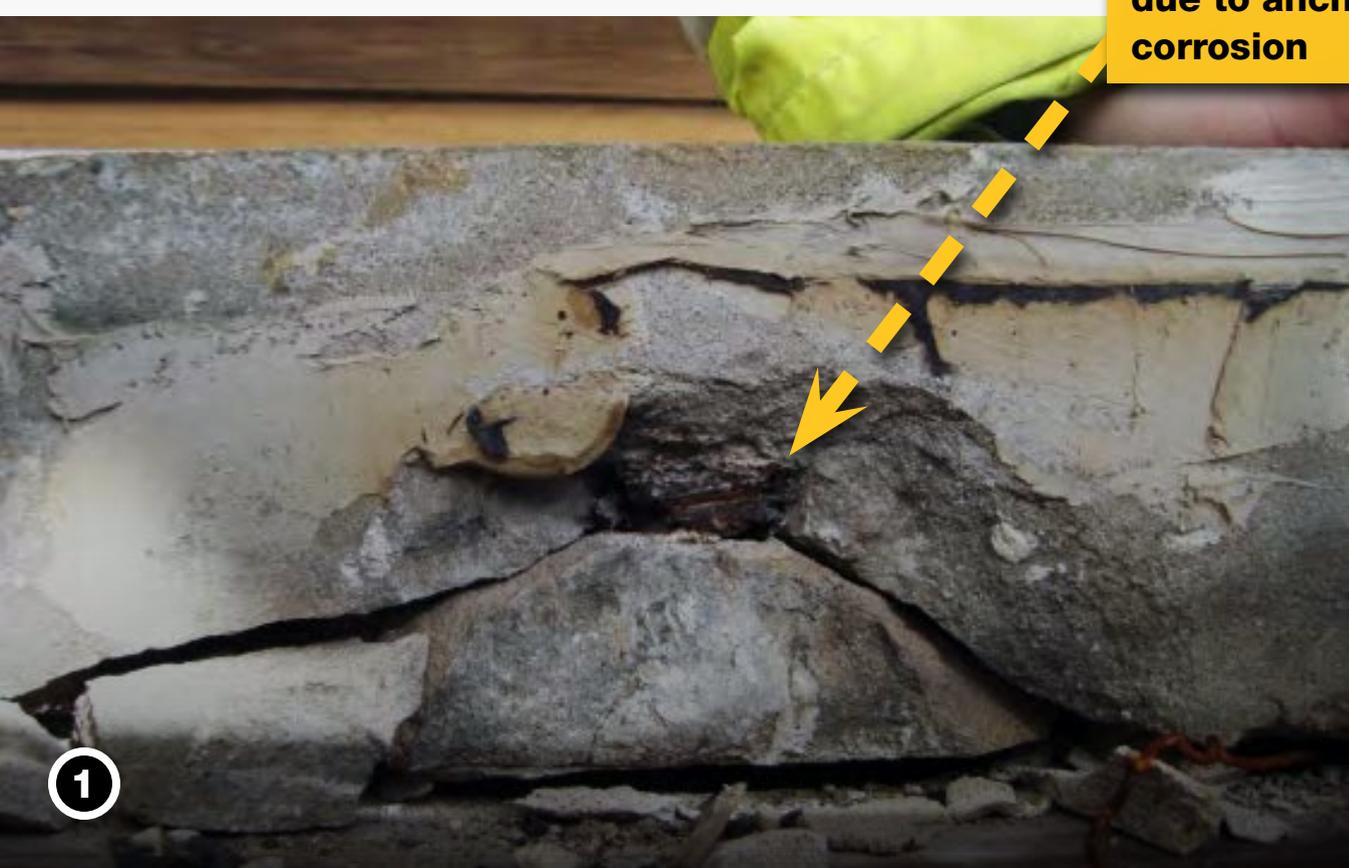
hidden cracking & spalling due to anchor corrosion

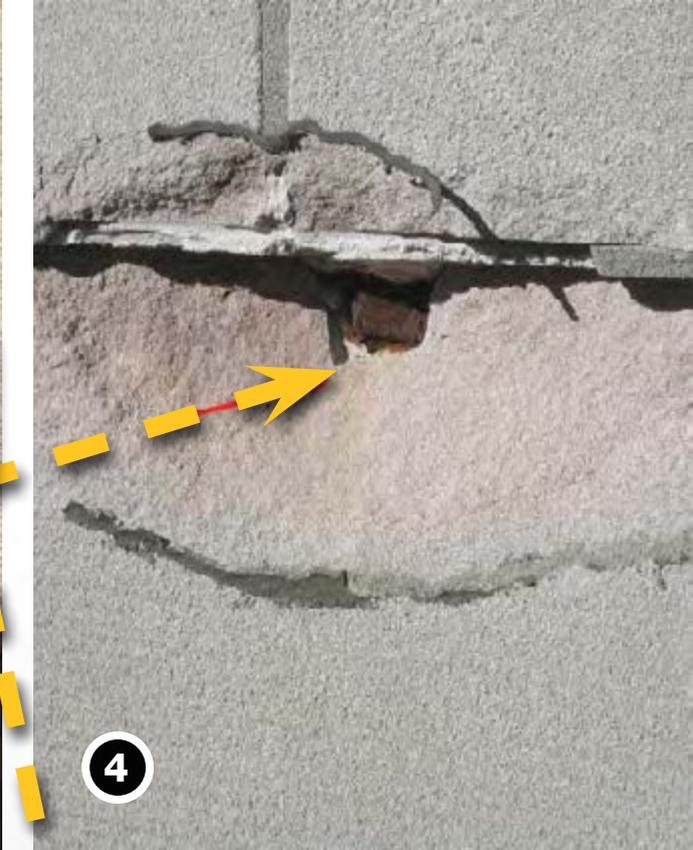
typically visible surface cracks & spalling

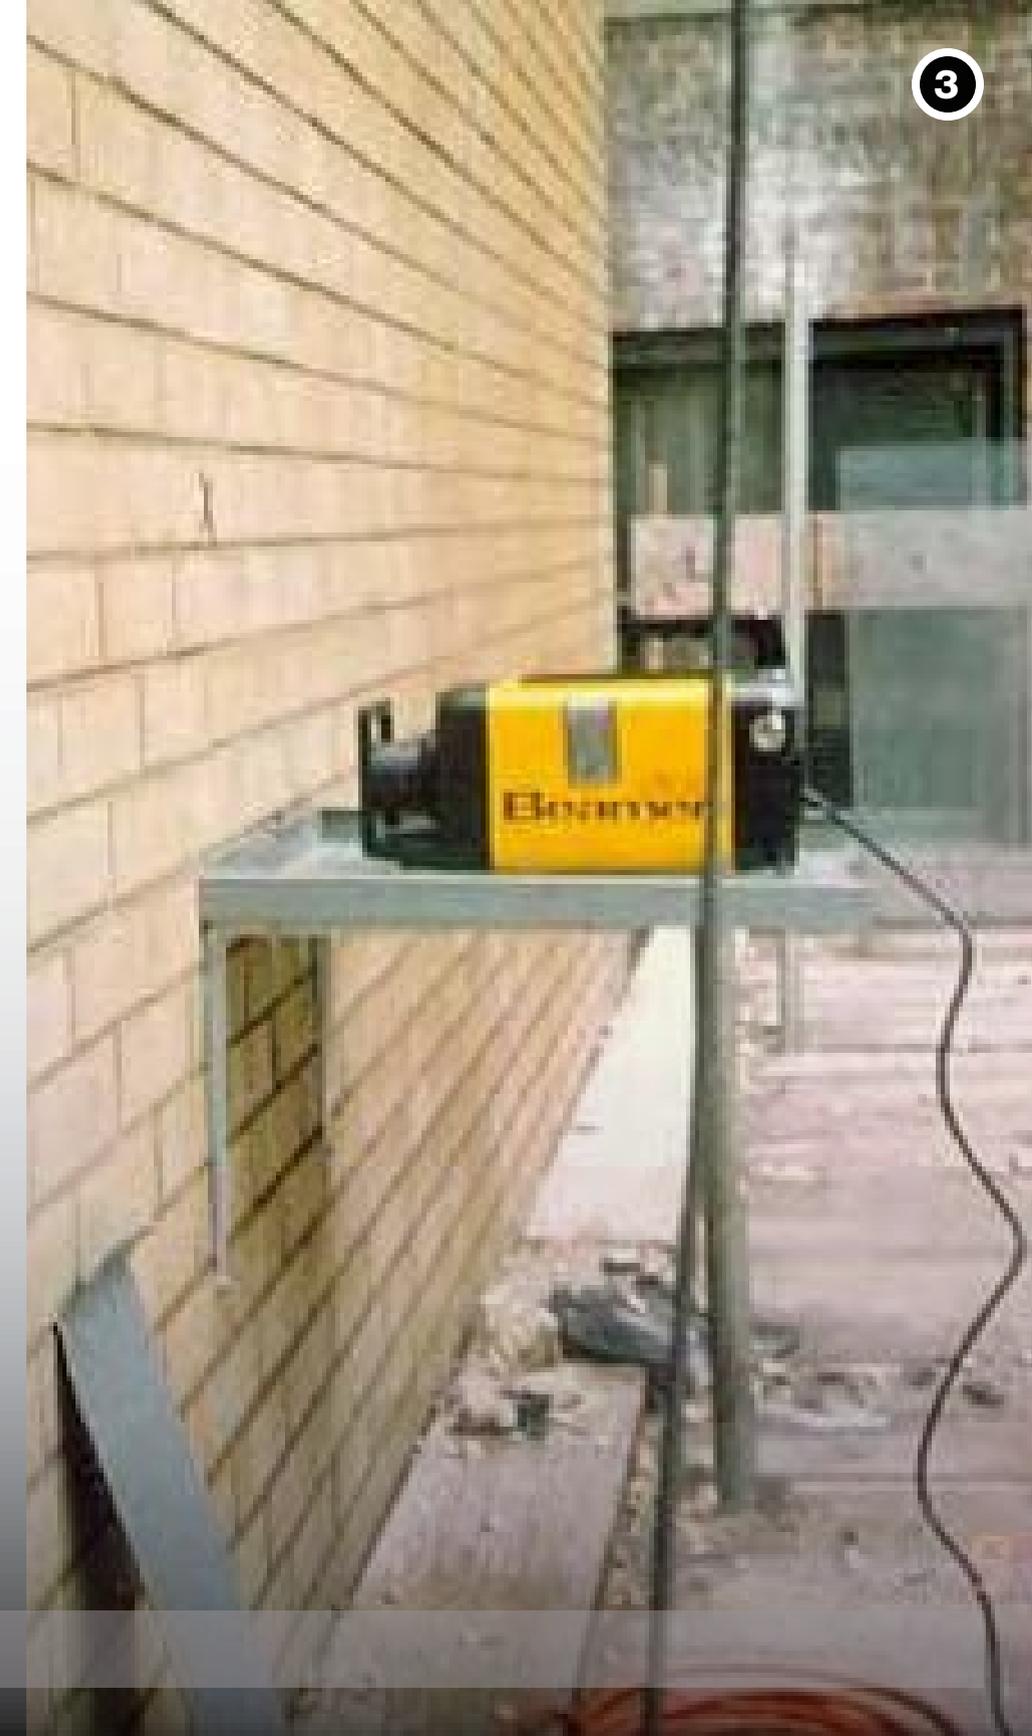
Midtown International Style Building New York, New York, USA (1957)

Observed Conditions Brick Panel Failure/Partial Collapse

Root Causes Field Modifications; No Soft Joints/Relieving Angles

40 years to failure

Potential Repair Spandrel Panel Replacement; Reskin

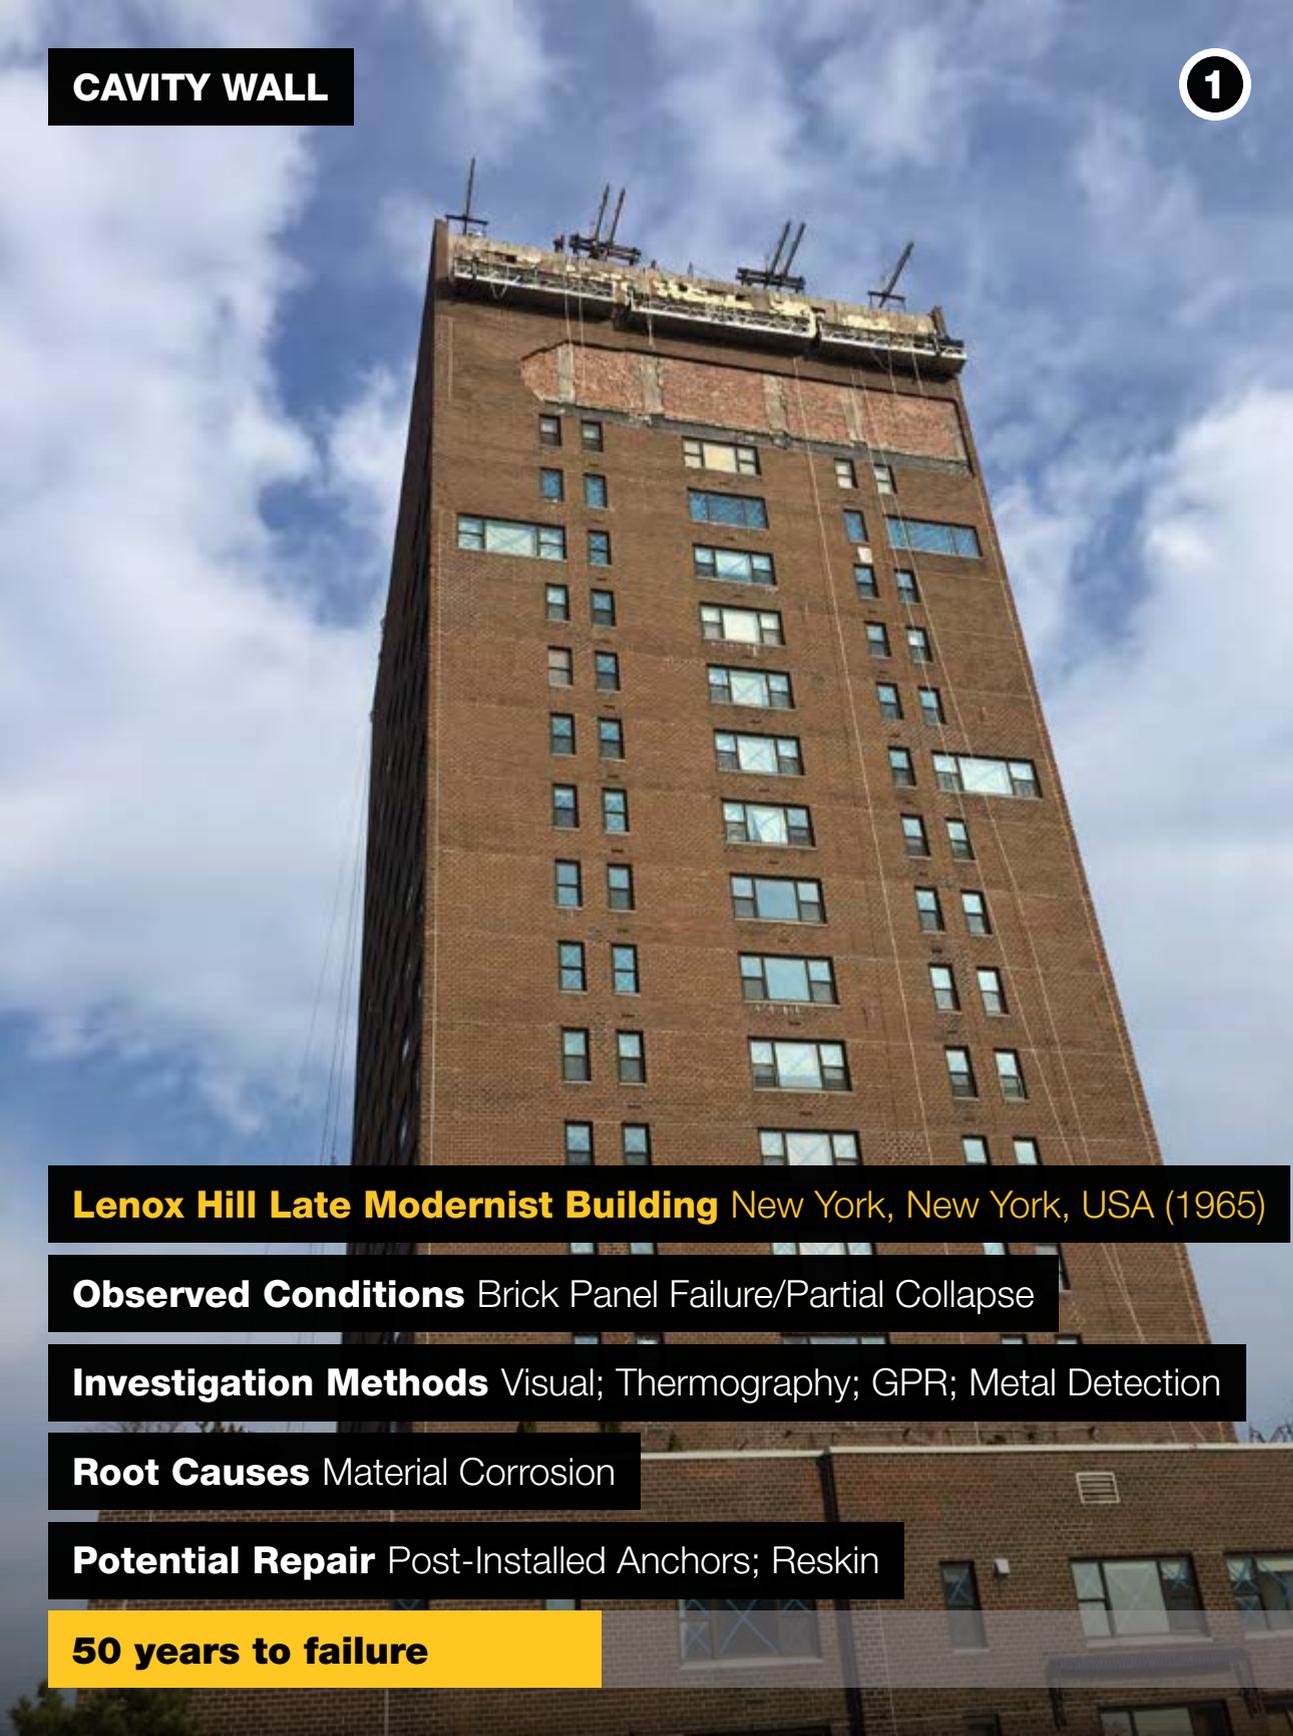
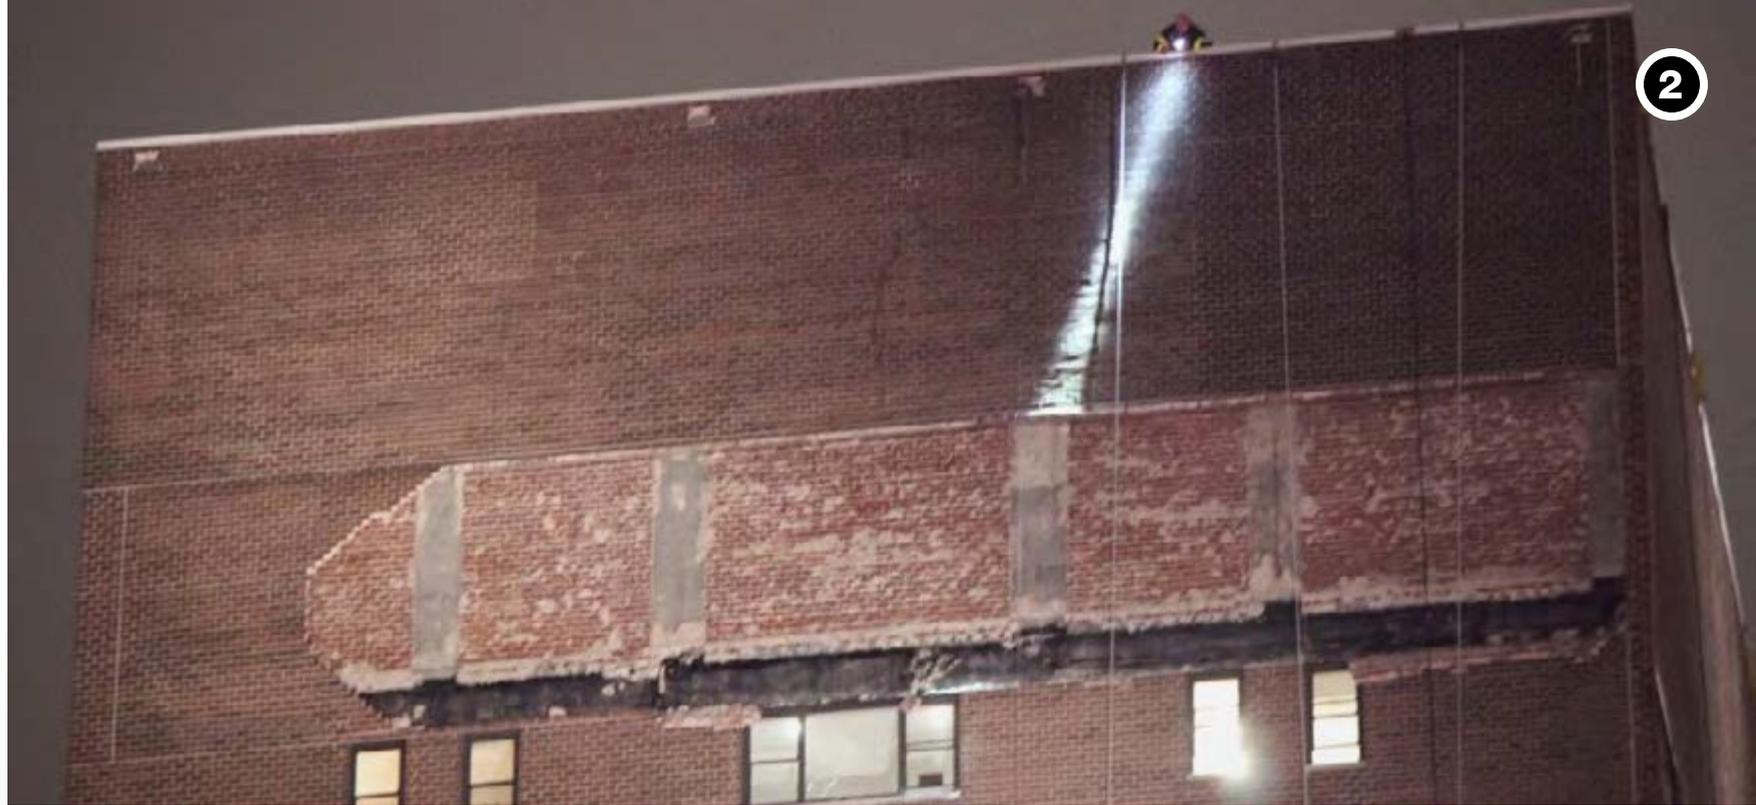
Lenox Hill Late Modernist Building New York, New York, USA (1965)

Observed Conditions Brick Panel Failure/Partial Collapse

Root Causes Material Corrosion

50 years to failure

Potential Repair Post-Installed Anchors; Reskin

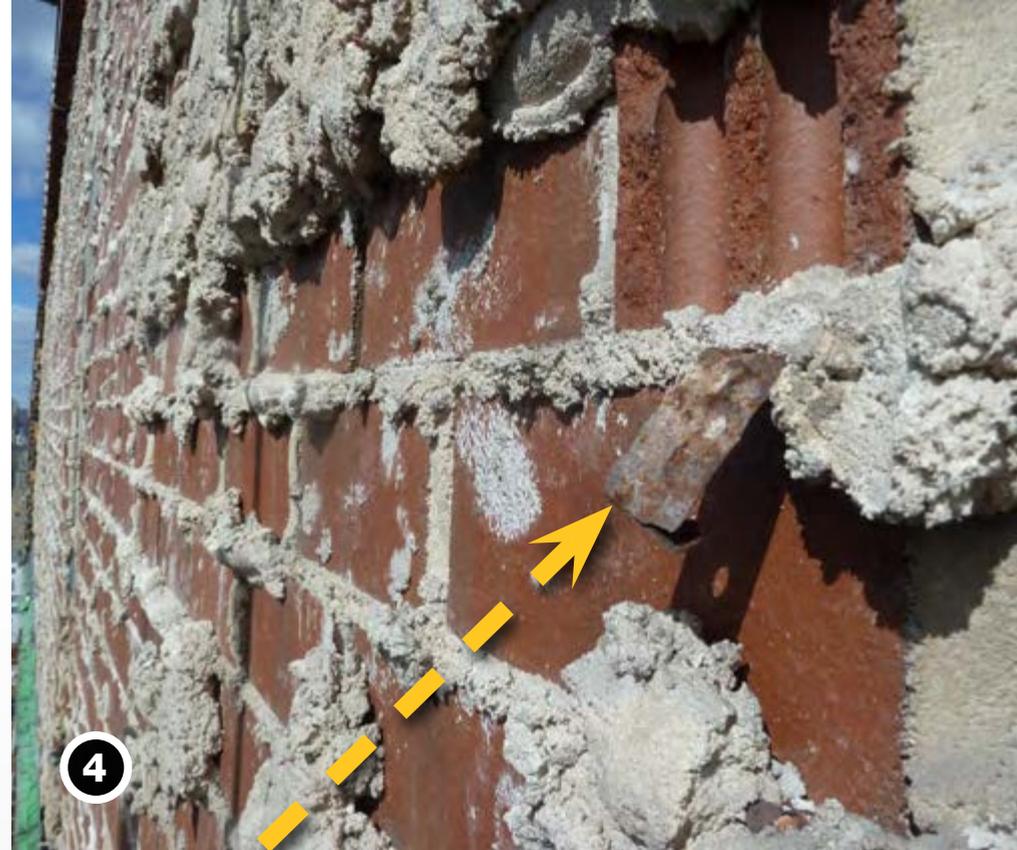
corroded brick ties

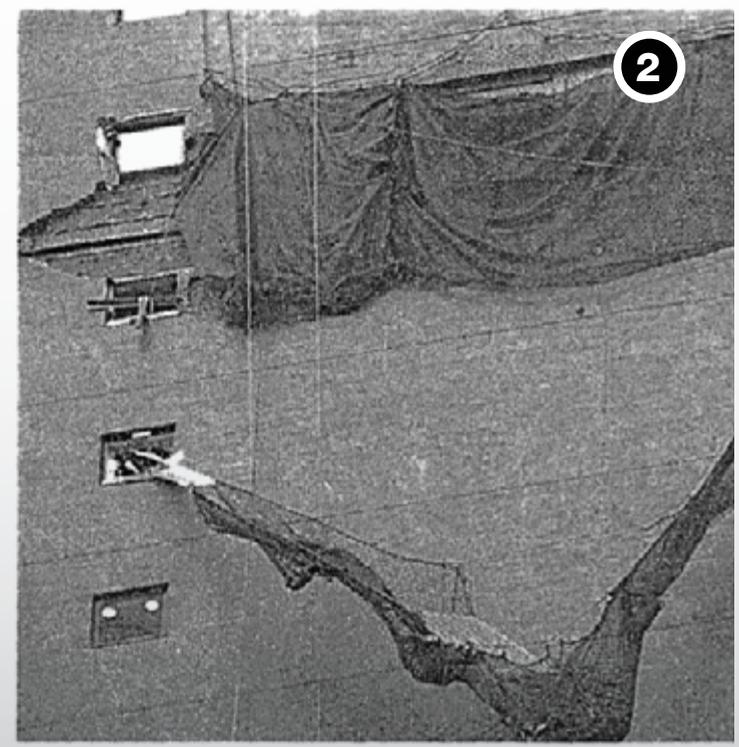
A safety net was bent by the weight of bricks that tore loose from the Madison Avenue yesterday. Some of the debris fell on the streets.

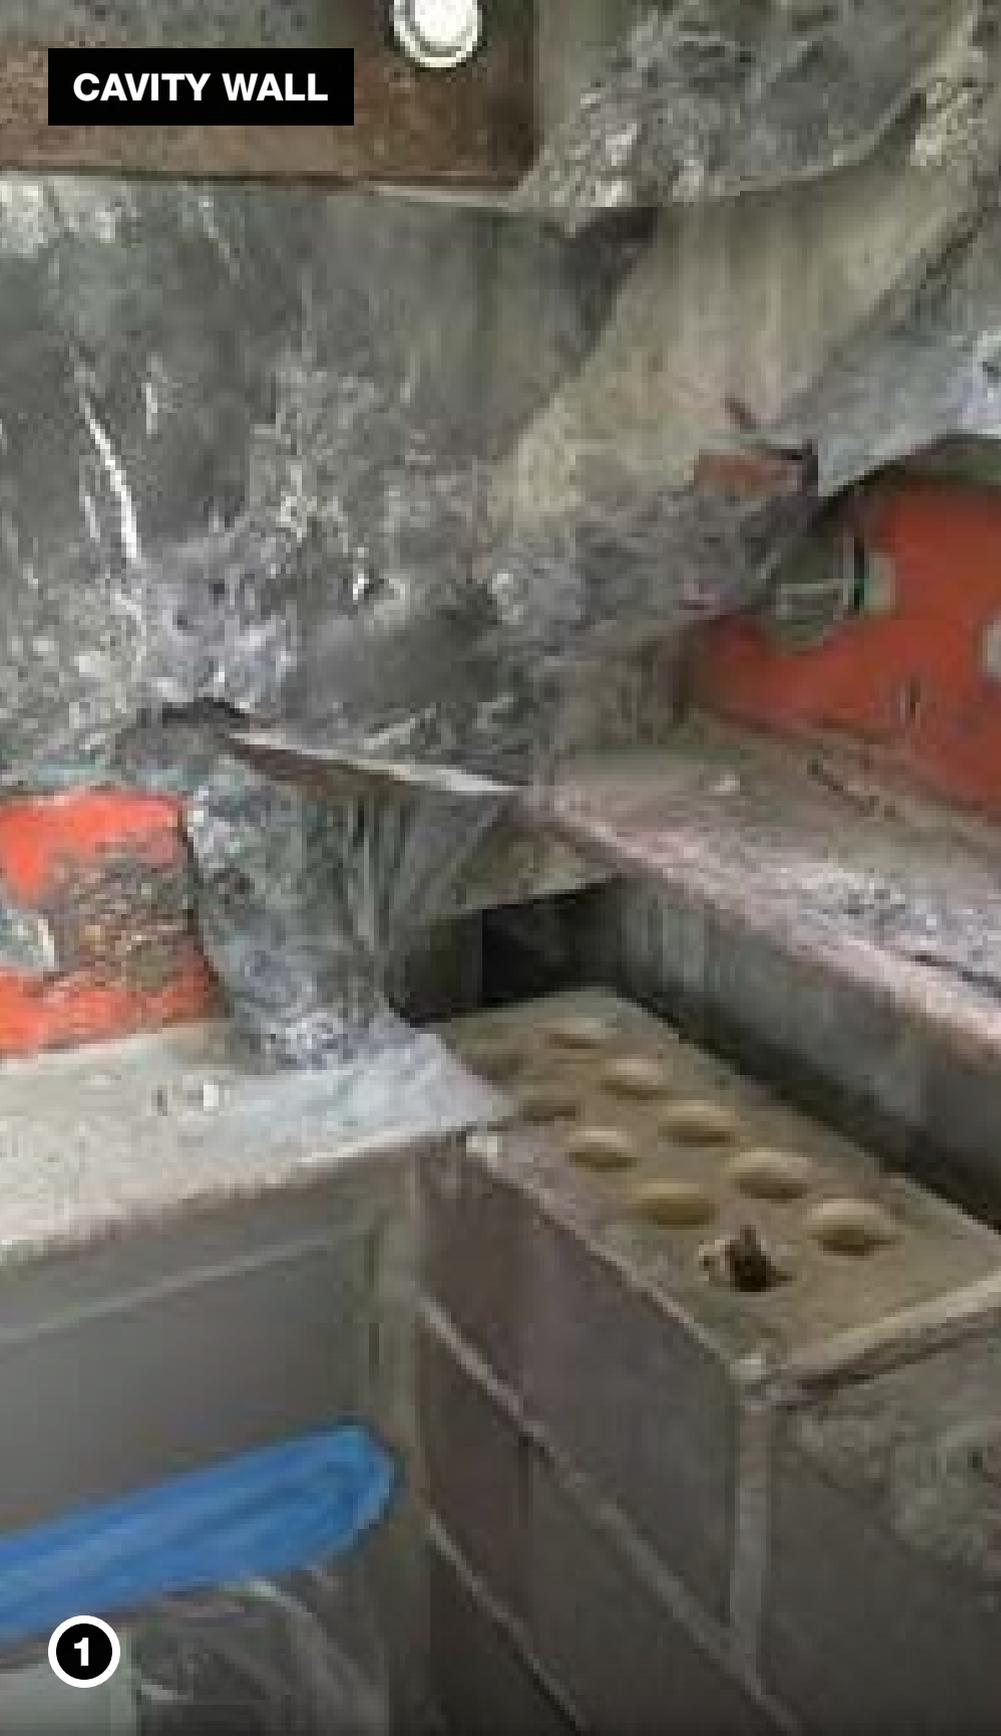
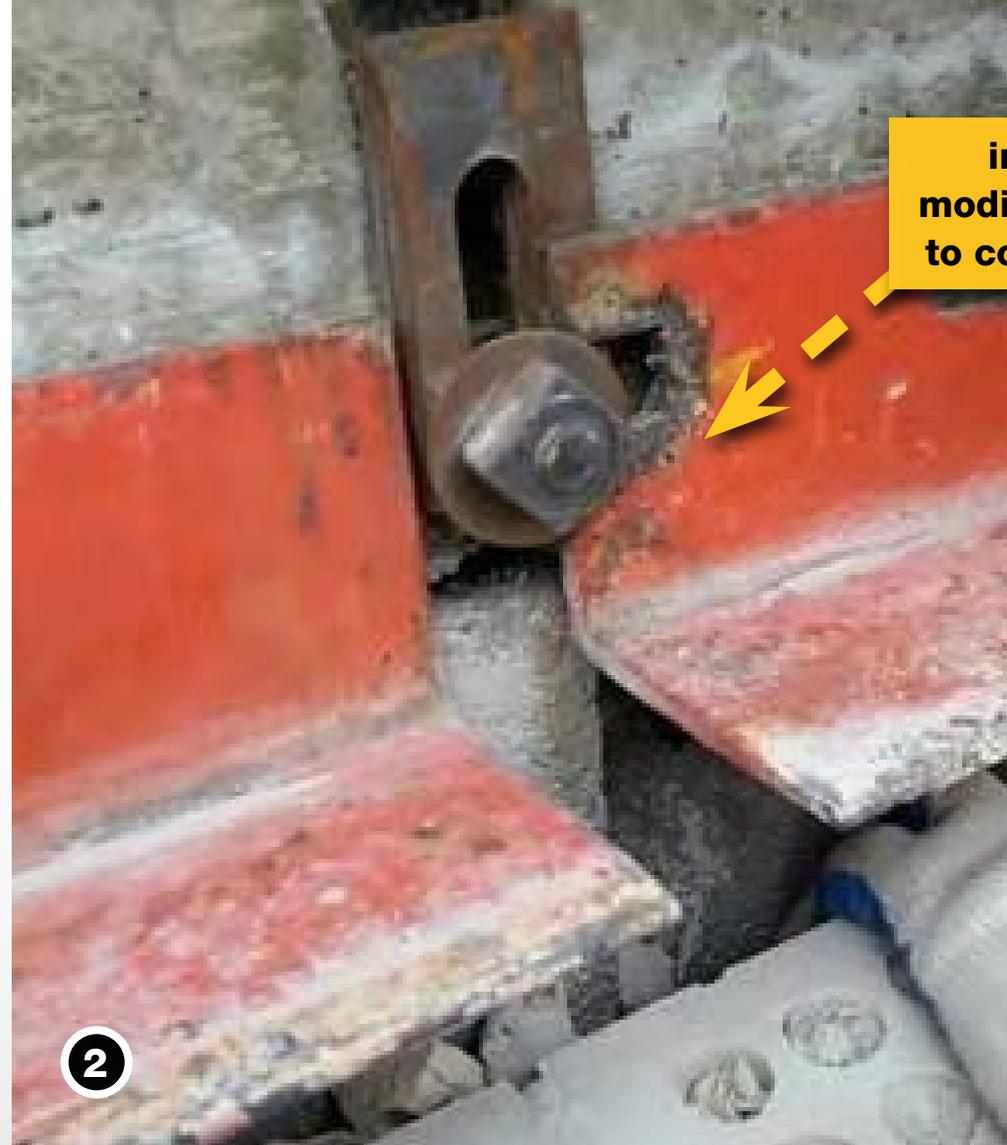
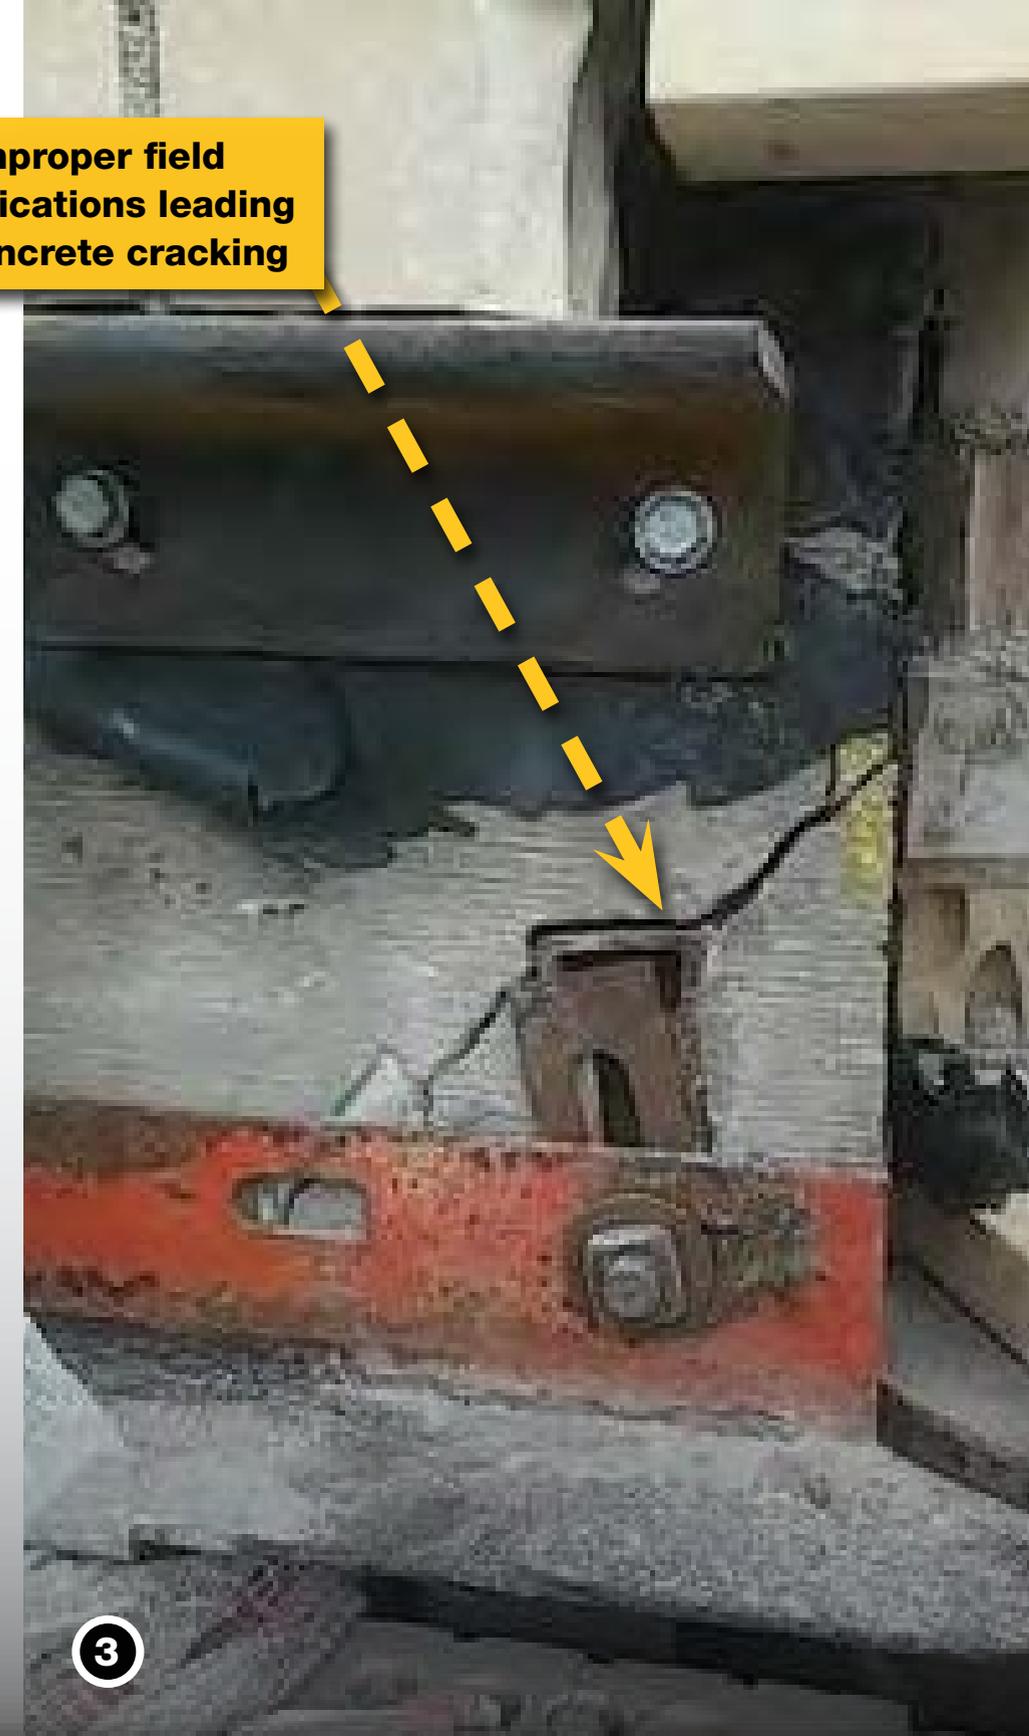
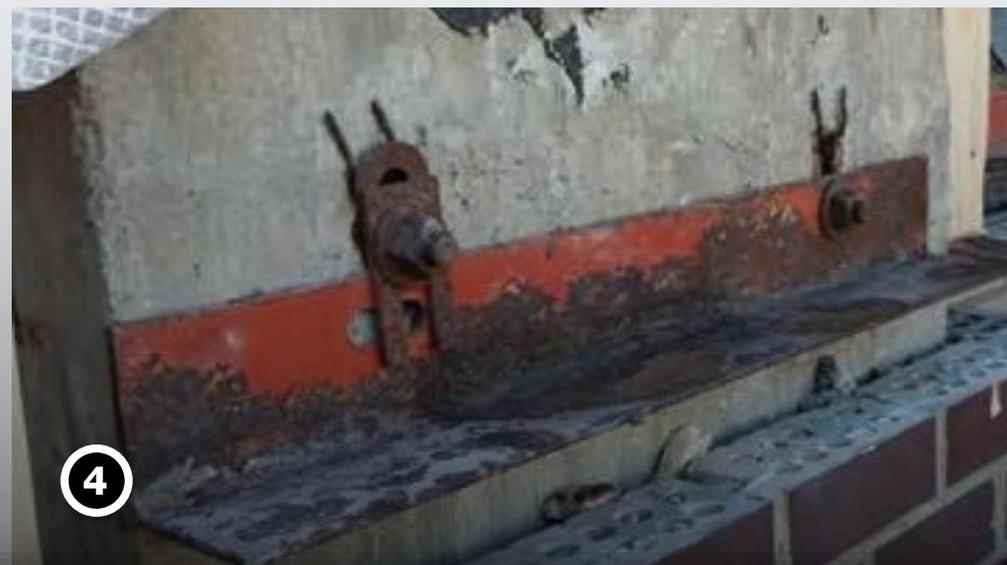
Upper West Side Late Modernist Building New York, New York, USA (1970)

Observed Conditions Cracked Masonry

Root Causes Installation Error; Field Modifications; Poor Workmanship

47 years to failure

Potential Repair Reskin; Relieving Angle Replacement; Pinning

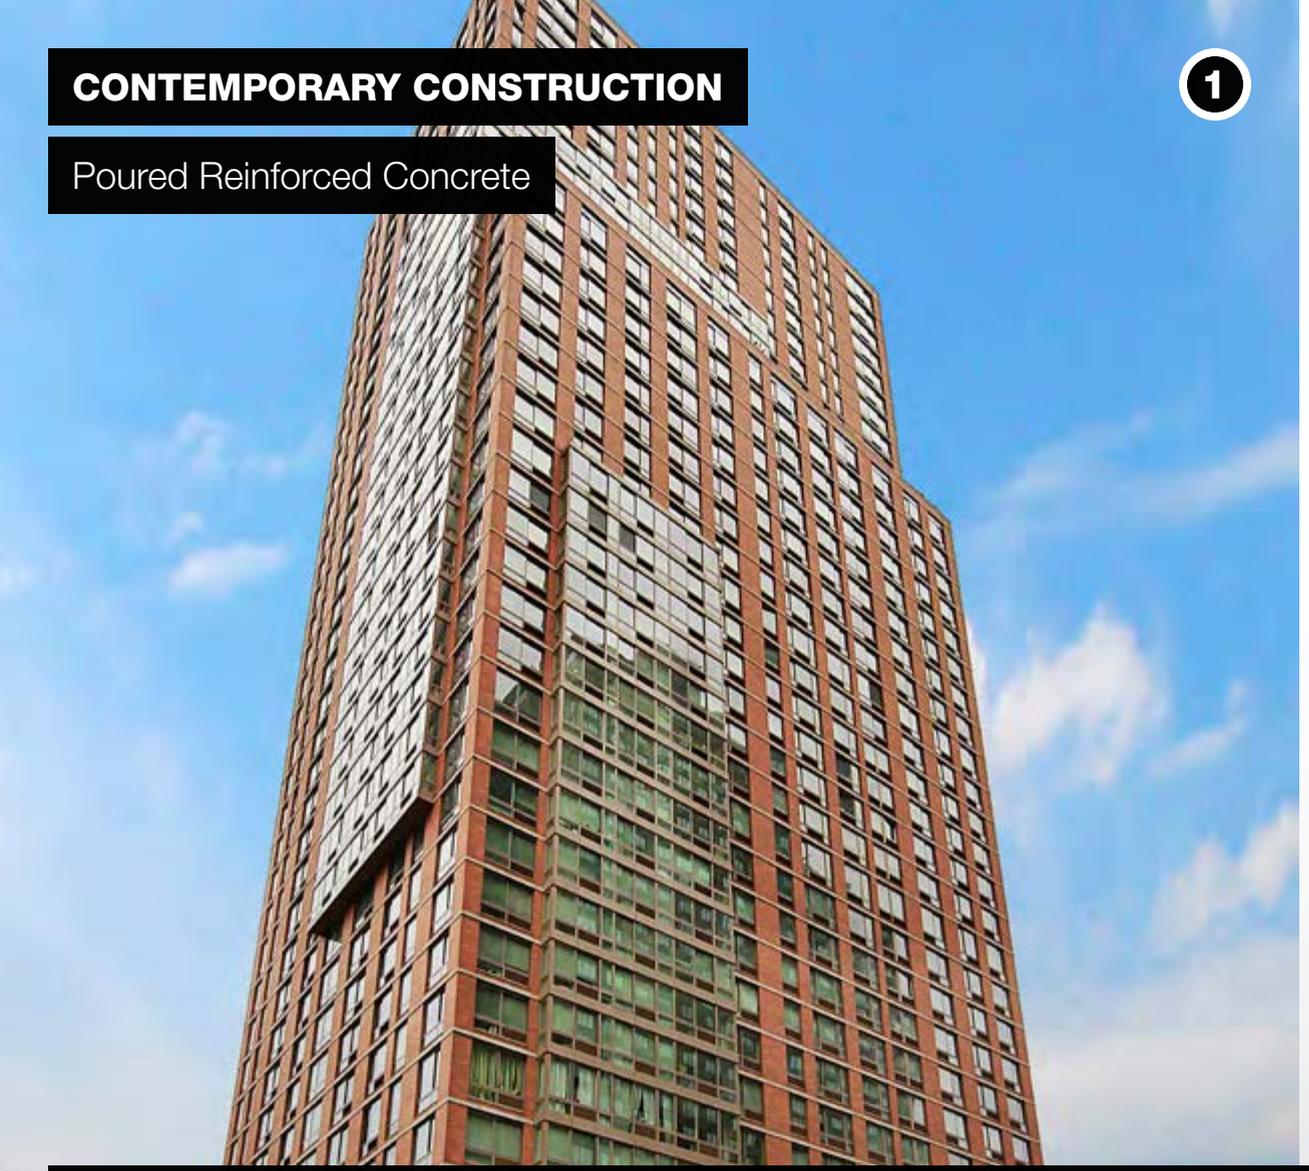
Upper East Side Contemporary Building New York, New York, USA (2005)

Observed Conditions Concrete Spalling

Root Causes Concrete Coverage

10 years to failure

Potential Repair Concrete Patching

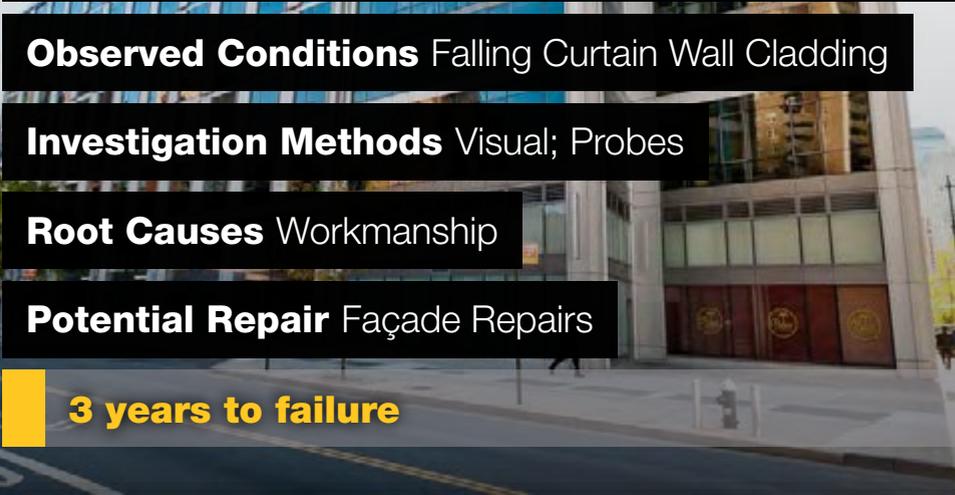
Financial District Contemporary Building New York, New York, USA (2008)

Observed Conditions Falling Curtain Wall Cladding

Root Causes Workmanship

3 years to failure

Potential Repair Façade Repairs
