Deteriorating Buildings: Ticking Time Bombs

TH205

Thursday, June 21, 2018 | 7:30 AM – 9:00 AM

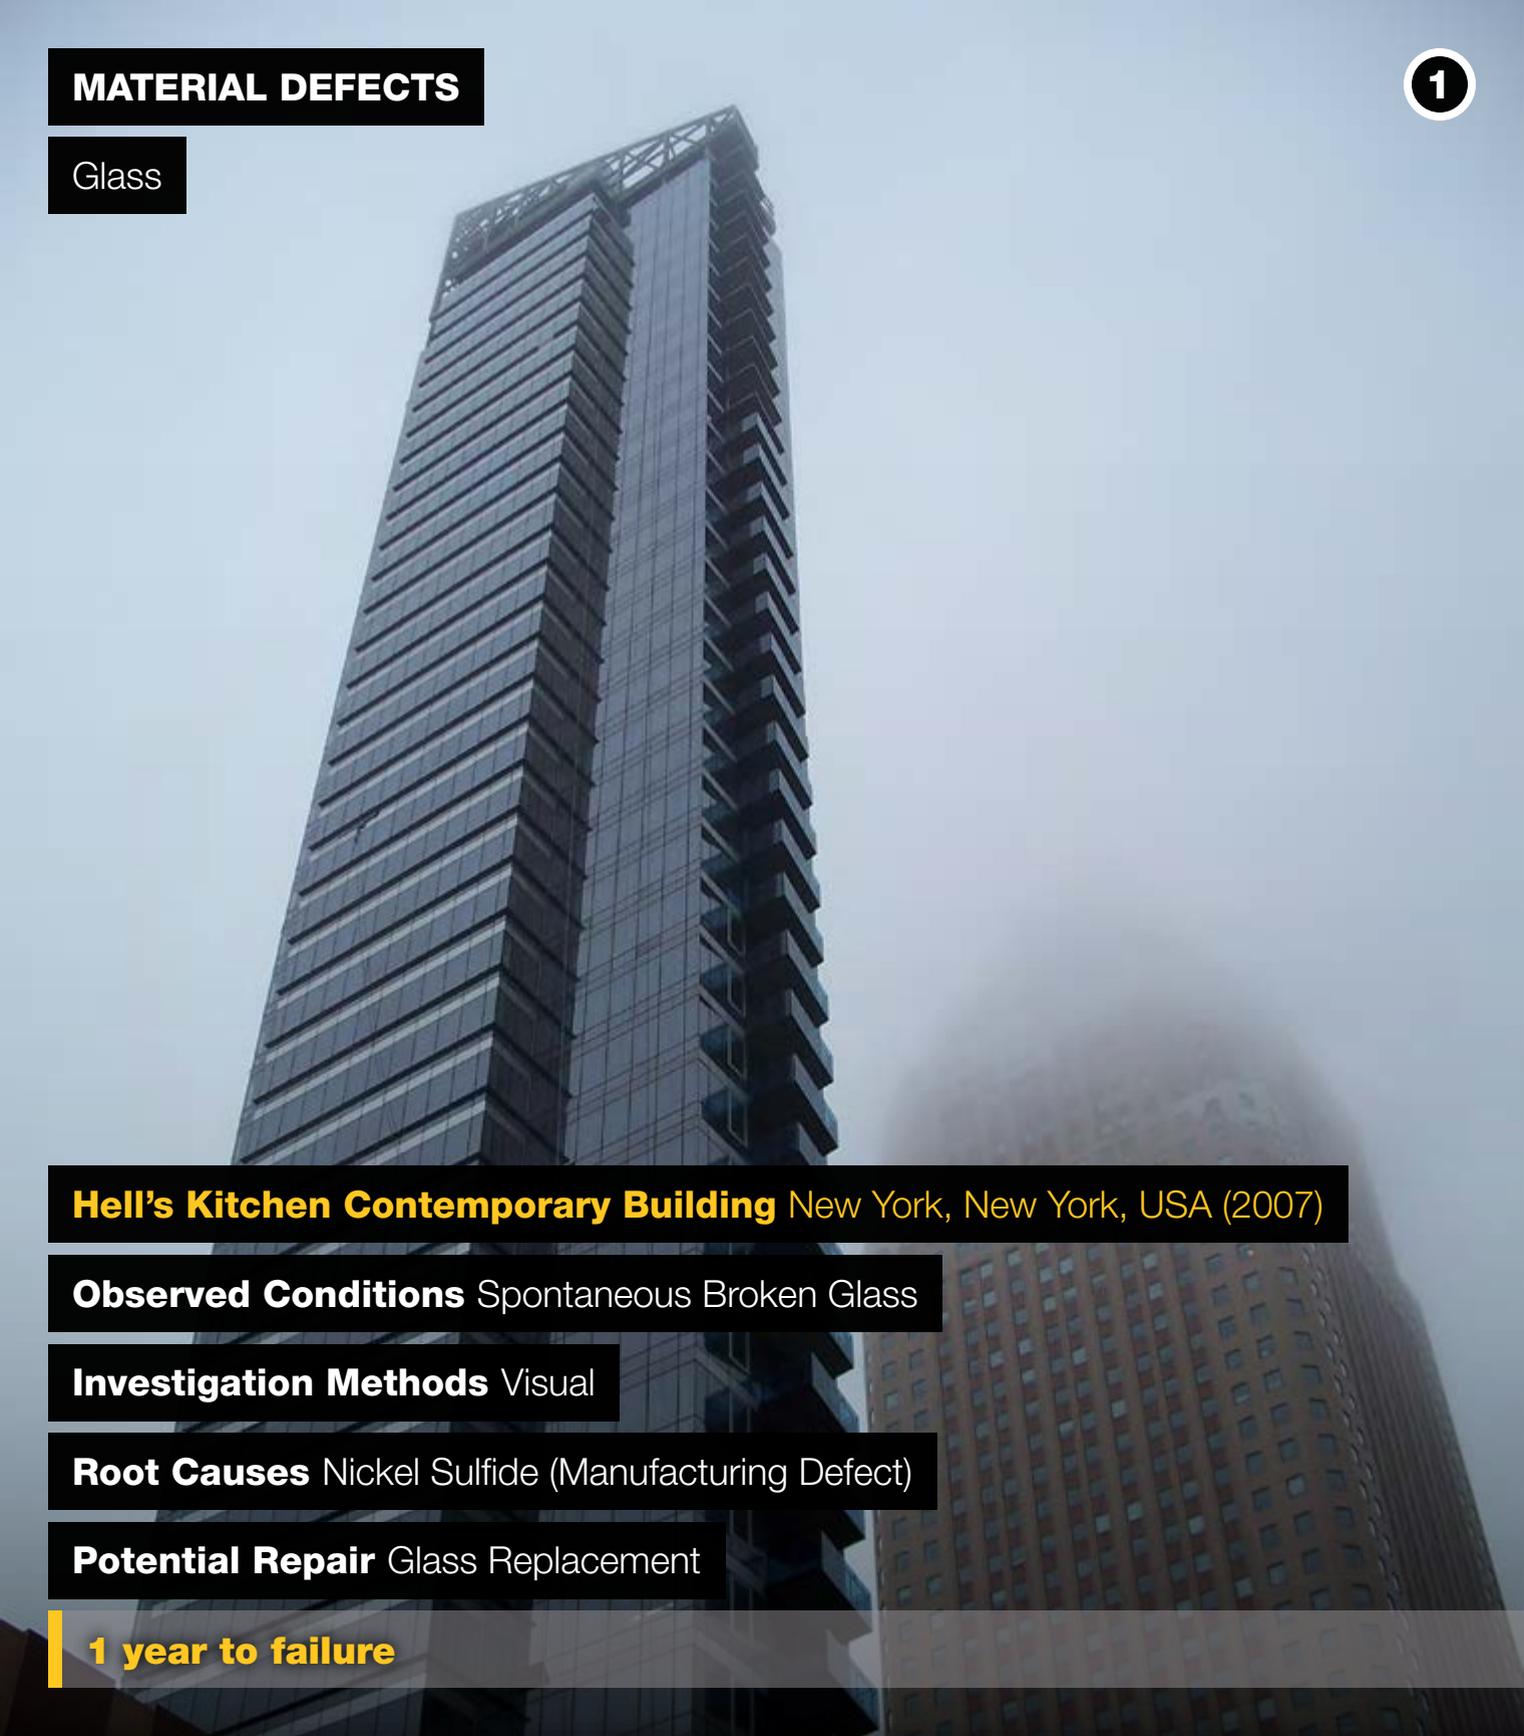
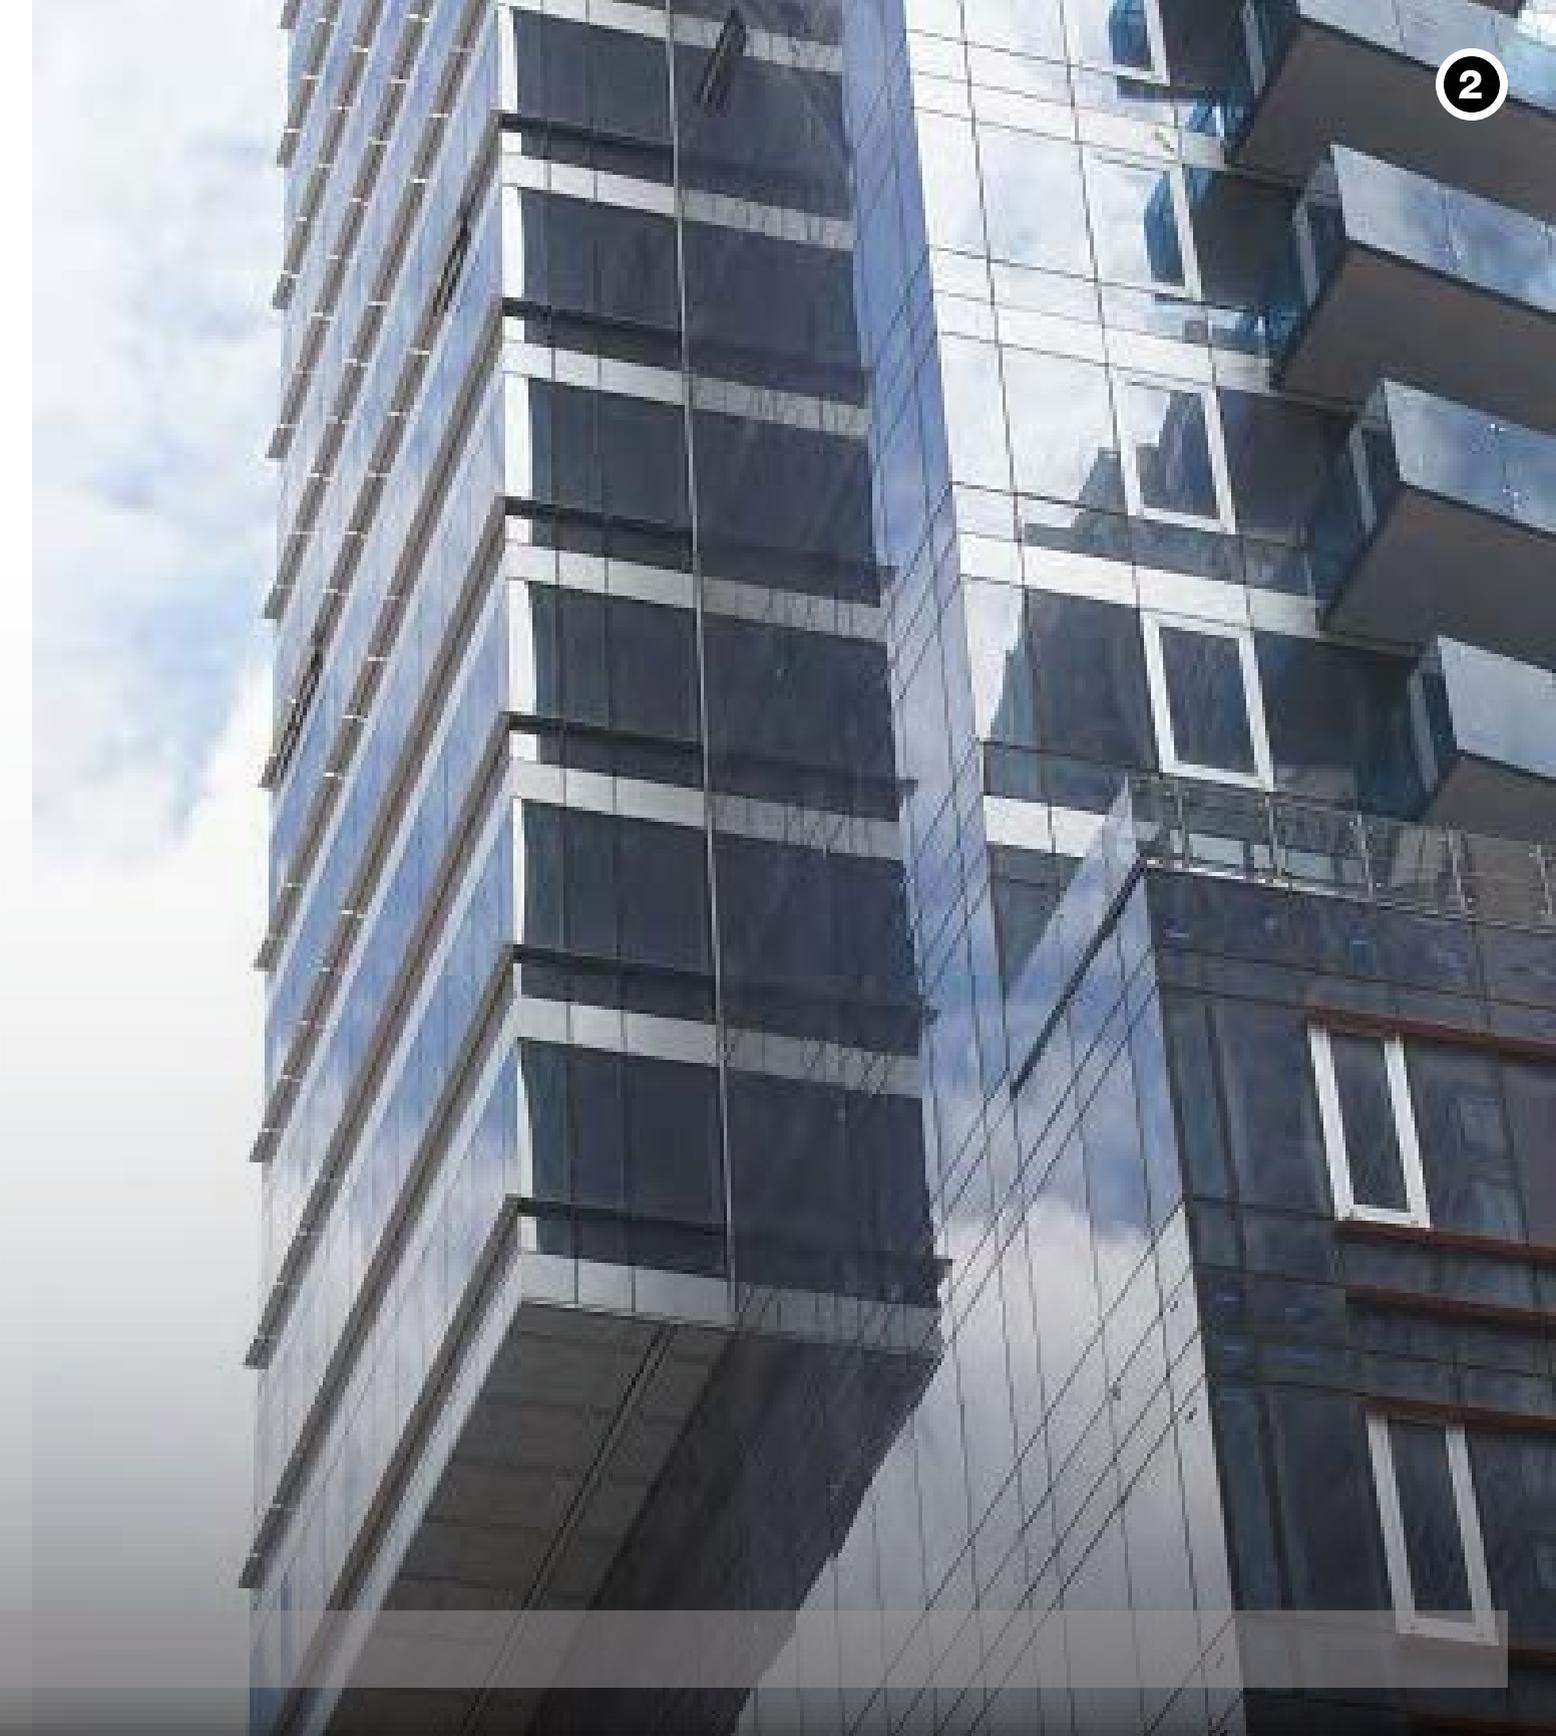
Hell's Kitchen Contemporary Building New York, New York, USA (2007)

Observed Conditions Spontaneous Broken Glass

Root Causes Nickel Sulfide (Manufacturing Defect)

1 year to failure

Potential Repair Glass Replacement

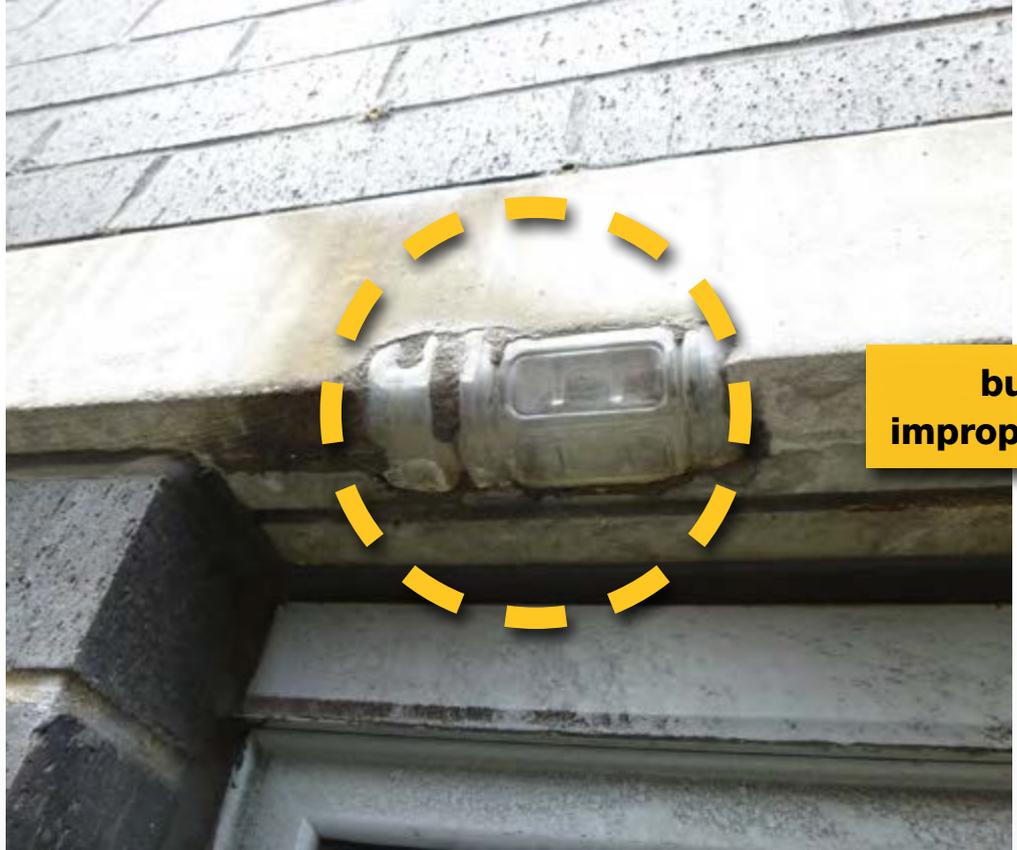
bulging due to improper formwork

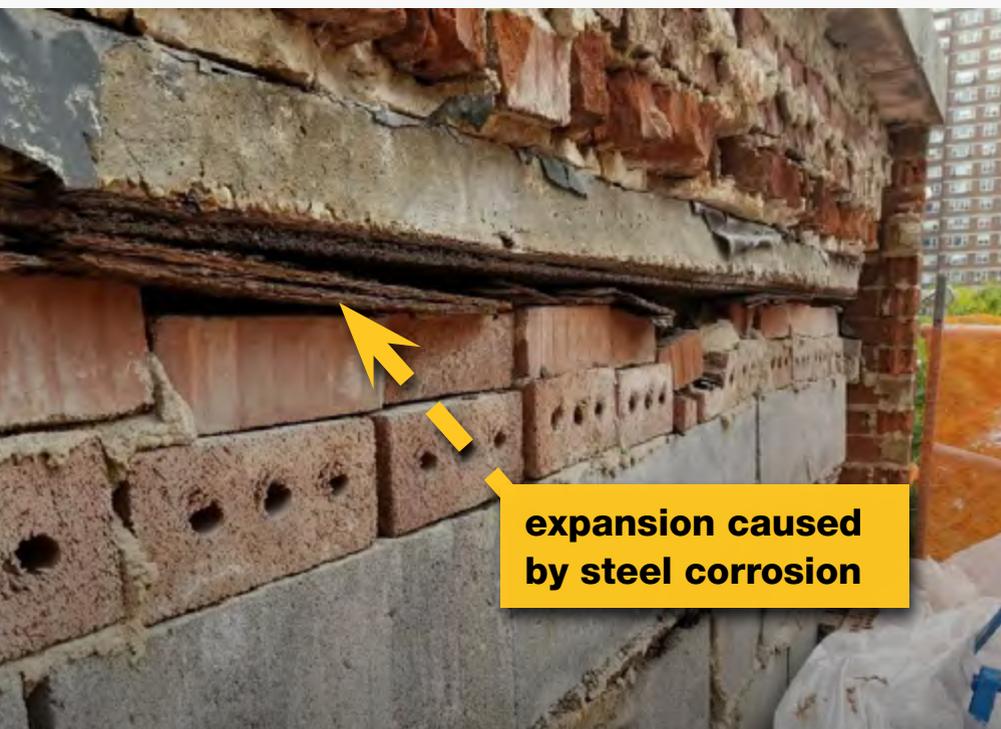
expansion caused by steel corrosion

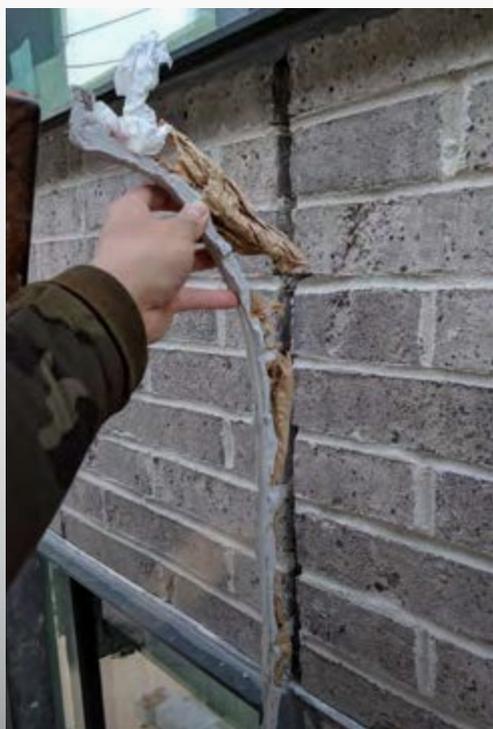
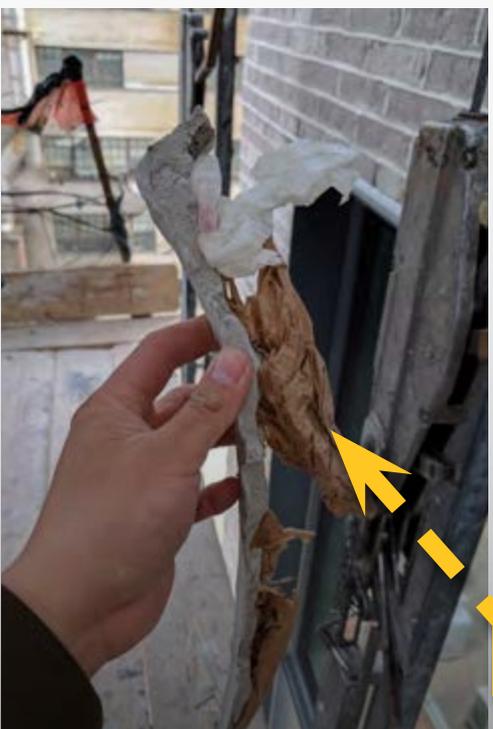
paper joints?
