Window Solutions for Historic Buildings

EL603a

6/21/2018

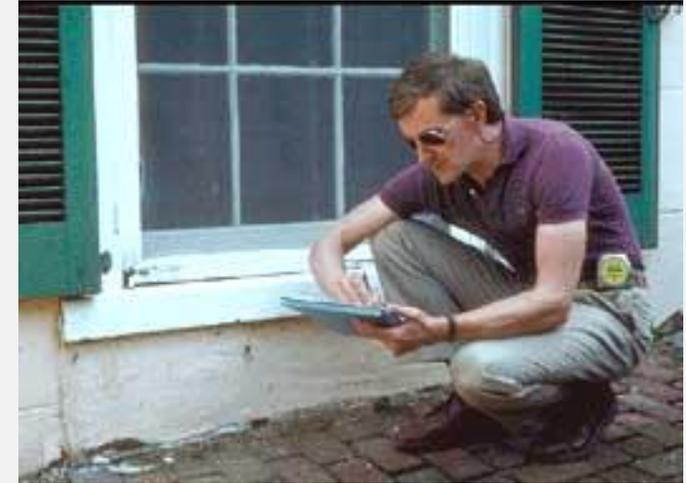
Window condition assessment preceding repair work

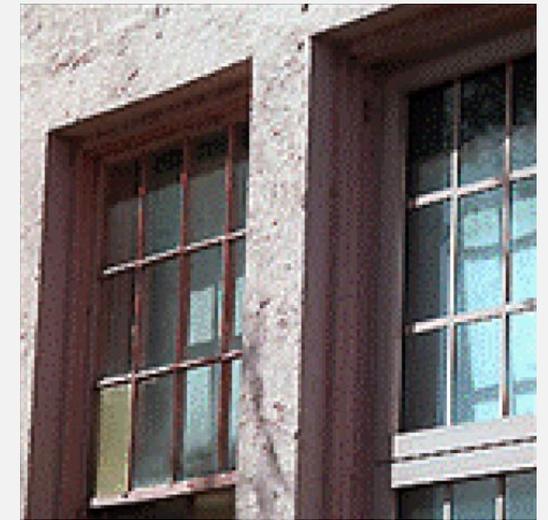
New window is radically different from historic window

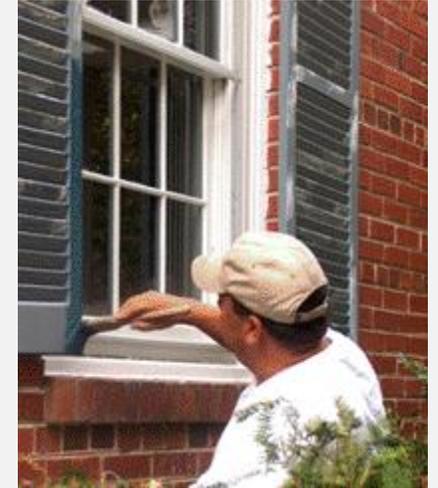
Re-application of protective coating systems

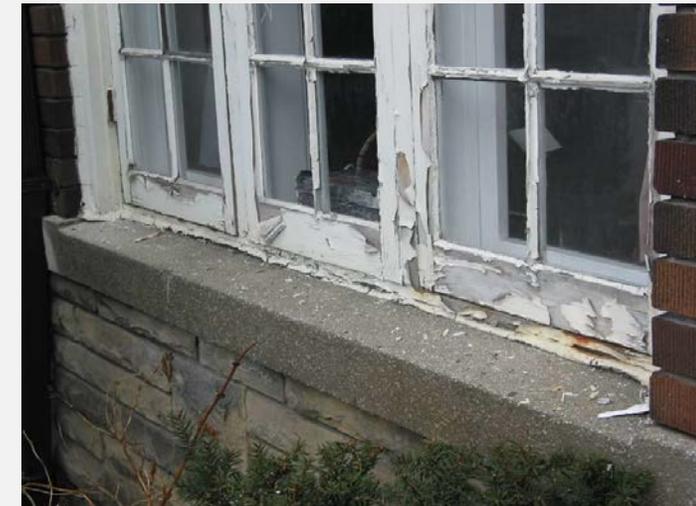
Failing to provide adequate protection of materials

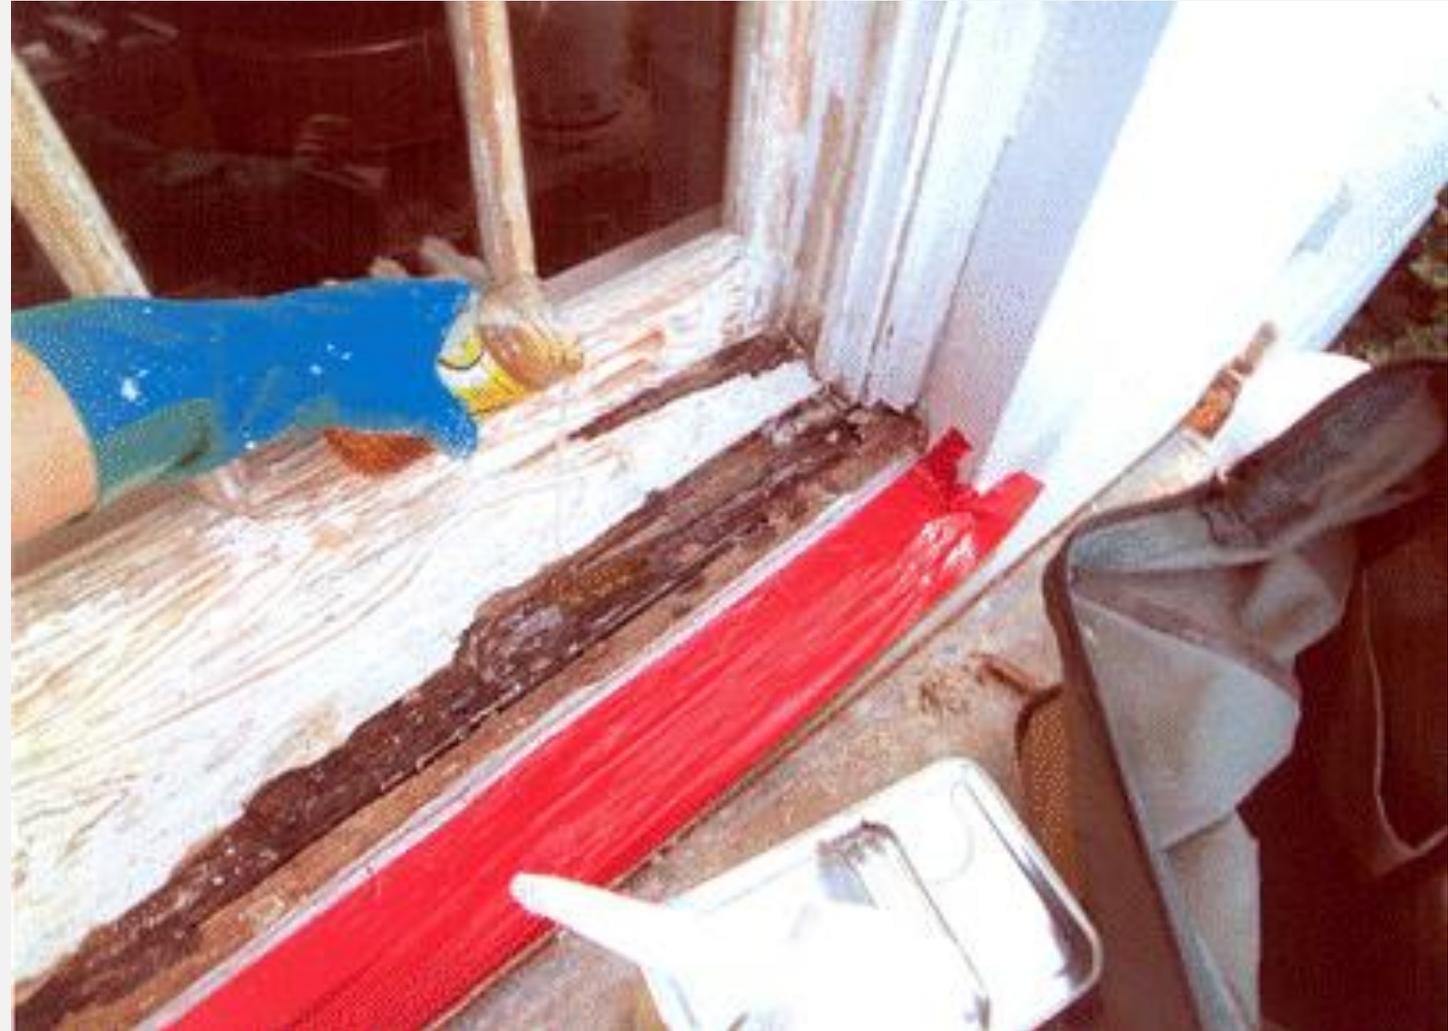
Repairing window frames by patching

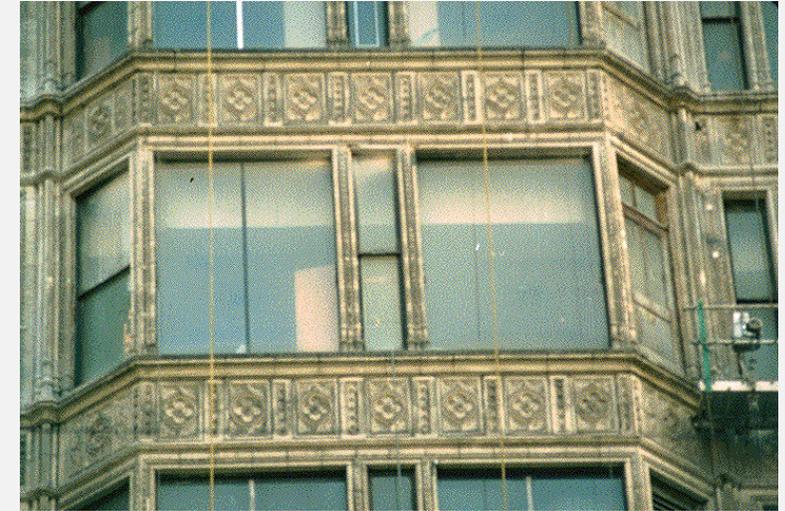
Deteriorated historic wood windows

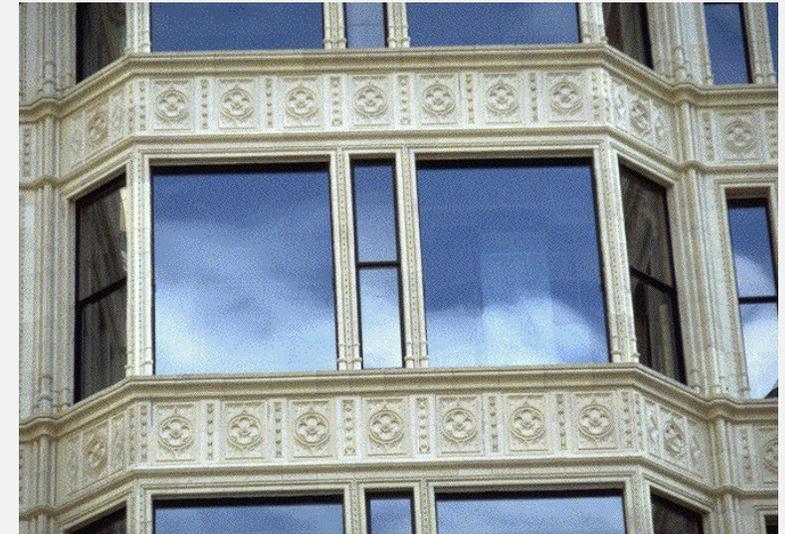
New replacement wood windows

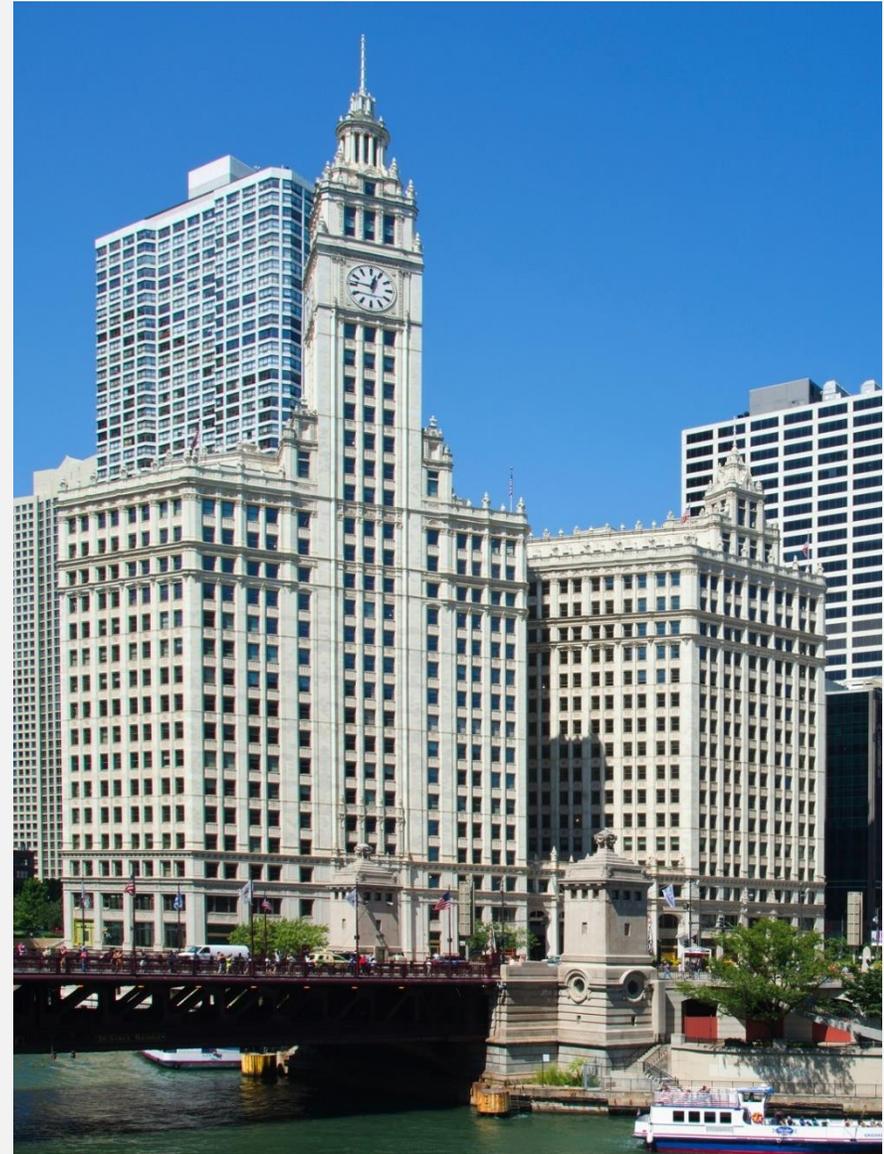
Simple window design is not significant to the historic character of the building

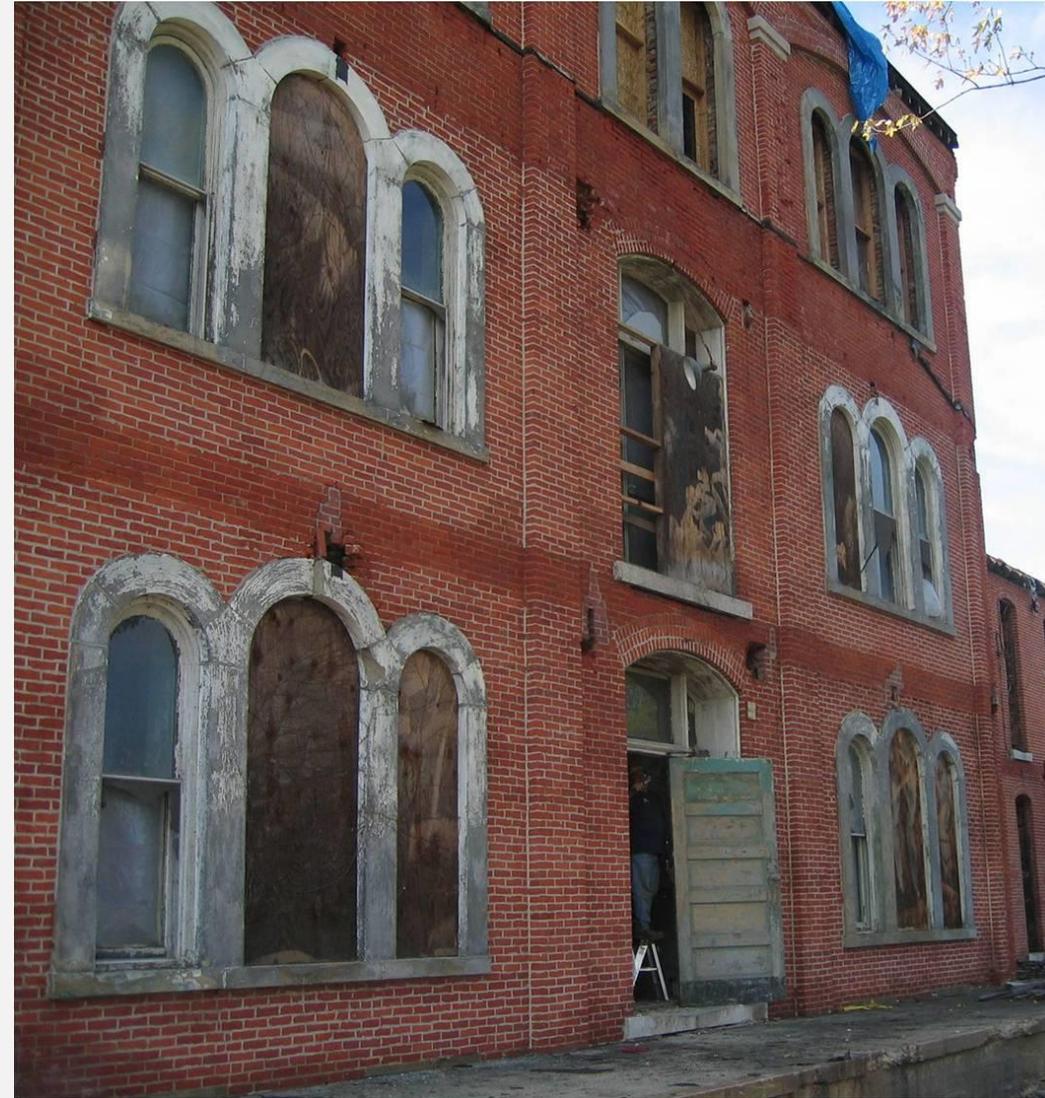
Install new windows when historic windows are missing

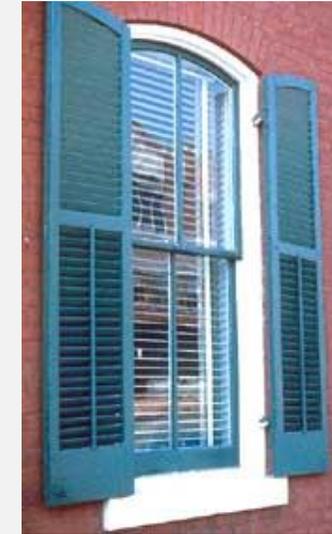
Energy conserving shutters

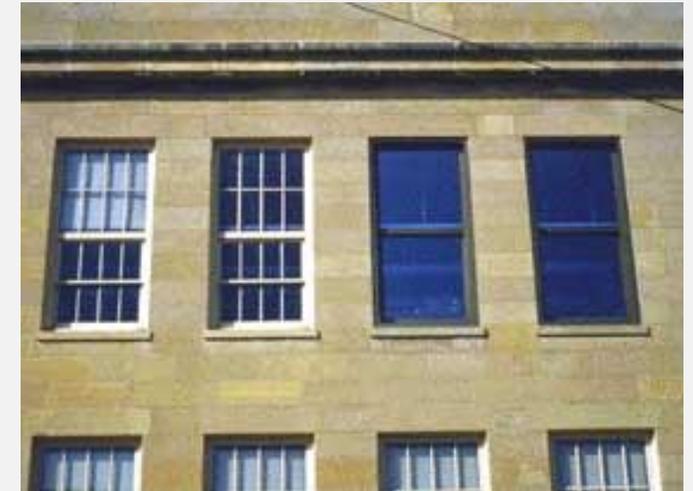
Heavily tinted glass – no muntins – on replacement windows

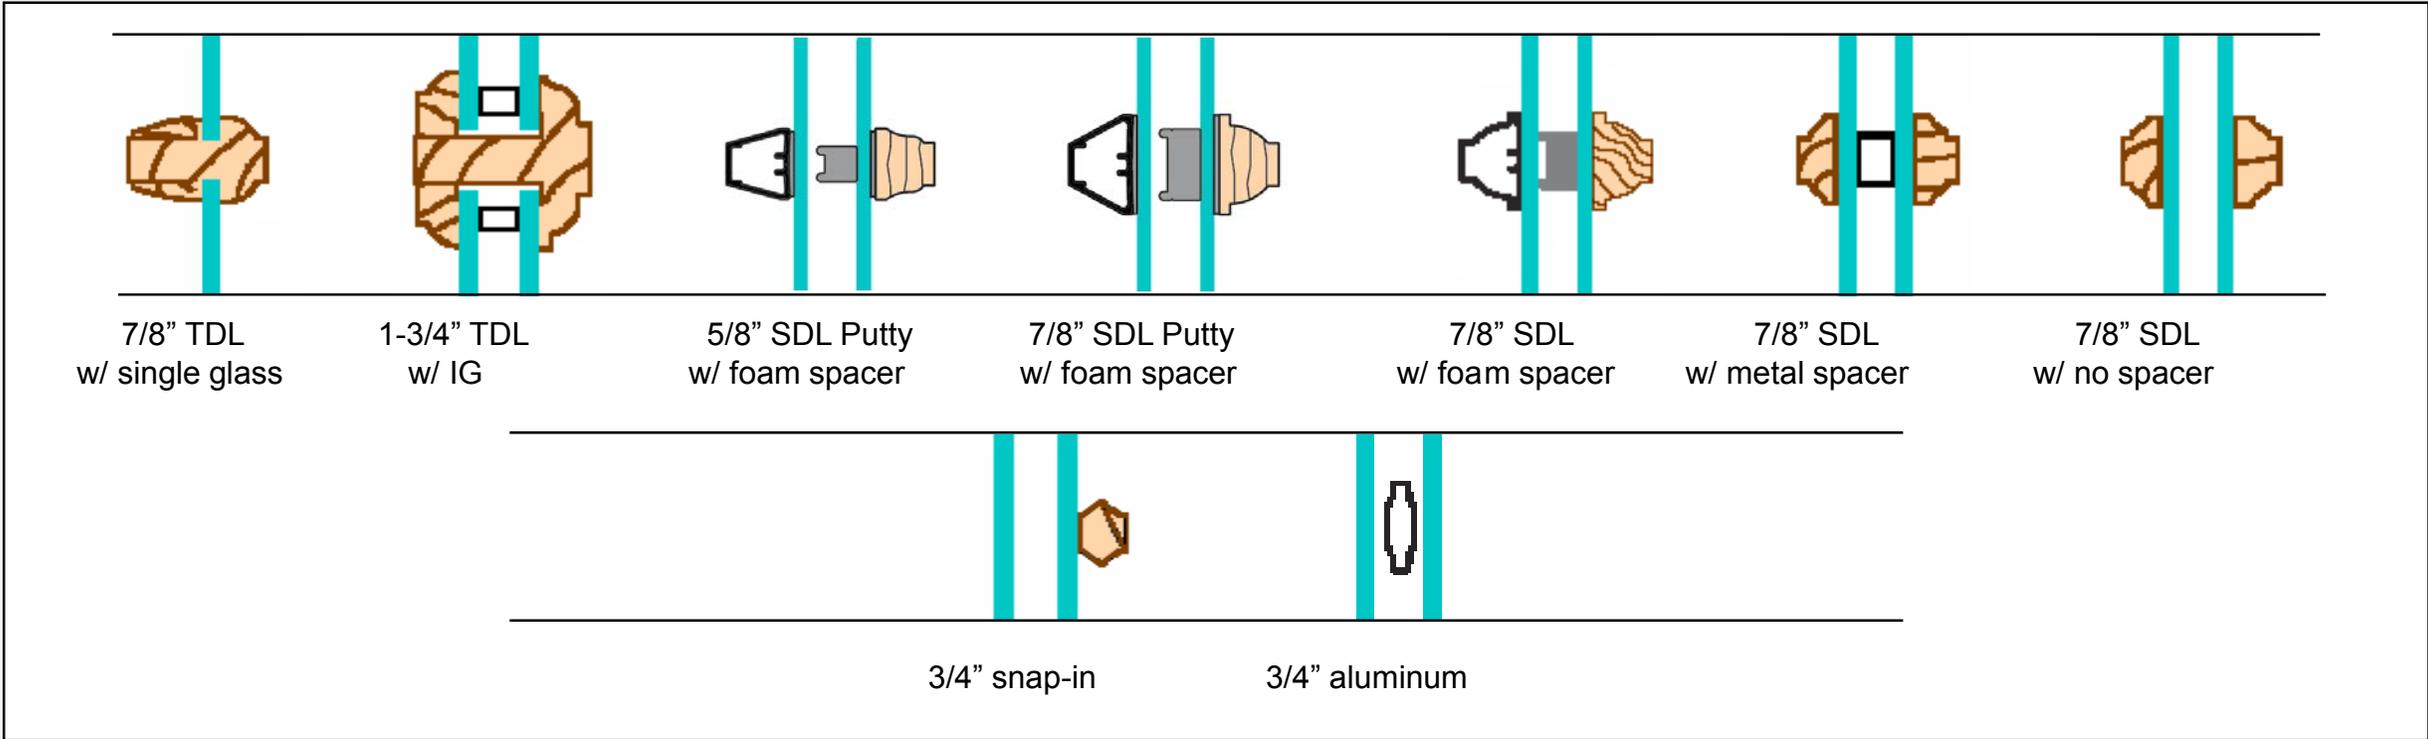
Muntin Bar Profiles

Muntin Bar Details

- Better water performance, fewer joints
- Improved structural performance
- Superior thermal performance
- Accepted by National Park Service

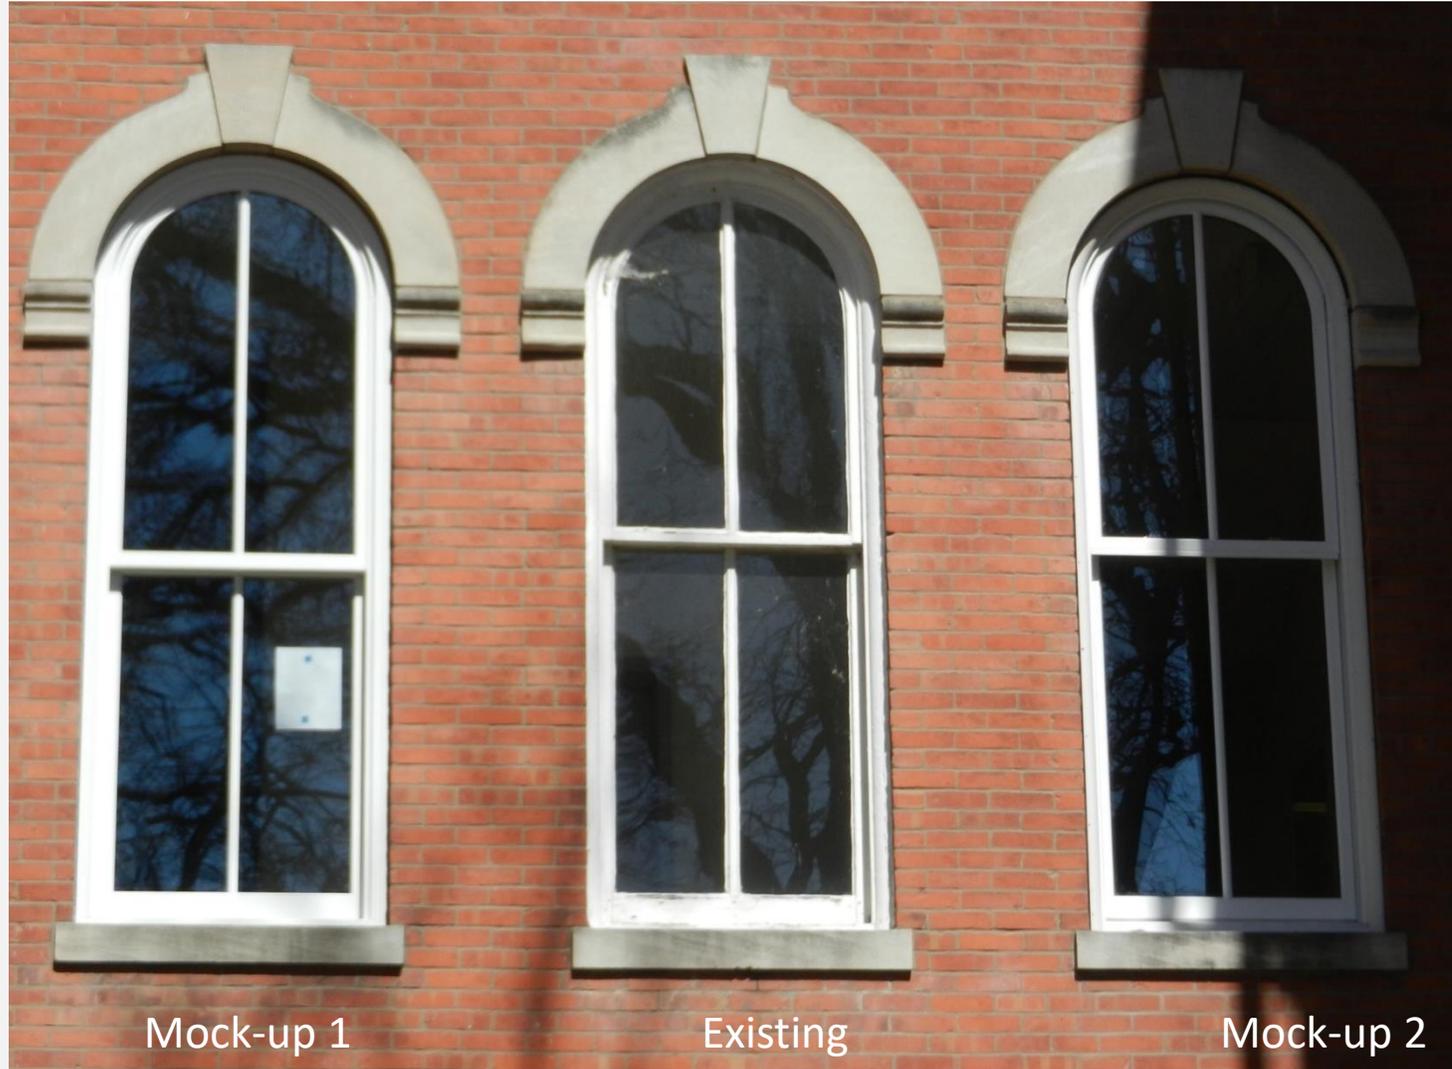
Verifying the Design – Mock-ups

Mock-up 1

Existing

Mock-up 2

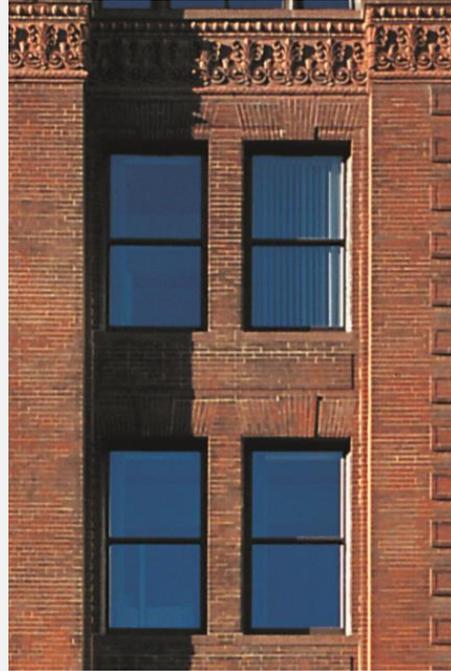
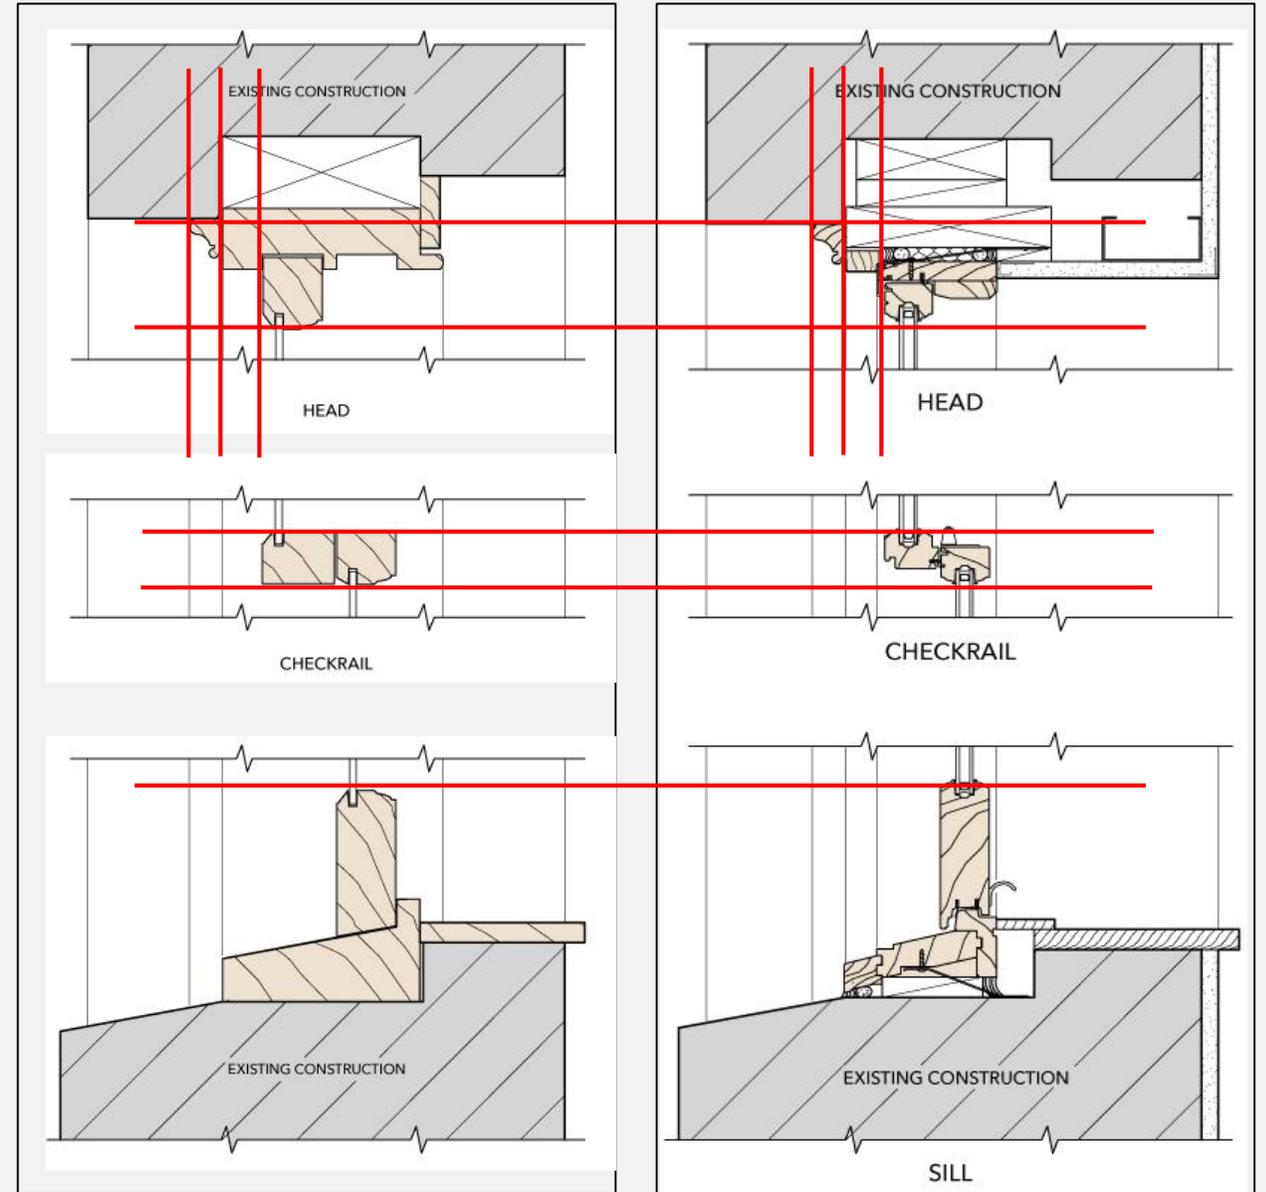
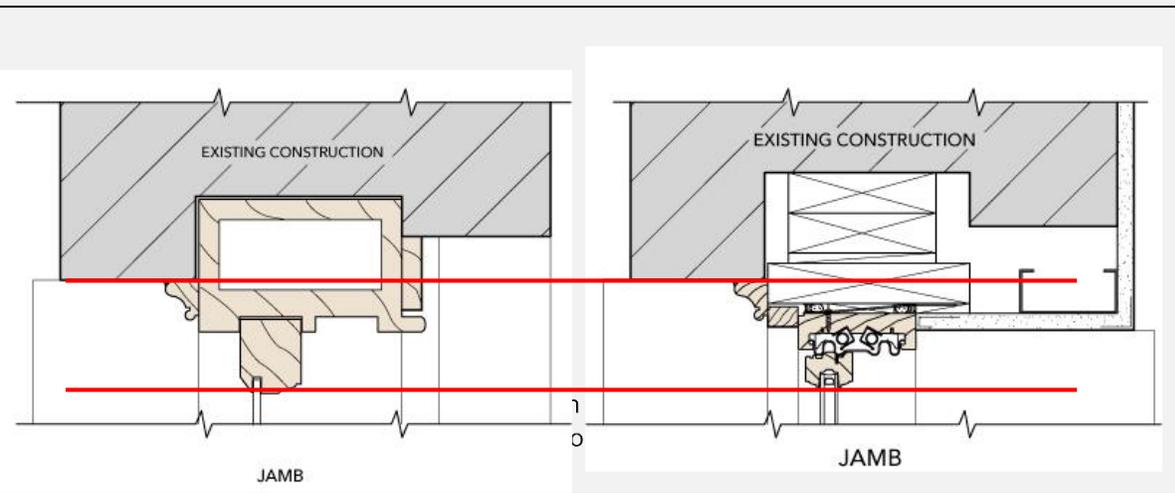
Existing vs. New Details

- Exact match
 - Sightlines
 - Set-backs
 - Brickmould profile
- Acceptable match
 - New product profiles

- Replace historic wood windows with new wood windows
- Complete tear-out
- Match sightlines but not profiles
- Replace clear single glass with low-E double glazing
- Owner emphasis on energy efficiency & sustainability

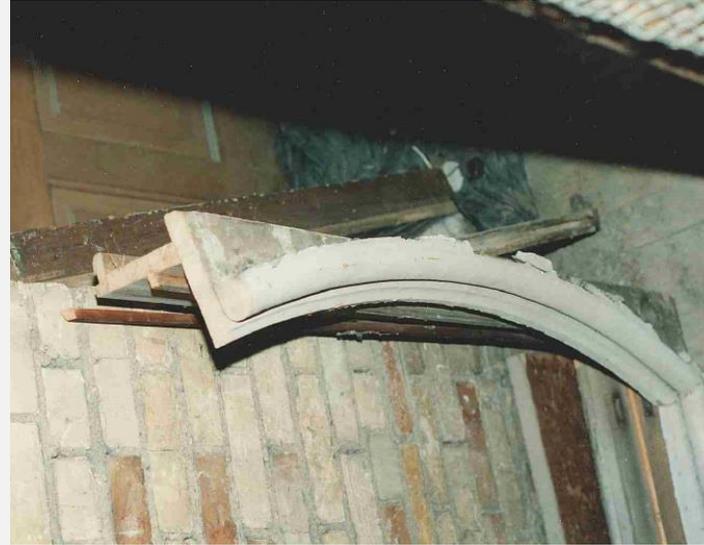
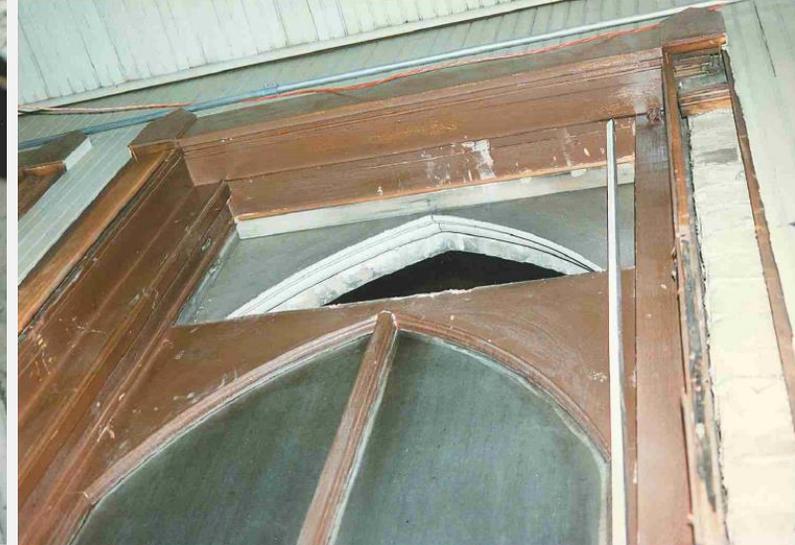
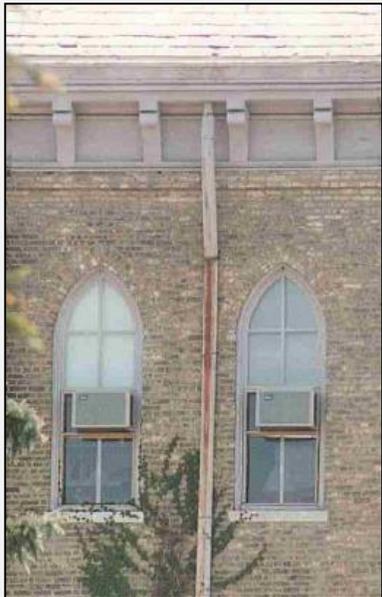
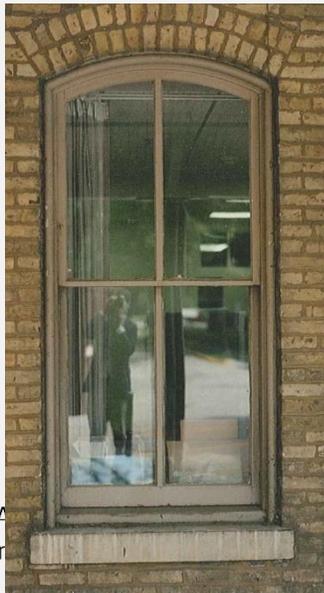
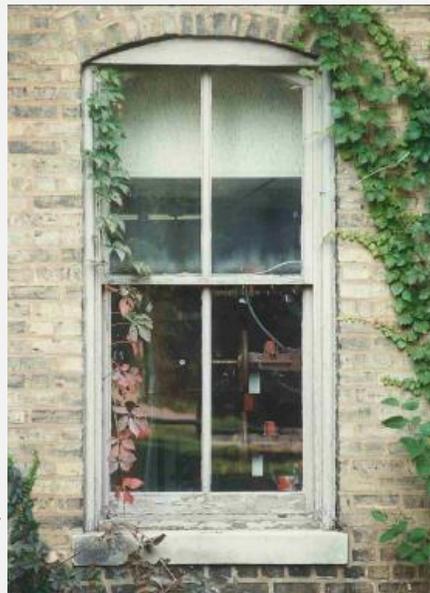
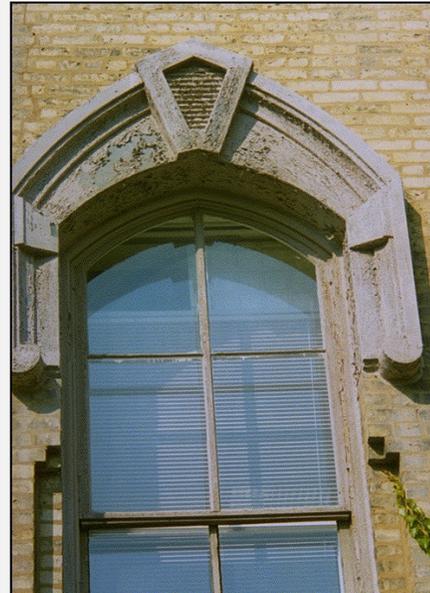
Existing Windows – Floors 1-5

- Wood, Single-glazed
- Double-hung (4' w x 11' h)
- Curve-top exteriors & rectangle-top interiors
- Flat arch-tops to gothic-tops
- 100+ different radii
- Some window air conditioners

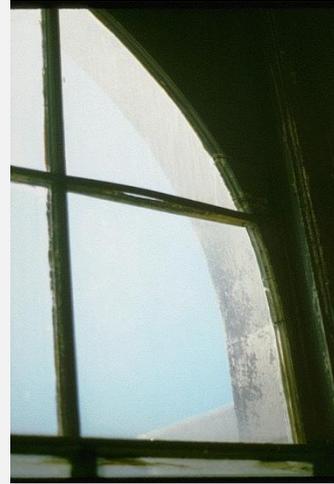
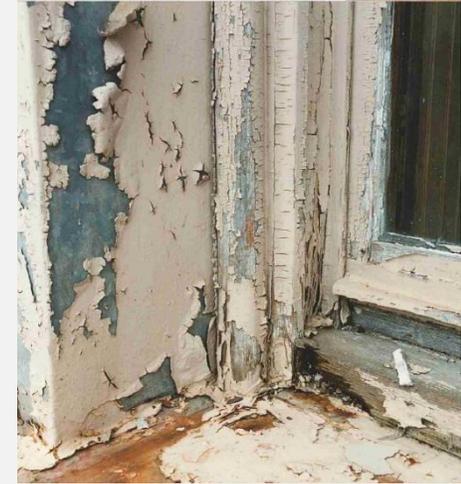
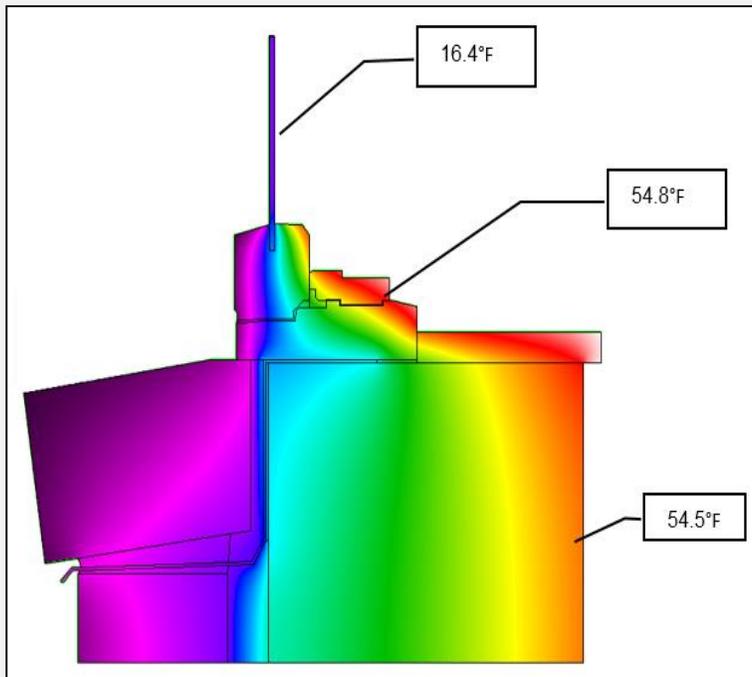
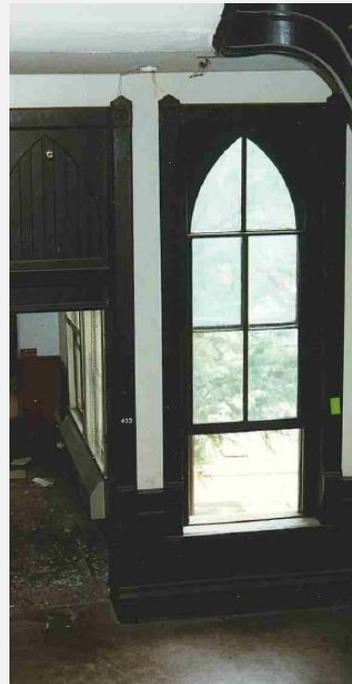
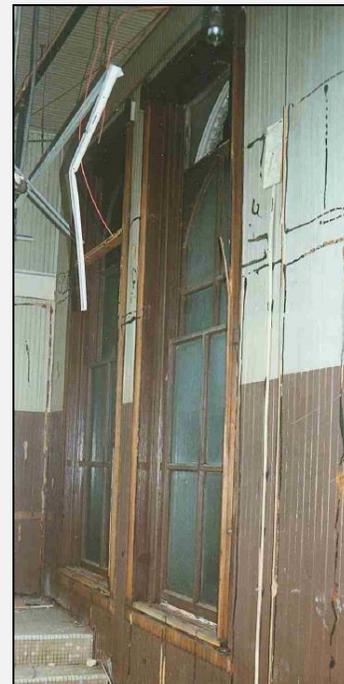
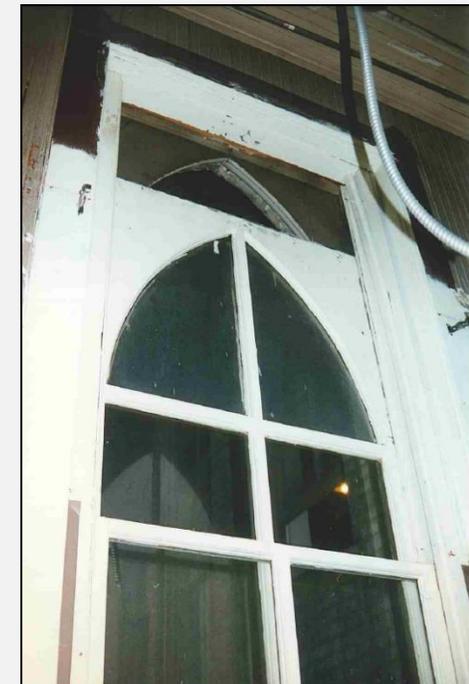
Existing Windows – Floors 1-5

- Divided lights, some failures, inconsistent widths
- Varying levels of deterioration
- Air & water leakage
- Condensation/Frost
